The Dahshour (Egypt) Earthquake of 12th of October 1992

Paper No. 7.25

M.M. Soliman

SYNOPSIS On the 12th of October, 1992 an earthquake of 5.7 moment magnitude hit Dahshour (Egypt) and the surrounding area. The characteristics of the building stock exposed to this earthquake is firstly presented in the paper. Then, the Dahshour earthquake is discussed in terms of the lessons that can be learned by engineers. The paper presents a short description of the geotechnical effects and the observed patterns of damage of the existing building categories and monuments. Finally, a list of the most important conclusions is introduced.

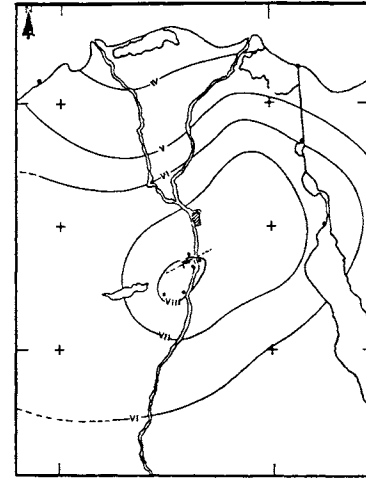
The Modified Mercalli Intensity (MMI) distribution presented by the Ain Shams Geophysical Research Team [1] and by Thenhaus, et al. [3], are presented in Figs 1 and 2, respectively.

Fig 1 (MMI) Distribution Presented by the Ain Shams Geophysical Research Team [1]

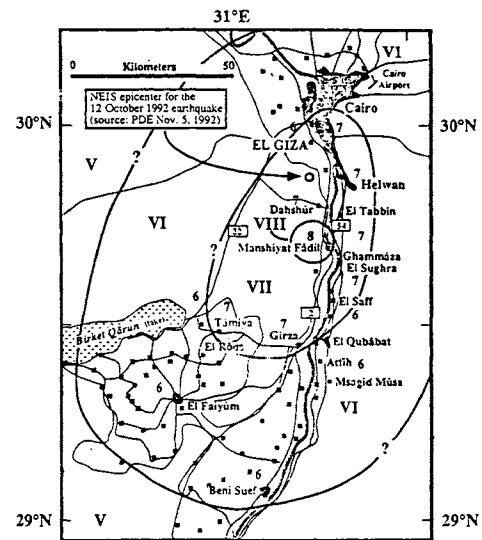
Fig 2 (MMI) Distribution Presented by Thenhaus, et al [3]
