ELLIS ISLAND: VIBRATION EFFECTS ON HISTORIC BUILDINGS CAUSED BY PILE DRIVING

Sixto Fernandez, MSc.
Schnabel Engineering
West Chester, Pennsylvania-USA 19382

ABSTRACT

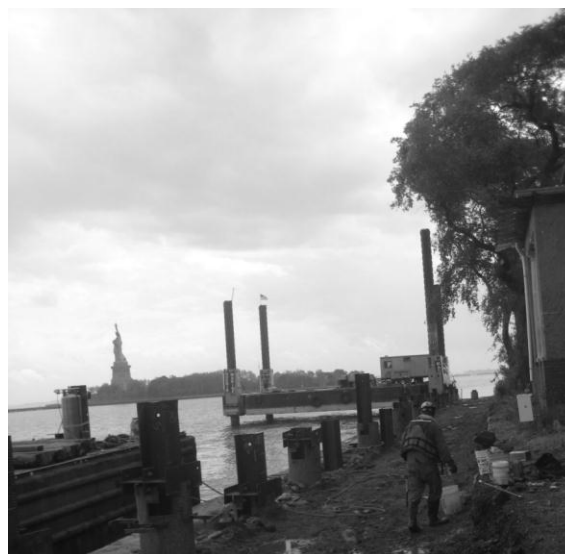
The soldier piles were steel H piles HP 14x89, 300 kip capacity in compression driven to rock. The lateral loads are taken by ground anchors. The piles are located parallel to the seawall as close as 20 ft from the buildings in some areas (Figure 4). The majority of the piles were driven along the South end of the Island. A total of about 120 piles were driven around the South end, East of the South side of the South Island and the ferry slip. Pre-drilling of the first 30 to 35 ft was used to reduce the vibration energy transmitted to the historic buildings.

The piles were driven from a barge with an air hammer. The hammer was a Vulcan-Bull 510 with a theoretical energy of 39,000 lb-ft. Figure 4 illustrates a typical driven piles arrangement and shows a typical location of the seismograph's boxes. These piles were located at the East side of the South Island, where the distances from the piles to the historic buildings are larger than those at the South end.

Fig 4. Typical driven piles and seismograph locations with respect to the buildings.

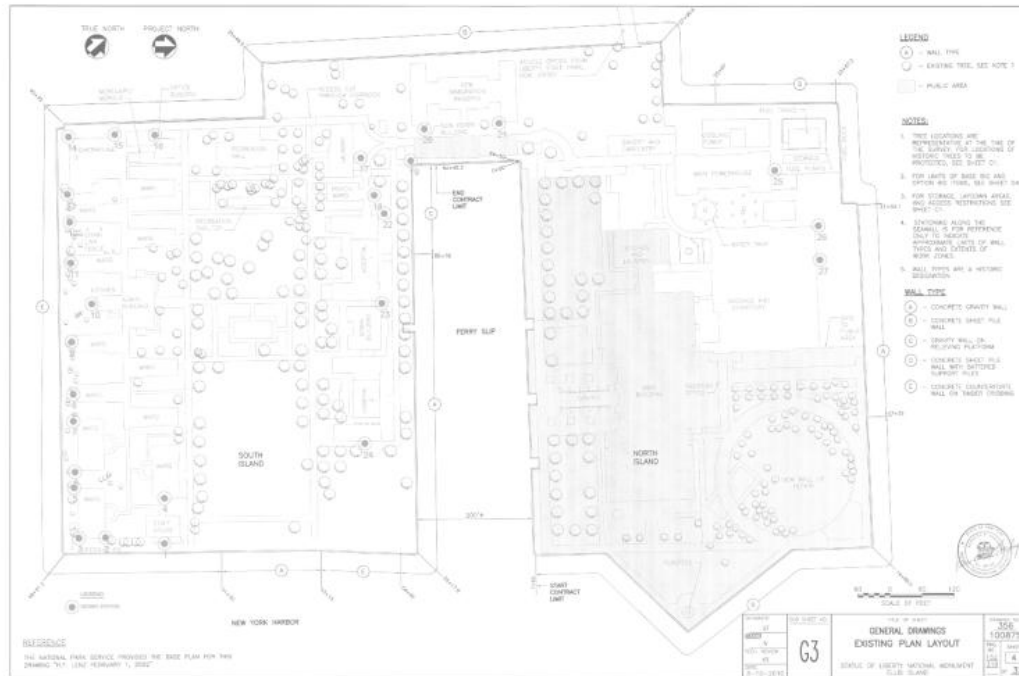
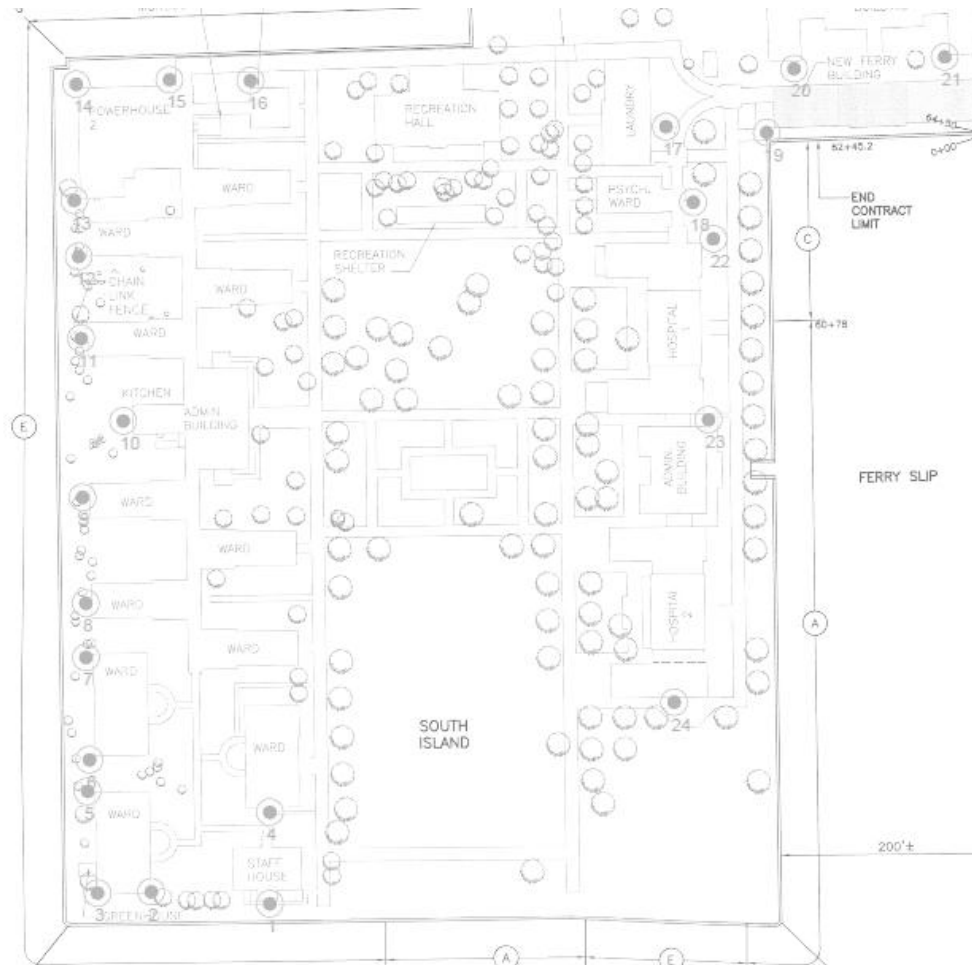
The location of the seismographs varied depending on the area that the contractor was driving piles. The concept of moveable stations permitted monitoring of vibrations for a radius of about 200 ft of pile driving at all times. An approximate location of all the used monitoring stations is shown in Figure 6.

Fig 6. Vibration monitoring stations; a) General plan; b) South Island
