Forensic Geotechnical Distress Evaluation of Damaged Buildings in Alluvial-Loessic Soils; A Case History

FORENSIC GEOTECHNICAL DISTRESS EVALUATION OF DAMAGED BUILDINGS IN ALLUVIAL-LOESSIC SOILS; A CASE HISTORY

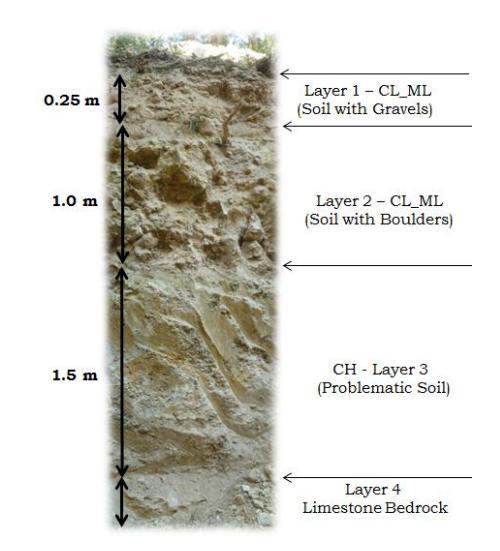
Geologically, the upper soil of research site is alluvial-loessic while deeper layers are a product of spontaneous weathering of underlain layers of limestone of "*Lucky Formation*". Occasionally, shale intercalating with limestone layers have also been reported at some location. The limestone layer is encountered at varying depths starting at shallow depth of 3m. Geologically the soils are classified as "*Marley Clays*". At one of the building site, three soil layers above the bed rock were encountered. The problematic "CH" layer as shown in Figure 7 while it's close up is shown in Figure 8.

Fig. 7. Soil Layers in the zone of influence

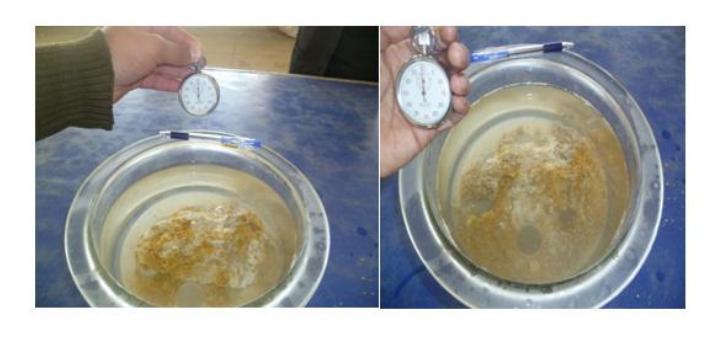
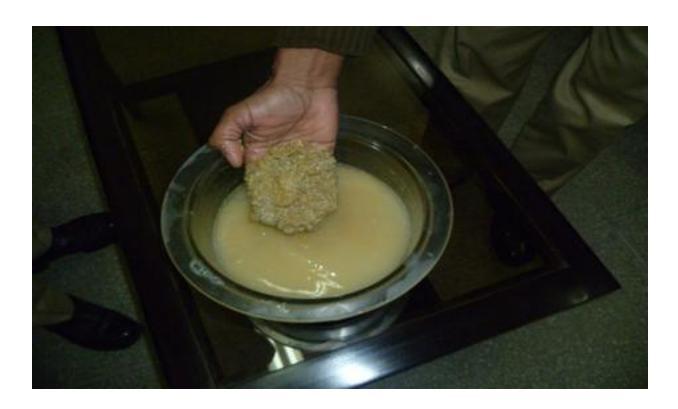
Crumb test was performed to study the dispersive potential of clay. High slaking of soil samples was observed for all the

samples of three test pits but turbidity was observed to be low, Figure 12.

Fig. 12. Crum Test; (a) Sample placed in water, (b) Sample after 20 minutes, (c) Sample after 45 minutes

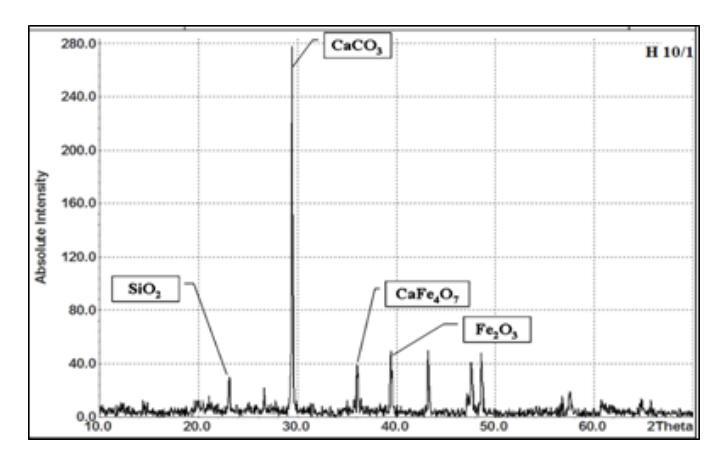
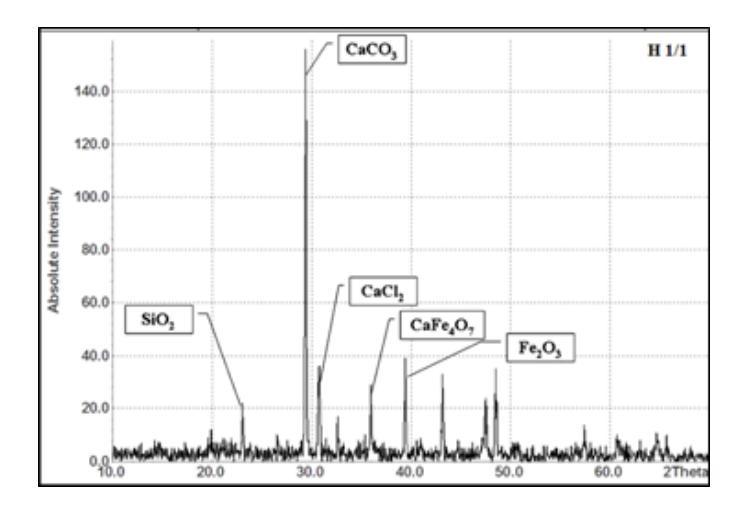
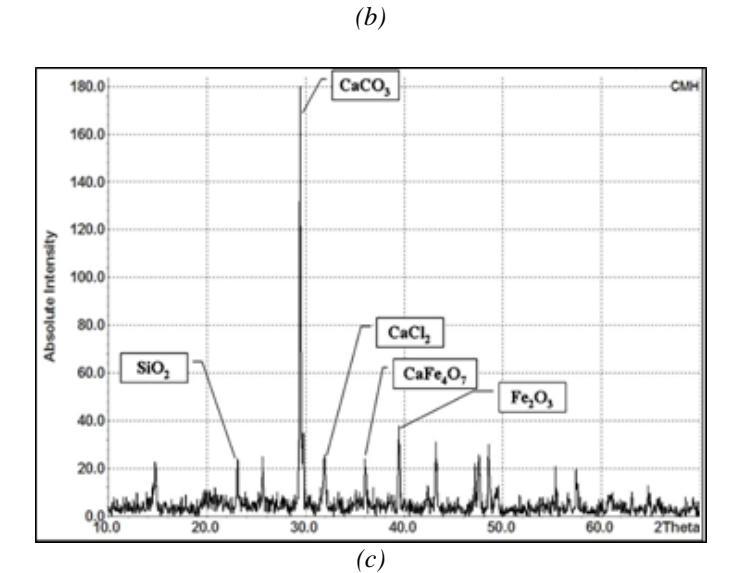
within a lattice. Scanning angle (2θ) was kept as 10° to 70° . The results of the samples from three research sites are shown in Figures 13 (a), (b) and (c).

Fig. 13. XRD analysis of three samples is shown in Figures (a), (b) and (c) above

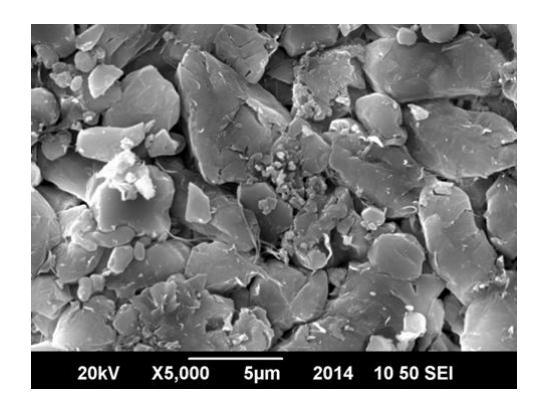
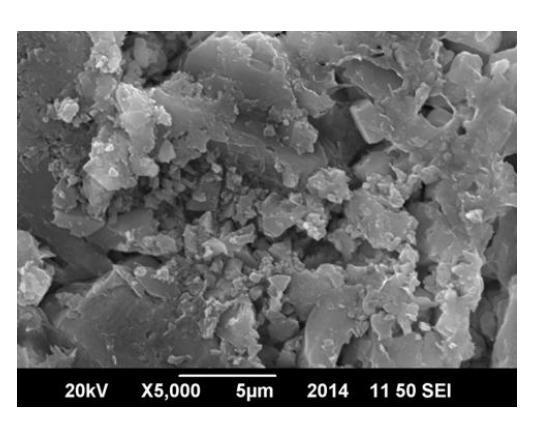
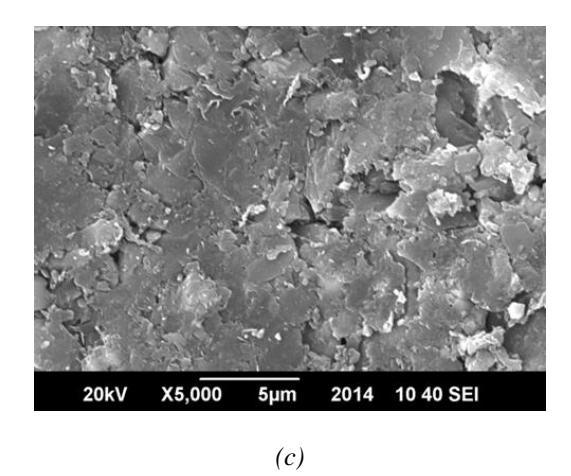
<u>SEM Analysis</u> SEM testing was a useful tool in visually observing the soil microstructure and complete elemental composition. It provides high resolution and long-depth-of-field images of sample surfaces and near surfaces. Electron microscope images of samples of all three research sites, Figure 14 (a), (b) and (c). The figures clearly show surfaces of montmorrolonite; irregularly shaped with other solids.

Fig. 14. SEM analysis of three samples is shown in Figures (a), (b) and (c) above
