# Lessons Learned from Liquefaction and Lifeline Performance During San Francisco Earthquakes

T. D. O'Rourke Cornell University, Ithaca, New York

# Lessons Learned from Liquefaction and Lifeline Performance During San Francisco Earthquakes Paper No. SOA12

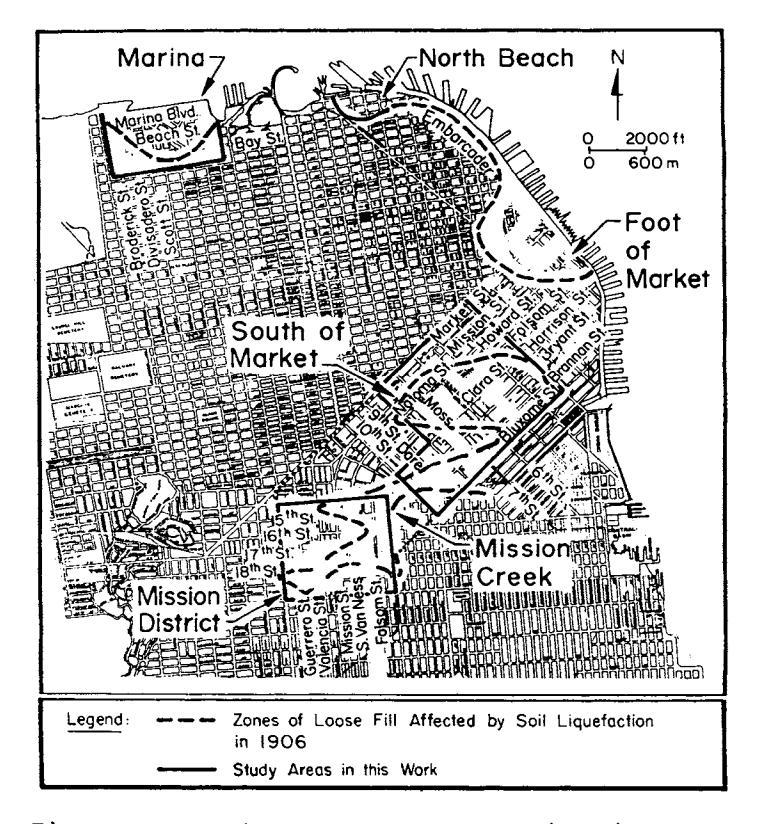
Figure 1 shows the areas of San Francisco in which soil liquefaction was observed in 1906 and 1989. This paper focuses on the Marina, Mission Creek, and South of Market areas. Subsurface data have been compiled and interpreted for the Marina (O'Rourke, et al., 1992 ) and the Mission Creek and South of Market areas (Pease and O'Rourke, 1993). The subsurface soil and groundwater conditions are described for each site, with special attention to the thickness of submerged fill and its relationship with liquefaction severity and buried pipeline damage. Large transient lateral shear strains are shown to be an important consequence of soil liquefaction. It is likely that lateral ground displacements associated with these strains are the primary cause of the extensive damage to the water distribution system in the Marina. The influence of surface gradient and thickness of liquefiable layer on the magnitude of soil displacement is evaluated on the basis of subsurface data and observations after the 1906 earthquake. The surface manifestation of liquefaction effects is evaluated with respect to the ratio of the non-liquefiable upper layer

Figure 1. Principal Areas of Soil Liquefaction in the 1906 and 1989 Earthquakes, showing the Marina, Mission District, and South of Market Study Areas

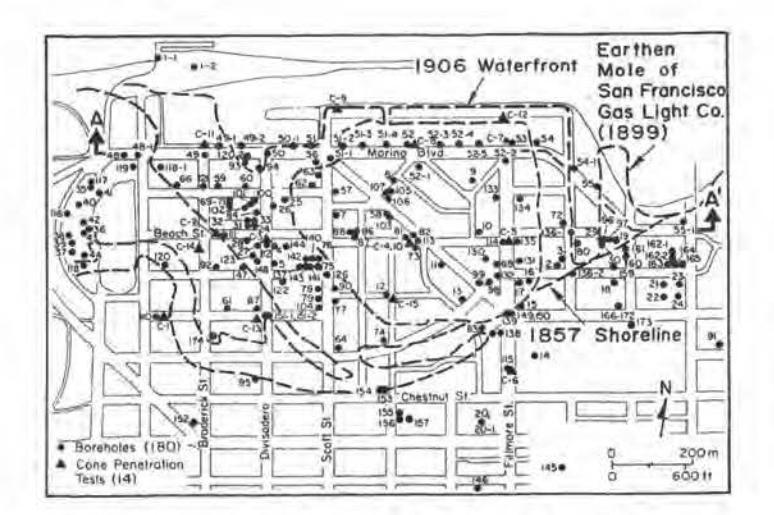
Figure 2. Locations of Conventional Boreholes, Cone Penetration Soundings, and Cross-Section A-A' in the Marina District

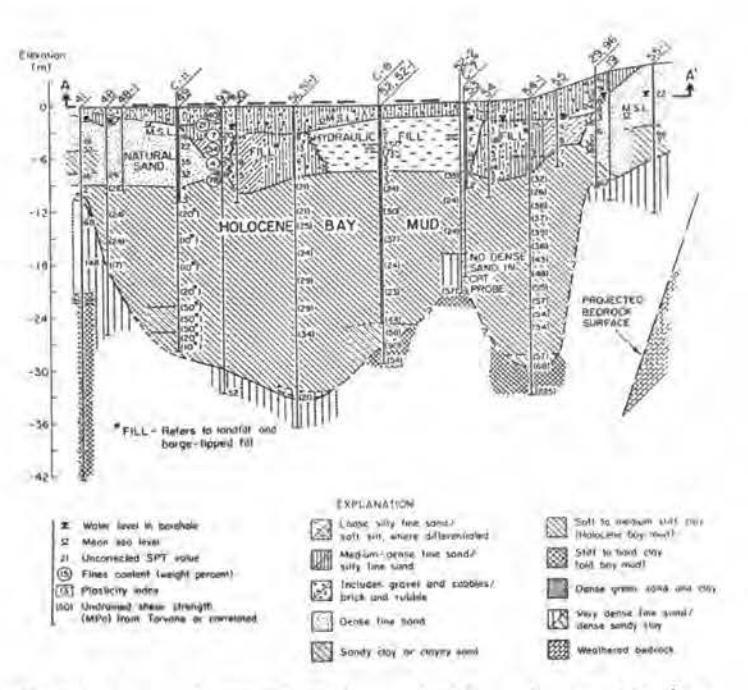
Cross-section A-A' in Figure 3 shows the soil profile along Marina Blvd. from approximately Baker St. to Buchanan St. Loose fills extend to a maximum depth of about 9 m. The depth to water table is approximately 2.5 m. Underlying the loose fills and natural sand deposits is Holocene bay mud, which in the cross-section varies from 9 to 32 m thickness. Underlying the mud are dense sand and stiff to hard clay.

Figure 3. Cross-Section A-A' along Marina Boulevard. Elevation refers to San Francisco City Datum, which is 2.7 m above Mean Sea Level (M.S.L.)

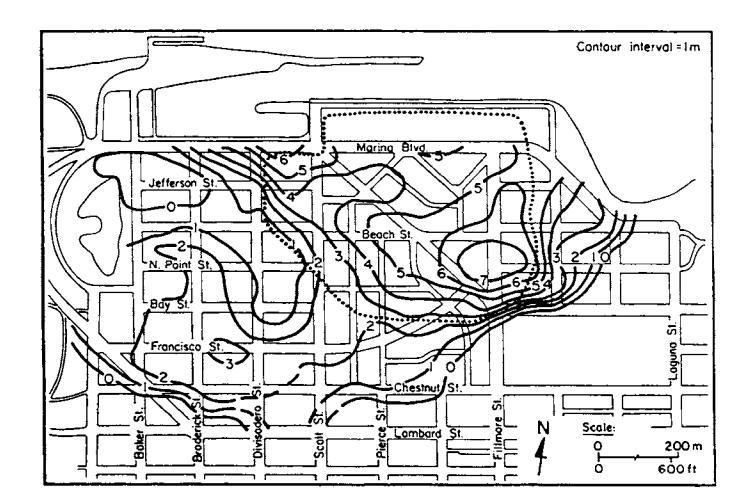
The submerged fill thickness plotted in Figure 4 may be regarded as a map of potentially liquefiable deposits, in which the increasing thickness reflects the potential for increasing liquefaction severity. In most land-tipped fill areas, there is less than 2 m thickness of submerged fill.

Figure 4. Thickness of Submerged Fill Deposits in the Marina District

The pattern of liquefaction settlement strongly reflects the distribution and thickness of submerged fill in Figure 4. Magnitude of settlement was less than 5 mm for streets southeast of Marina Cove overlying former sand dunes, and was from 0 to 10 mm in locations overlying the highest portions of former Strawberry Island. Settlement of land-tipped fill exceeds 80 mm between Divisadero and Scott Sts. where dumped fill thickness increases rapidly toward San Francisco Bay. Significant settlements also occurred inshore of Strawberry Island to the southwest, in the former marsh. From 40 to 60 mm of settlement occur overlying the former tidal channel in the marsh under Broderick and Divisadero Sts., which represents the location of locally thickest fill. Settlement is largest in areas underlain by hydraulic fill, where corrected survey measurements identify from 40 to 170 mm settlement. Uneven settlement occurred in the hydraulic fill, possibly due to large lateral variations in soil consistency and in thickness of non-liquefiable lenses in the fills (O'Rourke, et al., 1992).

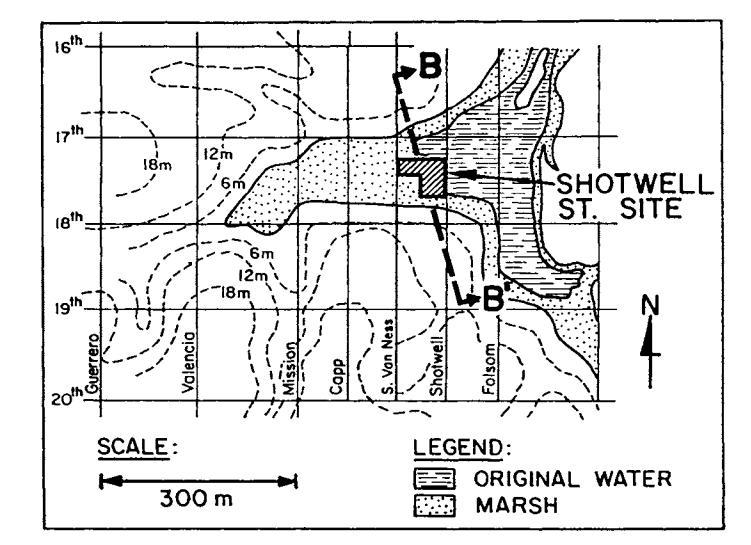
The 1.2  $\text{km}^2$  area, referred to as the Mission District in this work, is shown in Figure 11. The original water and marsh areas are shown in the figure, together with topographic contours mapped in 1853 (U.S. Coast Survey, 1853). Subsurface investigations were performed by Cornell researchers for USGS throughout this area, with one of the locations of concentrated

Figure 11. 1857 Topography, Marsh and Bay Regions, and Location of Section B-B' in the Mission District

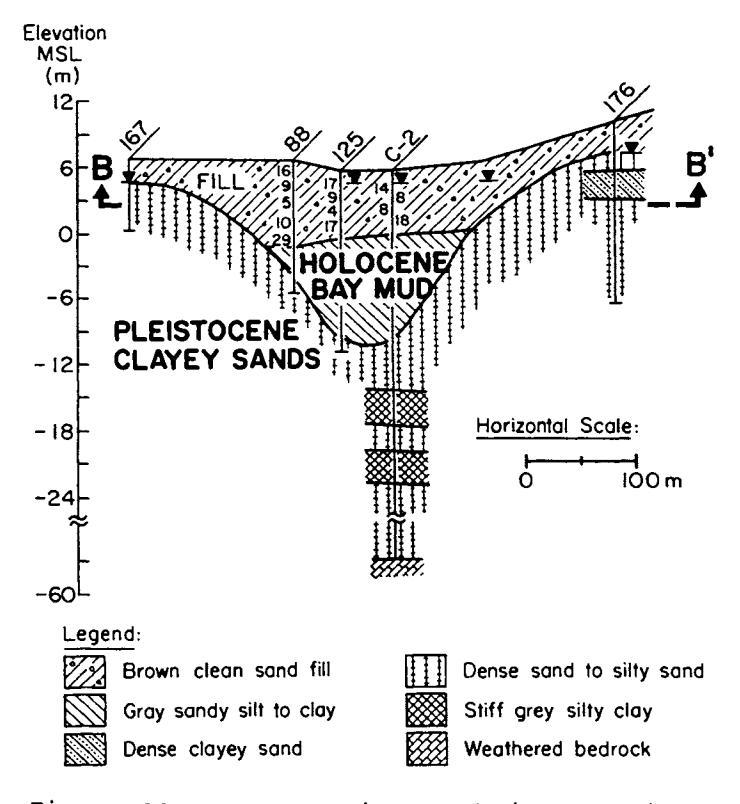
Figure 12. Cross-Section B-B' in the Mission District

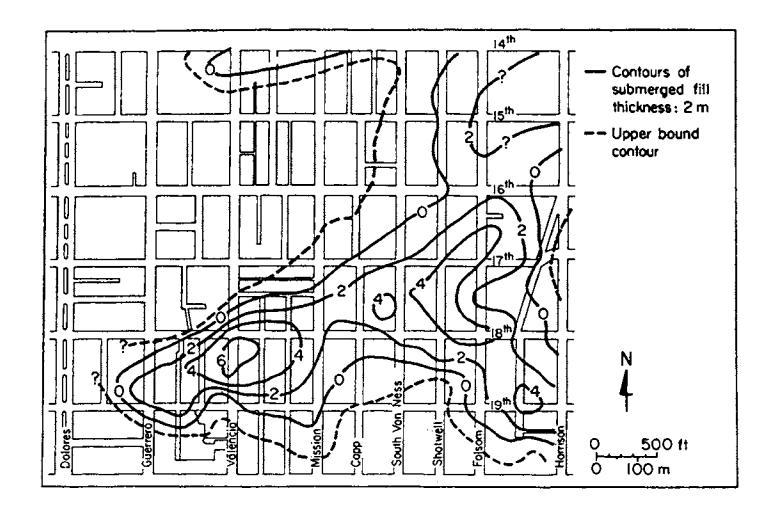
Figure 13. Thickness of Submerged Fill Deposits in the Mission District

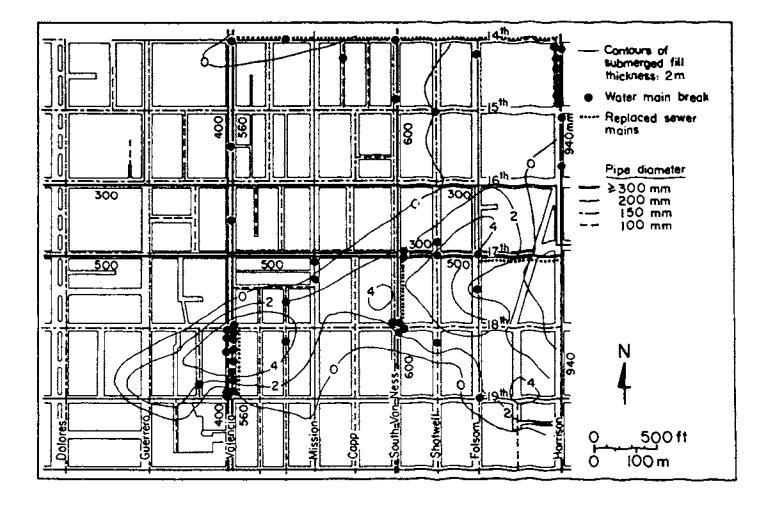
Surface Elevations and Figure 16. Street Gradients in the Mission trict

Figure 16 shows damage after the 1906 earthquake to the water supply and sewer system in the Mission District superimposed on the contours of liquefiable thickness. The locations and sizes of water mains are based on 1912 maps of the water distribution system (Edward Denny and Co., 1912). Water main breaks, shown by dark circles, refer to breaks reported by the Spring Valley Water Company (Schussler, 1906, Manson, 1908). In some cases where pipelines cross or run parallel, it is uncertain which pipes were broken. More than one break occurred at locations indicated by Manson on South Van Ness at 17th and 18th, and multiple breaks may have occurred at other Sewer damage is based on locations as well.

Fifty water main breaks, denoted by solid dots, were reported in the Mission District. Eighty percent of these breaks occurred in the zone overlying submerged fill. Two major areas of breakage occurred on major trunk lines across the submerged fill zones at Valencia St. and Harrison St. Between Valencia and Harrison Sts., breaks were less concentrated and tend to be located toward the margins, rather than the center of the submerged fill. In many cases they correspond to the locations of scarps and offsets in Figure 15.

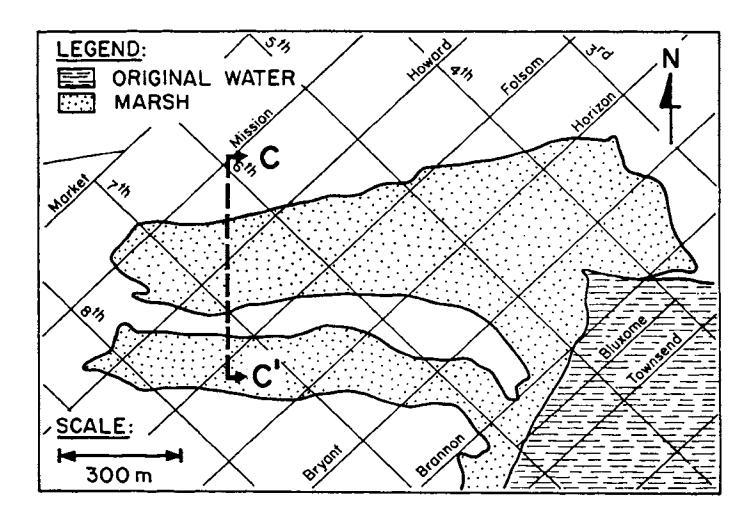
A study area of 2.2  $\text{km}^2$ , shown in Figure 17, is located in the South of Market, in a region bounded by Market and Townsend Sts. between 3rd and 8th Sts., and by Harrison and Division Sts. between 8th and 11th Sts. It includes two areas of major lateral spread in 1906: the former Sullivan Marsh and the channel of Lower Mission Creek near Dore St. Both these areas were tidal lands, artificially filled with soil from adjacent sand dunes. Liquefaction-induced damage was concentrated in the same zones after the 1989 Loma Prieta earthquake.

Figure 17. Boundaries of Marsh, Mission Bay, and Location of Section C-C' in the South of Market

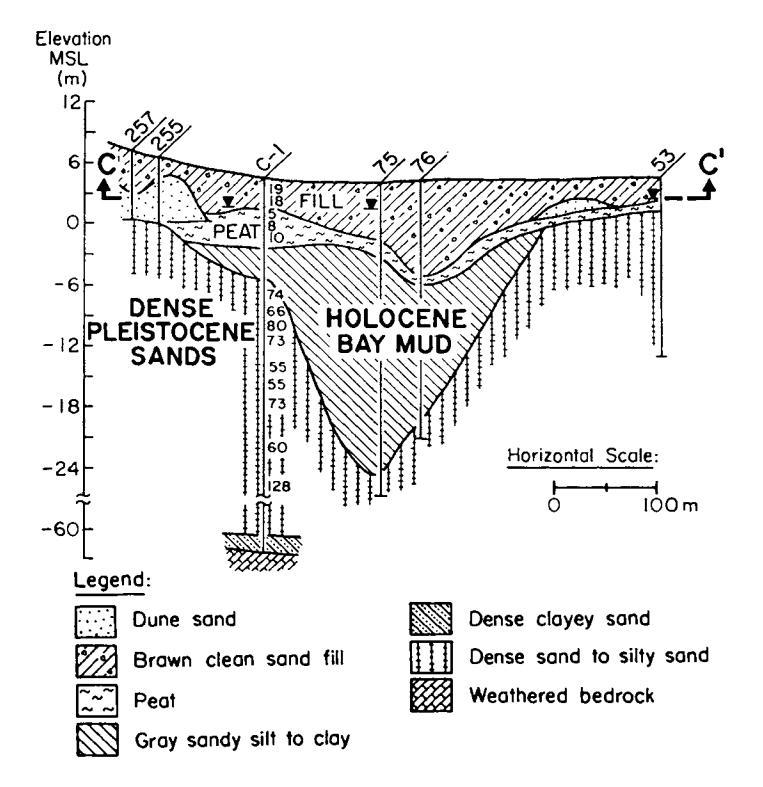
Cross-section C-C' in Figure 18 shows the subsurface conditions encountered along the western margin of buried marsh land, once referred to as Sullivan's Marsh. The soil profile was drawn on the basis of conventional borings and CPT soundings performed by Cornell researchers, as well as conventional borings collected for various construction projects. A database of 306 boreholes, soundings and surface excavations was collected to evaluate subsurface conditions. A detailed description of the data collection and mapping procedures is given by Pease and O'Rourke (1993).

Figure 18. Cross-Section C-C' in the South of Market

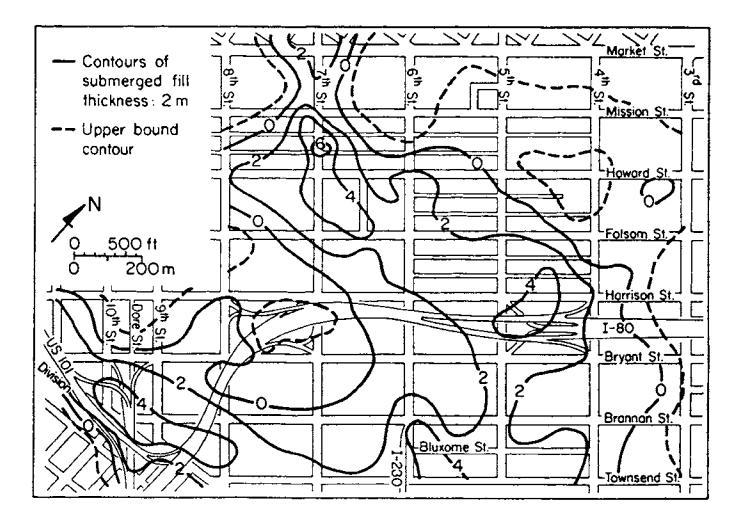
Extent and thickness of liquefiable deposits were evaluated by the same methodologies as described for the Marina District. Submerged fill thickness is mapped in Figure 19. Contours indicate fill thickness below the water table in meters. The zero contour indicates where the water table is at the level of the base of fill, and represents a theoretical boundary between regions where liquefaction can potentially occur and where it cannot occur. As a practical matter, a dashed upper bound contour has been drawn to represent a margin to accommodate uncertainties in elevations of the fill and the groundwater table. The upper bound contour represents locations where groundwater levels are within 2 m of the base of the fill deposit.

In Figure 19, approximately 6 m of saturated, loose fill occurs at 7th St. from Mission to Howard Sts. Submerged fill also exceeds 4 m along Mission Creek at Dore and Brannan Sts., 5th and Harrison Sts., and 6th and Townsend Sts. These areas overlie narrow buried ravines

Figure 19. Thickness of Submerged Fill Deposits in the South of Market

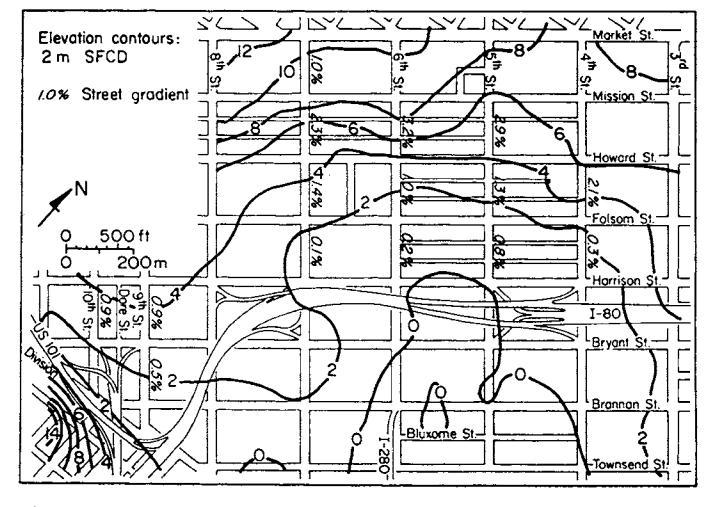
Current surface contours are illustrated in Figure 20. The map is based on survey data acquired at major street intersections by the City of San Francisco Department of Public Works, between 1985 and 1991. The contours are based on data at roughly 200 to 250 m spacings. Contours intervals are 2 m with respect to San Francisco City Datum. Average surface slopes in percent between intersections are shown in italics for selected streets.

Figure 20. Current Surface Elevations and Street Gradients in the South of Market

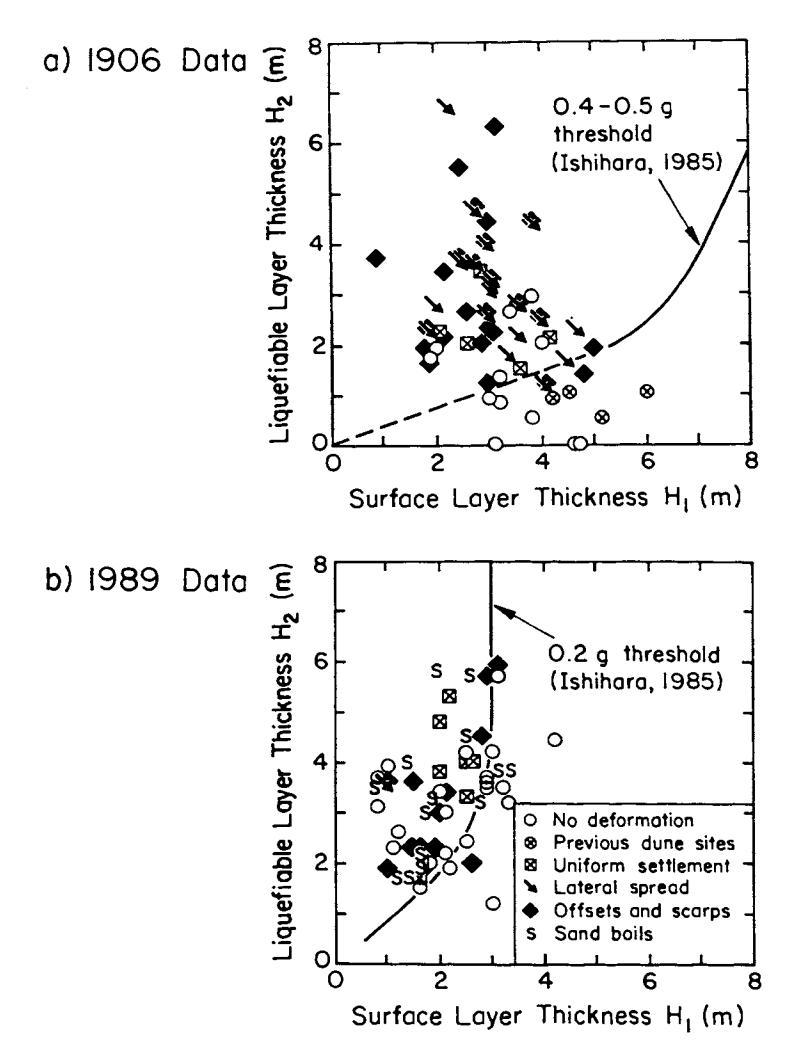
Figure 26. Ground Deformation in the South of Market and Mission District Plotted with Respect to Subsurface Geometry for the 1906 and 1989 earthquakes

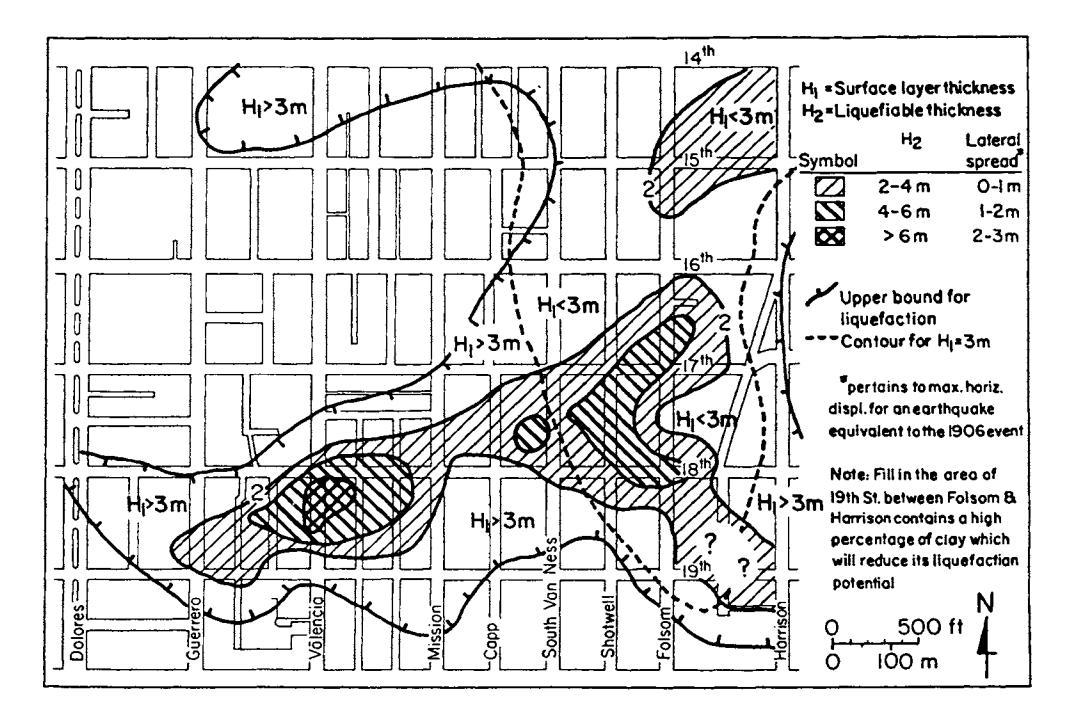
Figure 28. Liquefaction Hazard Map of the Mission District, Showing Zones of Highest Potential Damage and Lateral Movement for an Earthquake of Similar Magnitude to the 1906 San Francisco Earthquake. [Note: A dashed contour ( $H_1 = 3$  m) indicates the regions where surface layer thickness is less than 3 m, for which liquefaction damage is more likely to be observed during lower magnitude earthquakes, such as the 1989 Loma Prieta earthquake.]

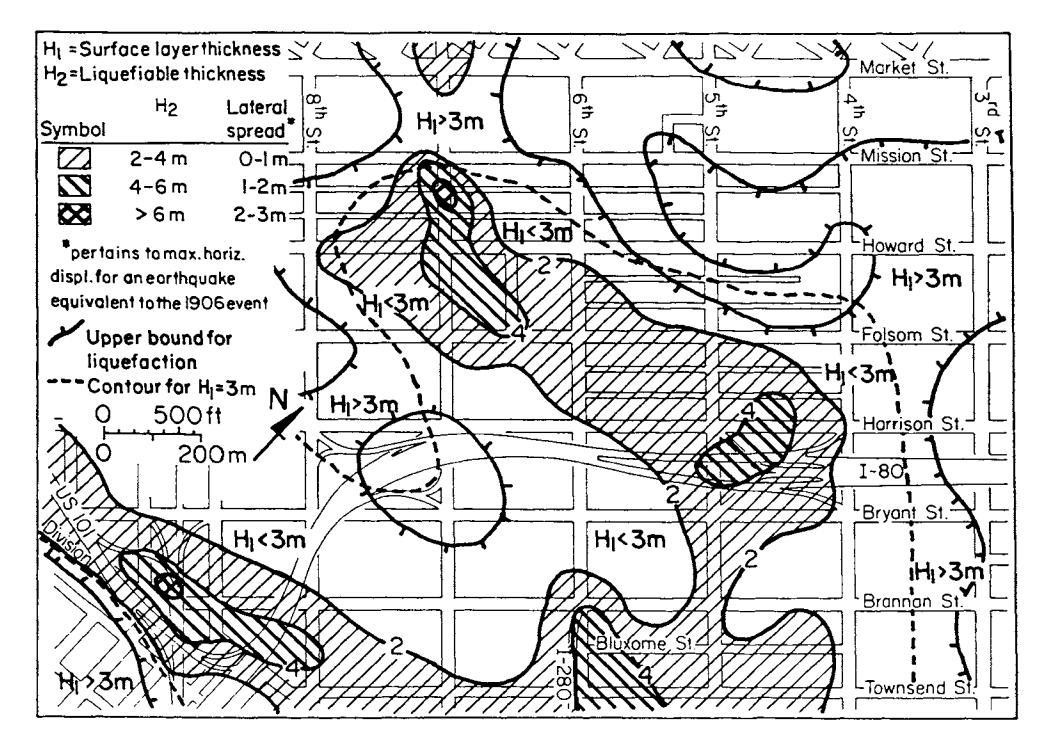
Figure 29. Liquefaction Hazard Map of the South of Market, Showing Zones of Highest Potential Damage and Lateral Movement for an Earthquake of Similar Magnitude to the 1906 San Francisco Earthquake [Note: A dashed contour ( $H_1 = 3$  m) indicates the regions where surface layer thickness is less than 3 m, where liquefaction damage is more likely to be observed during lower magnitude earthquakes, such as the 1989 Loma Prieta earthquake.] solidation, and magnitude of horizontal surface movement generated by transient lateral shear strain. These deformations contribute directly to pipeline damage, the disruptions of streets and sidewalks, and disturbance of related surface and subsurface structures. Buildings are damaged by these types of deformation and also by loss of bearing of shallow strip and spread footings founded on liquefiable deposits.
