Damage of Governmental Building Due to Geotechnical Properties (Case History)

DAMAGE OF GOVERNMENTAL BUILDING DUE TO GEOTECHNICAL PROPERTIES (CASE HISTORY)

This paper is a case study for a governmental building in a site located at Katamia zone (an extension of Great Cairo, Egypt). The site is belonging the Great Cairo Bus Station under the authority of Ministry of Transportation. It consists of two buildings and a shed for buses cleaning and lubrication. The buildings had been constructed since 15 years. However after two years of construction many cracks were noticed in the main building. Furthermore, after another few years, sever cracks had appeared in different parts of the building and the concrete water tank on the roof of same building had suffered from failure. The aim of this study is to know and examine the reasons of these cracks and damages which happened to the building, particularly the other building suffered no cracks or damages although it was built on the same soil and under the same conditions. Observation of the building movements were recorded over several years as well as soil investigation around and under the building. A structural analysis and an estimat

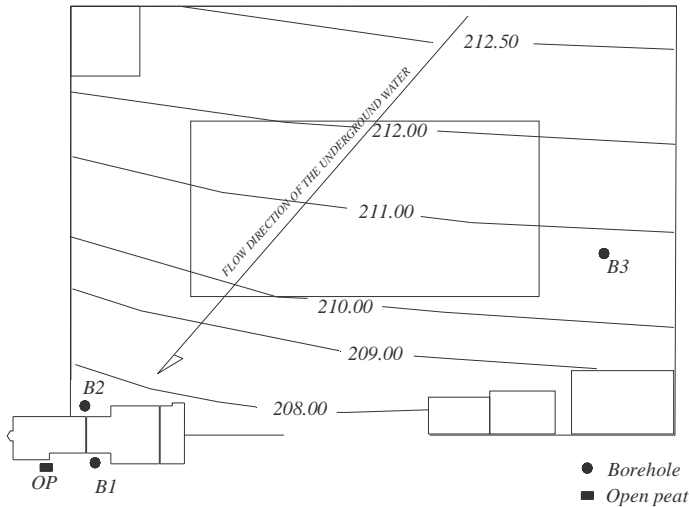
FIG. 1 The General Layout and Borehole Locations and Levels

In order to determine the causes of cracks and the movement of the building, two types of investigation were made, firstly two boreholes and one open pit were done. Figure (1) shows the location and level of them. Secondly, excavation around representative numbers of footing was made Fig. (2).

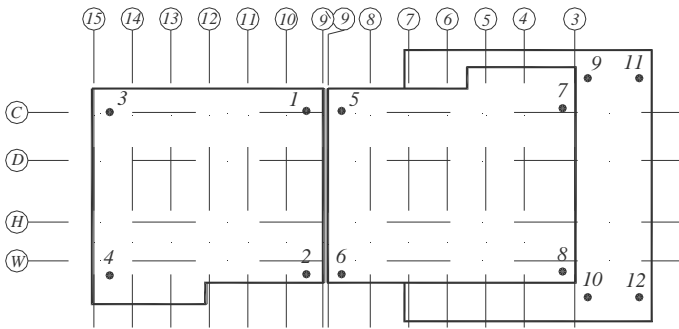
Fig.(6) Plan of The Locations of The monitoring Points and the Axis

Observation of the building movements were recorded over 5 years from 1996 through 2001. The horizontal and vertical movements were observed at 12 points as shown in Figs. (4 & 5). They were recorded by an optical teodolite, and the increase in the width of the construction joint was also measured.

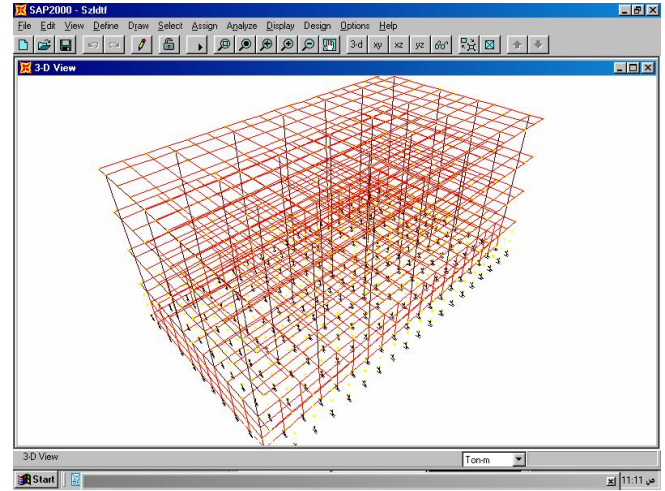
Fig. 6. Idealization of the Structure (F.E. Program)

After the deformation of the building and making up the monitoring of the vertical movement, a structural analysis for the building as well as estimation of stresses under foundation have been calculated using a three dimensional modeling (SAP 90program) for the finite element whereas the soil was modeling using springs and as shown in Fig. (6).

The trial and error technique has been adopted to simulate or to result in equal movements of compared to the vertical movement, which has been recorded from the monitoring program. The stress distributions were calculated and plotted as shown in Fig. (7).

As it was noticed the biggest settlement occurred at points 3 and 4 on axis number 15, where there was a big change in stresses. An increment nearly about 50% and sometimes is more than that. For the column at point (1) beside the expansion joint at axis number 9', it was broken near the beam as shown in Pho. (2).
