Evaluation and Repair of a Subterranean Parking Garage to Resist Hurricane Flood Levels

EVALUATION AND REPAIR OF A SUBTERRANEAN PARKING GARAGE TO RESIST HURRICANE FLOOD LEVELS

Matthew E. Meyer, P.E.
Senior Associate
Langan Engineering & Environmental Svcs.
Miami Lakes, FL - U.S.A

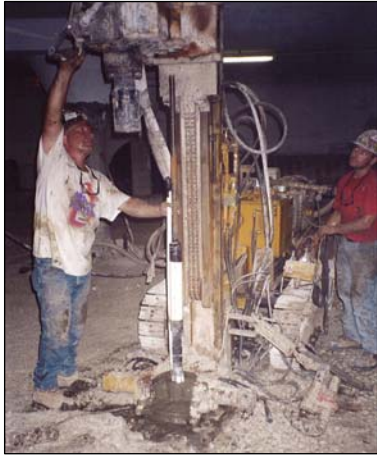
Photograph G – Low headroom anchor rig

All rock anchors were installed with a low headroom Klemm drill rig to the required embedment into the underlying Miami Limestone bearing layer. See Photograph G showing the low headroom drill rig and installation of an anchor into the grout filled hole.

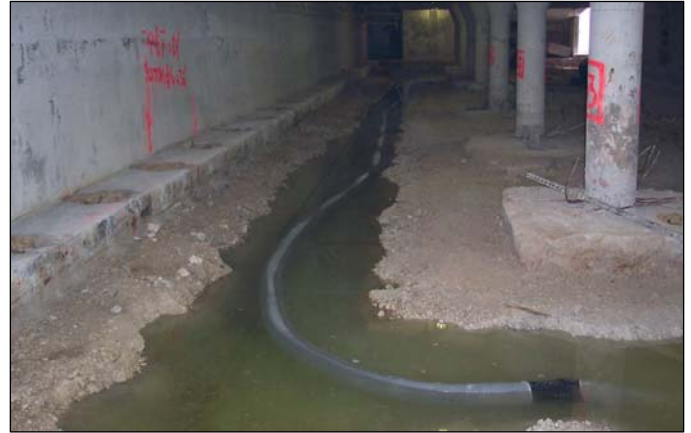
Photograph L – Lateral sock drain installation

For this project, a network of aggregate-filled lateral drains with geosynthetic encased perforated pipes were installed

between column footings to facilitate conveyance of the groundwater to two extraction locations. A well point vacuum extraction pump was hard-connected to the lateral buried corrugated, perforated pipe at each extraction location. The flow rate required to maintain the project site in a dewatered condition varied but was typically on the order of 1,000 gallons per minute (gpm-0.063 m³/sec). See Photograph L and M.
