Foundation Rehabilitation of Bridge over Danube: the Role of Pile Integrity Testing

FOUNDATION REHABILITATION OF BRIDGE OVER DANUBE: THE ROLE OF PILE INTEGRITY TESTING

The construction of the bridge near Pöchlarn over Danube, in Austria was begun 1998 and completed in 2002. The four middle piers of the bridge consist of sink caissons made of pre-cast reinforced concrete elements. Each caisson is founded on 18 bored piles of 1.2 m diameter. In a first step, two pilot piles of about 40 m length are installed for each caisson. After the pilot piles were completed, an accident happened in April 1999. A cargo ship collided with the pier no 3 and damaged the two pilot piles. Since the piles were below water level, it was very difficult to inspect the damage. Therefore, integrity tests were carried out to know the level of damage. The possible scenarios range from local repair to installation of new pilot piles. The paper describes a case study of the repair works of the damaged piles, where under water pile integrity tests were carried out.

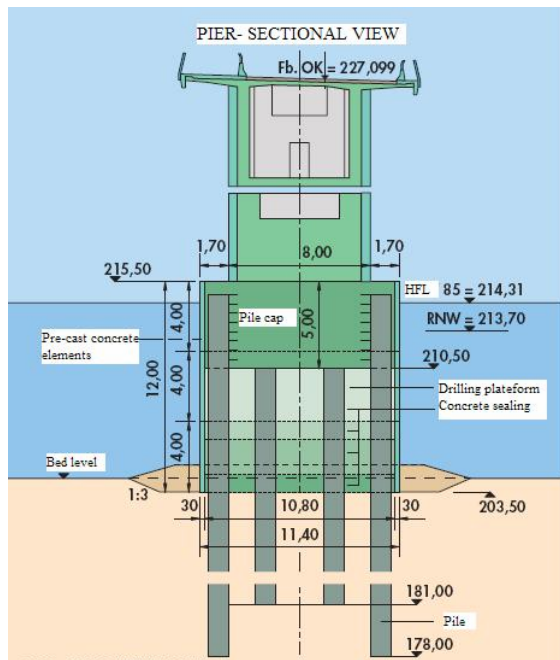
Fig. 1: The sectional view of the pier

The construction of the bridge near Pöchlarn over Danube in Austria was begun 1998 and completed in 2002. The bridge is a cantilever bridge made of hollow box of reinforced concrete. The bridge has a total length of about 460 m, which consists of three middle spans of each 105 m and two spans to the ramps of each 72.5 m. The four middle piers consist of sink caissons made of three pieces pre-cast reinforced concrete oval shape elements. Each caisson is founded on 18 bored piles of 1.2 m diameter. In a first step, two pilot piles of about 40 m length are installed for each caisson. These two pilot piles provide some guide for caisson sinking. Afterwards the caisson is sunk and the rest 16 piles are installed in the foundation box (see Fig. 1).

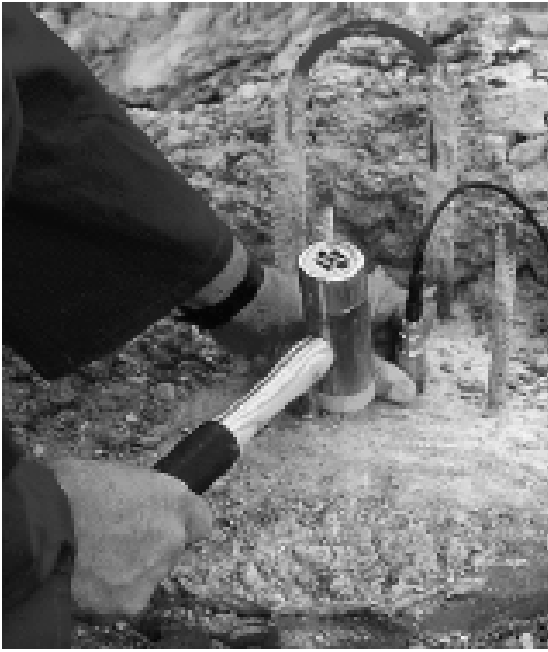
Fig. 3: Wave generation with the help of a hammer

The SIT test is performed with a hand held hammer (Fig. 3) to generate an impact. An accelerometer or geophone is placed on top of the pile to be tested to measure the response to the hammer impact and a data acquisition and interpretation electronic instrument is attached to the computer. The test works well in concrete or timber foundations that are not excessively slender.

As a rule the test should be carried out on the pile top surface, free of dirt and cracks. But in our case the pile top surface was under water and there was no possibility of physical inspection. Moreover, there was a problem to generate the sonic impulse into the body of pile. It is relatively difficult to control the hammer blow under the water, which was still more difficult in flowing water. In addition, the water film on the pile top substantially reduces the blow energy, which means, a strong blow is needed to generate the required intensity of the sonic impulses.
