## Foundations on Expansive Soils in Mexico

Enrique Padilla-Corona  
COSIC - Consultants, Guadalajara, México

Padilla-Corona, Enrique, "Foundations on Expansive Soils in Mexico" (2008). *International Conference on Case Histories in Geotechnical Engineering*. 16.

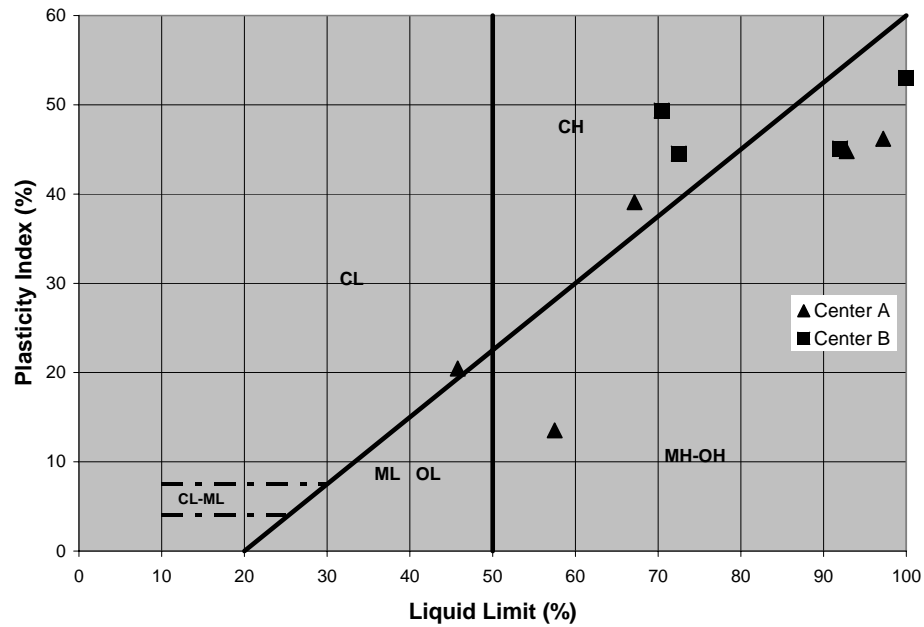
Additionally, the expansive soil layers were identified using laboratory index tests such as the Casagrande classification criterion. Fig. 2 shows the location of these soils on the plasticity letter where three clays are classified as high plasticity (CH), five clayed silties are classified as medium plasticity (MH), and the rest, sandy clay, is classified as medium plasticity (CL).

Fig.2 Location of typical expansive soils in the Casagrande plasticity chart.
