Rapid repair of severely damaged RC columns under combined loading of flexure, shear, and torsion with externally bonded CFRP

RAPID REPAIR OF SEVERELY DAMAGED RC COLUMNS UNDER
COMBINED LOADING OF FLEXURE, SHEAR, AND TORSION
WITH EXTERNALLY BONDED CFRP

A DISSERTATION

CIVIL ENGINEERING

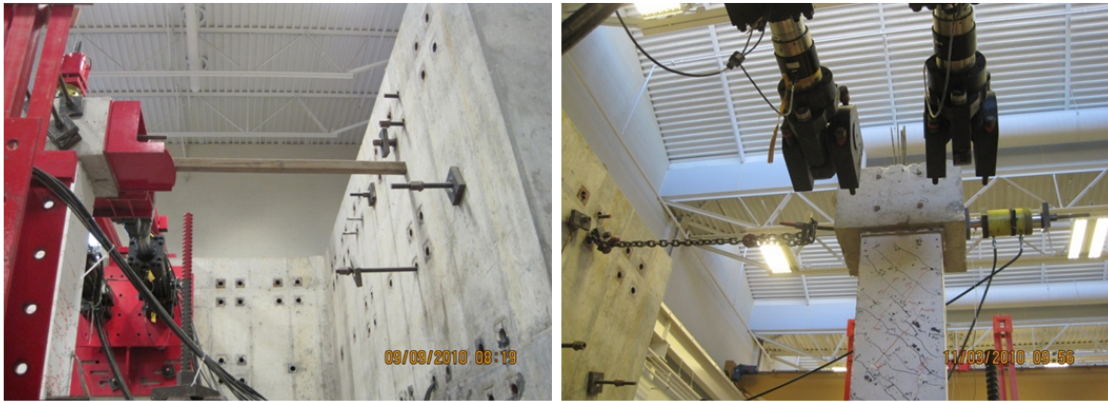
Figure A.1. Column Straightening

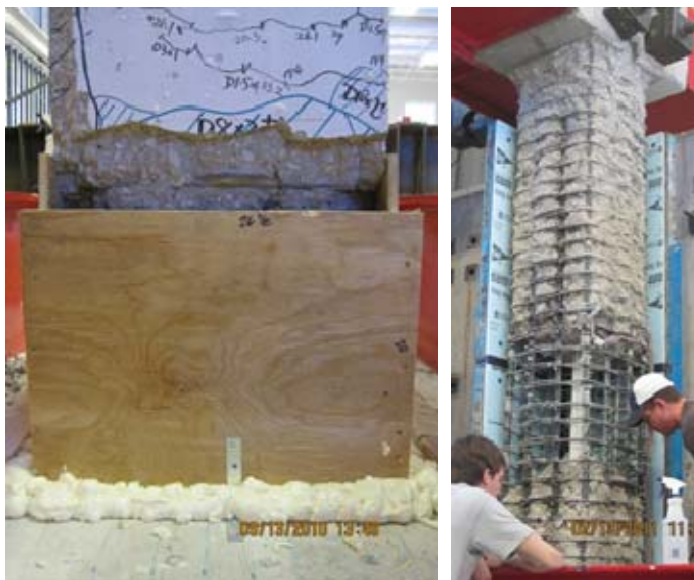
Figure A.3. Formwork for Placement of Repair Mortar

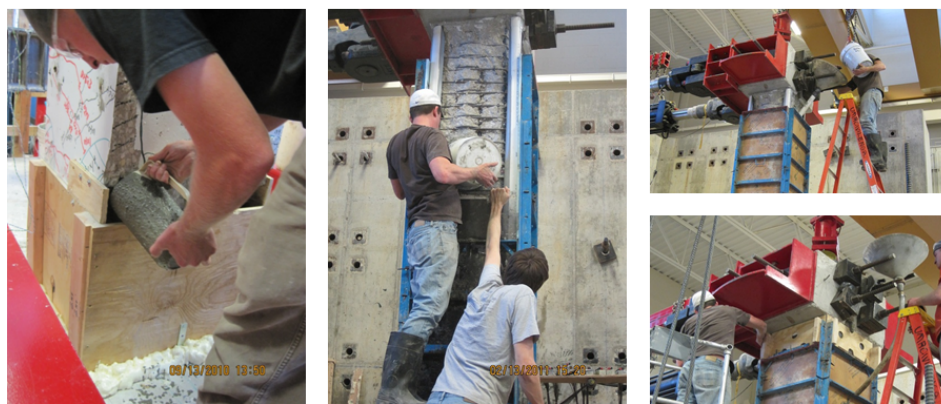
Figure A.4. Placement of Repair Mortar

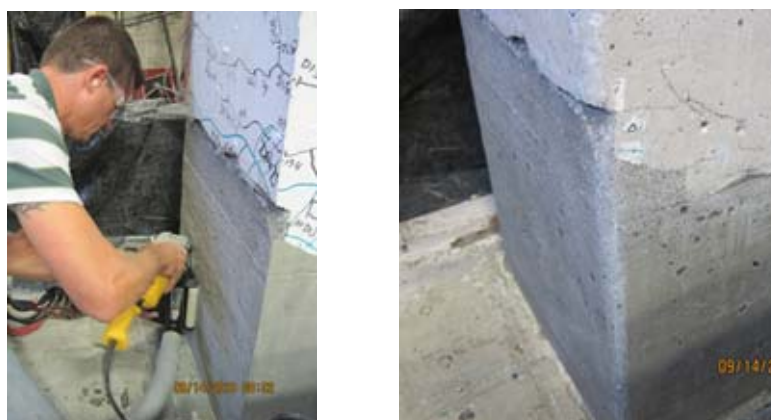
Figure A.5. Concrete Surface Smoothing

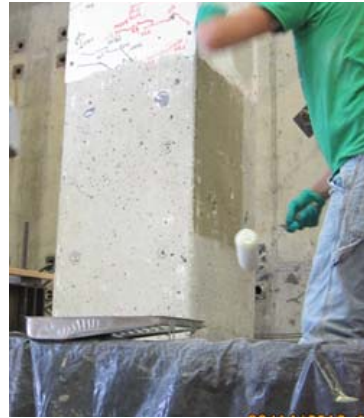
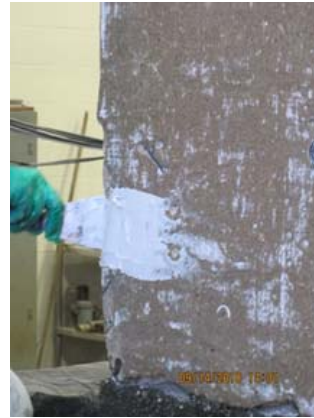
Figure A.6. Concrete Surface Preparation

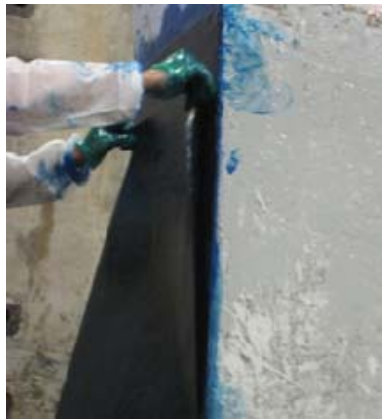
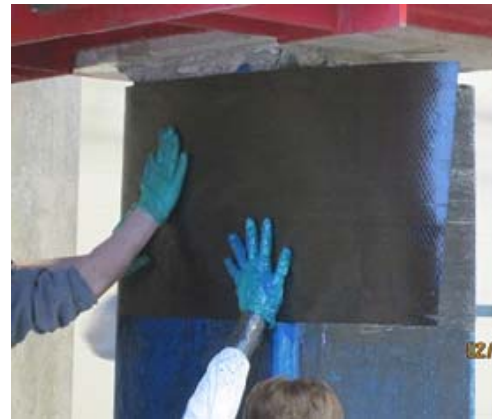
Figure A.7. Application of MBrace® CFRP System

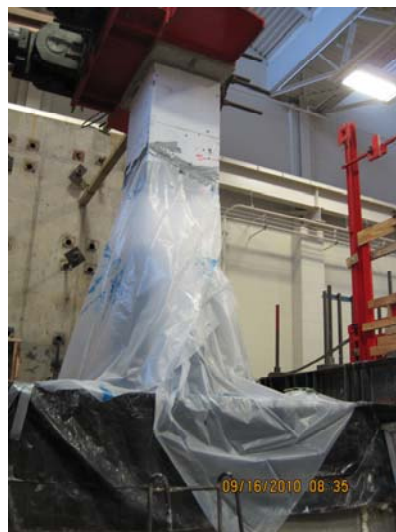
Figure A.8. Curing of the CFRP System
