LIQUEFACTION-INDUCED DAMAGE IN THE 2010-2011 CHRISTCHURCH (NEW ZEALAND) EARTHQUAKES

Misko Cubrinovski

University of Canterbury
Christchurch 8140, New Zealand

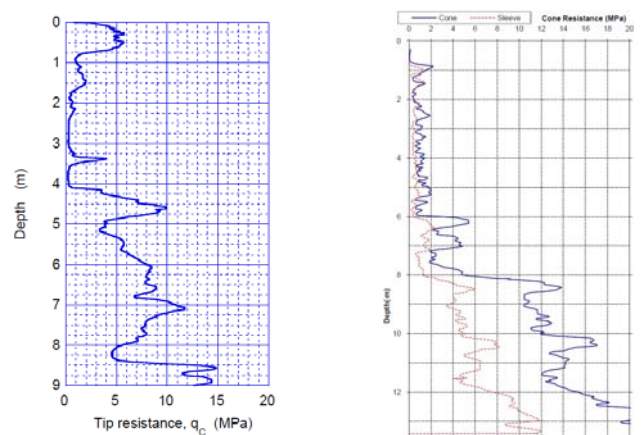
content predominantly in the range between 0% and 30%. Importantly, the fines are non-plastic silts. The soils in the top 5-6 m are often in a very loose state, with CPT cone tip resistance (q_c) of about 2-4 MPa. The cone resistance typically increases to 7-10 MPa at depths between 6 m and 10 m, however lower resistances are often encountered in areas close to wetlands. Characteristic CPT resistance for these areas is shown in Fig. 6. These areas are within the zone where severe liquefaction occurred during multiple events.

Fig. 6 CPT resistance in areas of severe liquefaction

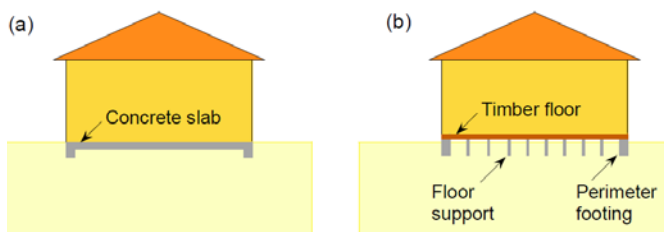
Four different foundation types have been largely used in the Christchurch region for residential buildings, i.e. concrete slab on grade, timber floor with perimeter footing, piled foundations and more recently rib-raft or waffle slab with inverted beams. The concrete slab on grade and the perimeter footing (schematically shown in Fig. 7) are the two prevalent foundation types used in approximately 80% of the housing stock in Christchurch. The slab on grade is unreinforced (except for the thickened perimeter beam) approximately 100 mm thick concrete slab for one-storey houses, and it is reinforced by a low capacity wire-mesh for two-storey houses. The slab rests on un-compacted or poorly compacted gravel bed. The concrete perimeter foundations range from unreinforced concrete filled with loose bricks (old construction) to (continuous) reinforced concrete foundations (newer construction). As shown in Fig. 7, the timber floor, which is elevated above the ground, is supported along its edges by the perimeter footing and by uniformly spaced concrete/timber supports ('piers') across the floor area.

Fig. 7 Prevalent house foundation types in Christchurch: (a) concrete slab; (b) concrete perimeter footing

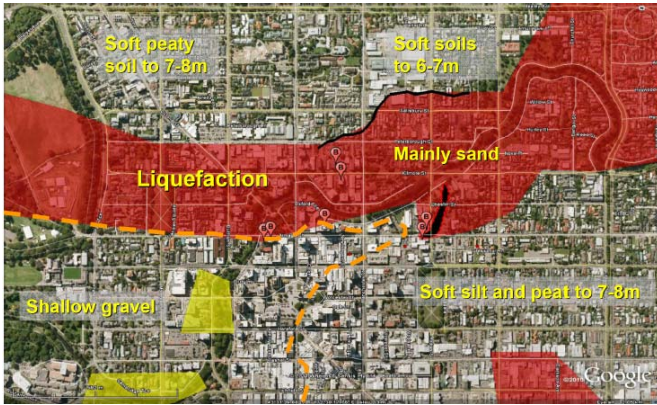
Figure 11 shows the observed liquefaction in the CBD as documented after the Christchurch earthquake. The principal zone of liquefaction (red color area) stretches west to east through the CBD, from Hagley Park to the west, along the Avon River to the northeast boundary of the CBD at the Fitzgerald Avenue Bridge. This zone is of particular interest because many high-rise buildings on shallow foundations and deep foundations were affected by moderate to severe liquefaction in different ways. Note that this zone consists mostly of sandy soils and largely coincides with the path of the Avon River and network of old streams. The solid black lines (area) indicate zones of pronounced ground distress (cracking and slumping) caused by liquefaction. Also shown in the figure are the predominant soils in the top 7-8 m of the CBD deposits, indicating the significant variability of the soils across the CBD.

Fig. 11 Liquefaction map for the CBD (22 February 2011 earthquake) indicating zones of pronounced ground distress, and predominant soils in the top 7 m to 8 m of the deposits
