International Conference on Case Histories in Geotechnical Engineering

Geotechnical Problems in the 2011 Tohoku Pacific Earthquakes

GEOTECHNICAL PROBLEMS IN THE 2011 TOHOKU PACIFIC EARTHQUAKES

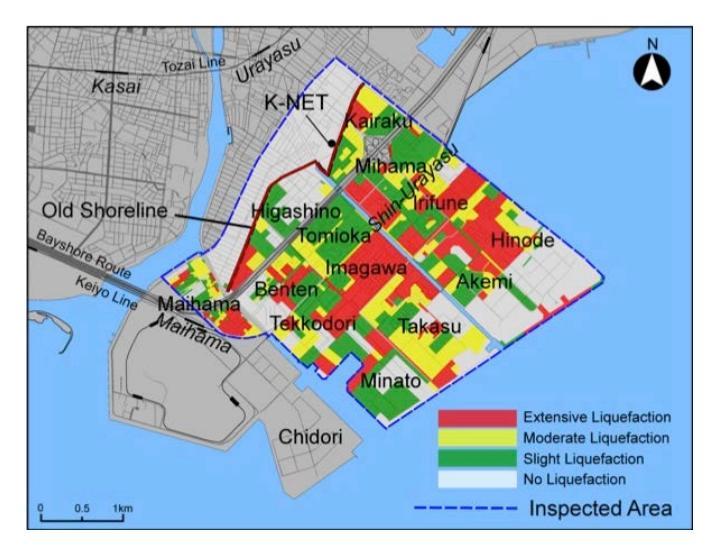
Fig. 9. Map showing extent of liquefaction damage (Tokimatsu et al, 2011)

Our geotechnical reconnaissance survey was carried out in the area circled with the dotted line in Fig. 7. Figure 9 shows a damage map in which the extent of soil liquefaction is classified into four categories (i.e., no, slight, moderate, and extensive), based on the field performance of soils and buildings including ground settlements as well as settlements and tilting of houses. It can be confirmed that, liquefaction-induced damage was not seen on the north of the old coastline as of 1964 but was widely developed in the area reclaimed after that year. The areas that had experienced liquefaction in the 1987 Chiba-ken Toho-oki Earthquake did

re-liquefy. Summarized below are the typical findings in the reclaimed area:

1) In the area where liquefaction occurred, many sand boils (Photo 1) and ground settlements were obnserved. Underground facilities, such as manholes, emergency water tanks and parking lots were uplifted (Photos 2 and 3), tapping water and sewerage systems.

2) Many buildings and houses on spread foundations (Photos 4-6) tilted and settled without any damage to superstructure.

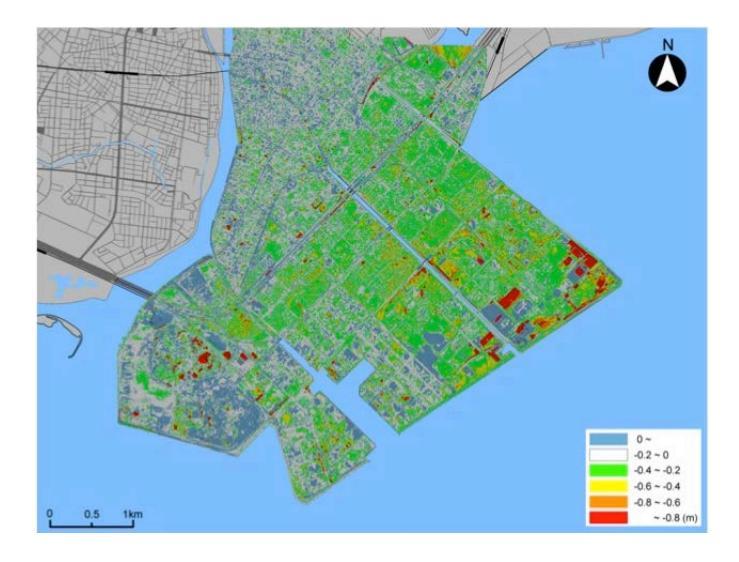
Fig. 12. Map showing vertical ground settlement between 2006 and 2011 (Tokimatsu & Katsumata, 2012)

Figure 12 shows ground settlements estimated from the difference between the altitudes obtained before and after the quake using airborne laser scanning survey. The ground in the liquefied area after the quake has settled 0.2 to 0.4 m on the average, with smaller settlements on the roads. The value of subsidence reached as much as 0.6 to 0.8 m in some areas. These ground settlements from the laser scanning survey appear to be consistent with the ground settlements observed in the field. Comparison of Fig. 12 with Figs. 9 and 10 suggests that the area with larger ground settlements experienced more severe liquefaction damage to buildings.

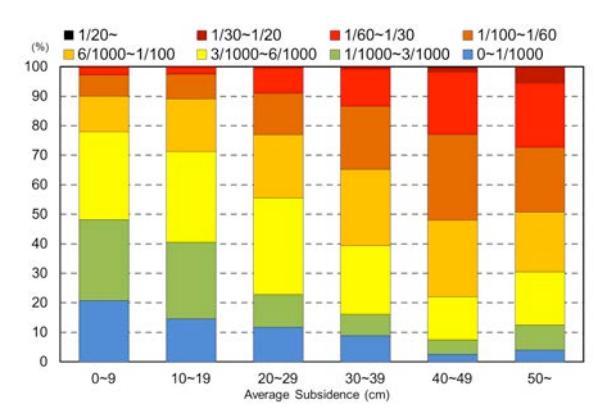
Fig. 13. Relation between ground settlement and angle of inclination (Tokimatsu & Katsumata, 2012)

residential houses with respect to ground settlement, prepared from Figs. 10 and 12. Figure 13 apparently shows that the inclination angle tends to increase with increasing liquefaction-induced ground settlement. For example, about 10% houses titled more than 1/100 if the liquefaction-induced settlement (S) is on the order of 10-20 cm, whereas about 50% houses tilted when S becomes greater than 40 cm.

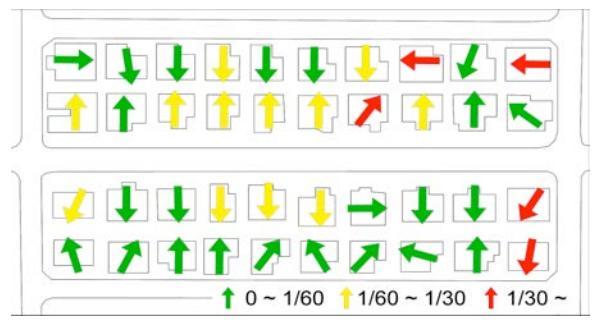
Fig. 14. Typical result of tilting angle and direction of houses in a district (Urayasu City, 2012)

A close inspection of the damage to houses suggests that, when two buildings stand closely together, they often tilt toward each other, as in Photo 4 and Fig. 14. This is supposed to occur because the ground settlement between the two structures is greater due to their combined weight loads. When buildings face a street, they tend to tilt backward as shown in Photo 5 and Fig. 14, probably because they tended to incline toward the closer buildings located behind them.

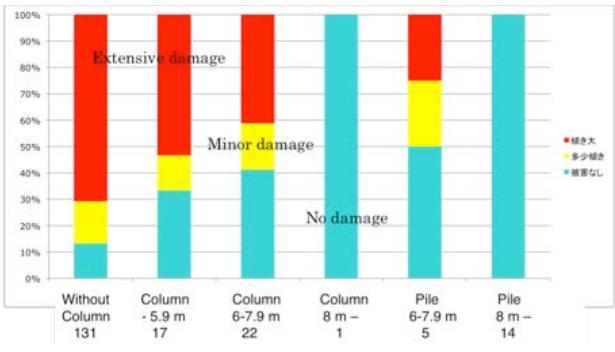
Fig. 15. Relation of depths of cement column piles or steel pipe piles with damage to houses (Urayasu City, 2012)

Many residential houses adopted cement column piles or steel pipe piles for reducing uneven settlement caused by very soft surface soils. Figure 15 summarizes the performance of such 151 houses located in the heavily damage area with thickness

of reclaimed fill greater than 8 m. The damage to houses tends to decrease with increasing length of pile, regardless of pile type.

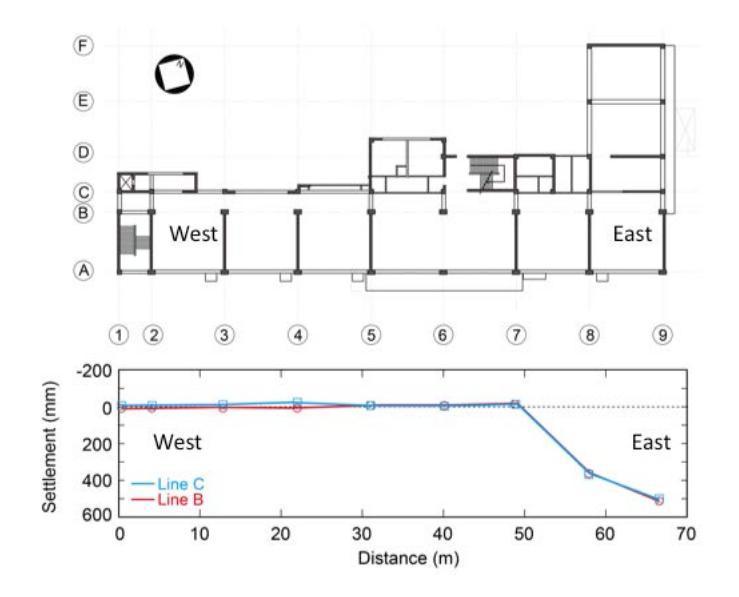
Fig. 21. Plan of elementary school in Omiya

An east part of a 4-story elementary school building in Omiya, Saitama Prefecture, the plan of which is shown in Fig. 21, settled by about 500 mm against the remaining west part, inducing extensive shear failures of the grade beams as well as those of the superstructure near the interface (Photo 13). The building was constructed in 1977-1978 and founded reinforced concrete piles with a length of 36 m and a diameter of 450 mm. The near surface soils around the building doe not consist of liquefiable sandy soils but humic soils, the thickness of which increases towards the north.

An excavation survey confirmed that the piles on the northern part failed near the pile heads (Photo 14), with those on the

southern part undamaged. The uneven performance of pile foundation within a building could have caused the uneven vertical displacement, and thereby inducing the shear failure of beams. The excavation survey also showed that the ground on the north settled more and induced a longer projection of piles on the north side of the building. This suggests that the difference in soil condition below the building might have induced the uneven failure of pile foundations within the building.

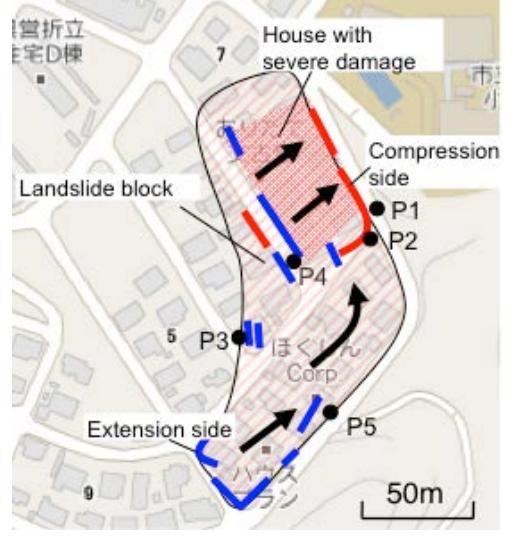
Fig. 23. Map showing landslide block in Oritate housing complex (Tokimatsu et al., 2011)

Figure 23 shows a damaged area in Oritate 5-chome, where many retaining walls were broken. At the lower part of a slope (P1 in Fig. 23), retaining walls had collapsed as if pushed out by backfill soil (Photo 17). Above that point, at P2, ground under a retaining wall was raised. It is believed that the

earthfill had moved toward the street, exerting a compressive force. At a somewhat high point on the slope (P3), there were major cracks in a residential land plot. At a high part of the slope, there were also retaining walls with tensile cracks. Figure 23 shows the points of tension and compression found from these examples, suggesting that landslide occurred in the hatched part in the figure. A comparison with an old topographical map (around 1964) shows that the landslide area roughly corresponds to a valley in the old landscape. The March earthquake apparently led the entire earth and sand used to fill up the valley to shift.

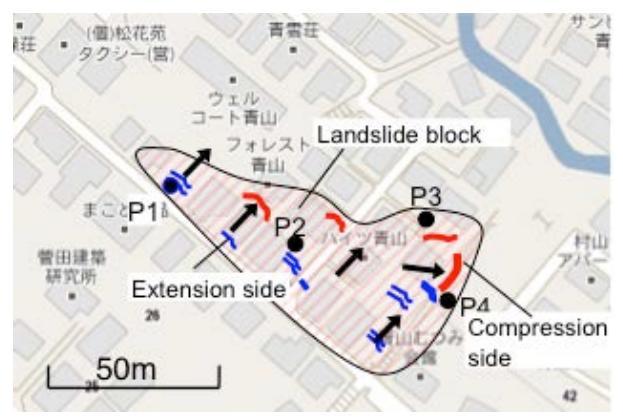
Fig. 24. Map showing landslide block in Aoyama housing complex (Tokimatsu et al., 2011)

Figure 24 shows the damaged area in Aoyama 2-chome. A major crack had formed in a housing lot in the upper part of the slope (P1 in Fig. 24). The crack was as deep as 70 cm.

Closer to a valley at P2, the retaining wall shifted about 1 meter to the valley side, causing ground to sink and leaving a void below the foundation, as in Photo 19. At the lower part of the slope, a residential land plot was destroyed as if pushed out, as in Photo 20 (At P3 in Fig. 24). Figure 24 shows the points of tension and compression found from these examples, which indicates that the landslide area was a shaded part in the figure. Comparing it with an old topographical map (around 1964) finds that the area roughly coincides with an earth cliff in the old landscape. The landslide occurred in the residential land developed by widening earthfill along the cliff. Residents

said that the groundwater level in the neighborhood is extremely shallow at about 1 meter deep, which is considered to be a factor leading to the landslide.

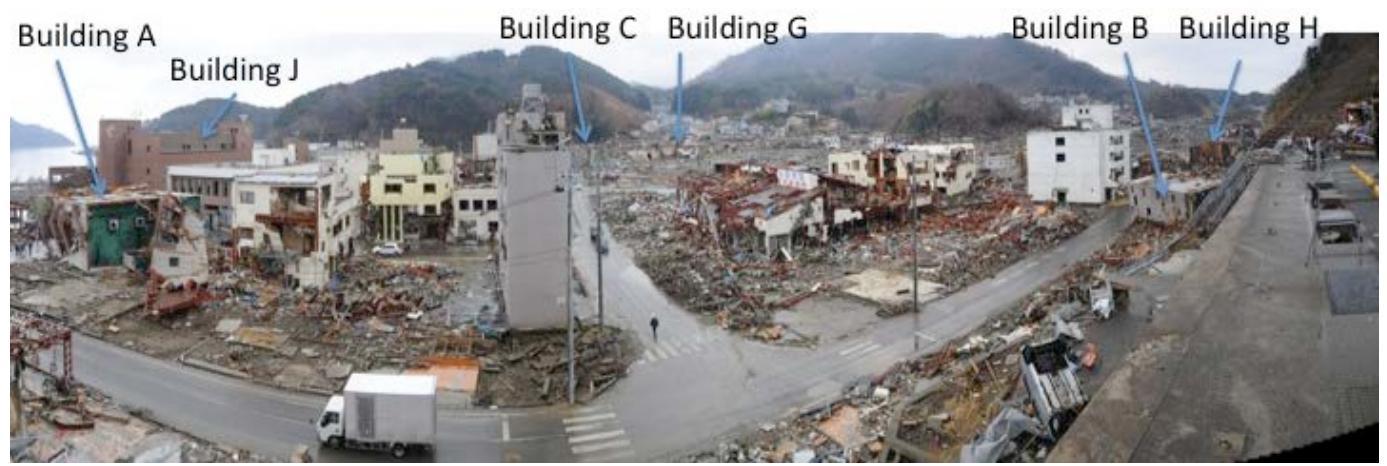
Photo 21. View of Onagawa from Point P1 (Tokimatsu et al., 2011)
