Geotechnical Damage Due to Bihar Earthquake of August 1988

SYNOPSIS: The Bihar-Nepal earthquake of August 21, 1988 (magnitude 6.6) caused significant loss of life and property. Besides the epicentral area, two distant places (Munger in India and Bhaktapur in Nepal) suffered significantly. This was also the case in the 1934 earthquake (magnitude 8.4) and is due to peculiar geology of the area. Geotechnical damage in the affected area includes liquefaction, cracking and subsidence of embankments, and cracks in bridge abutments and wing walls. Besides, in the hilly regions of Sikkim, landslides and rockfalls disrupted road network significantly. Extensive damage took place in the eastern Nepal also. This paper describes the geotechnical damage to the Indian areas only.

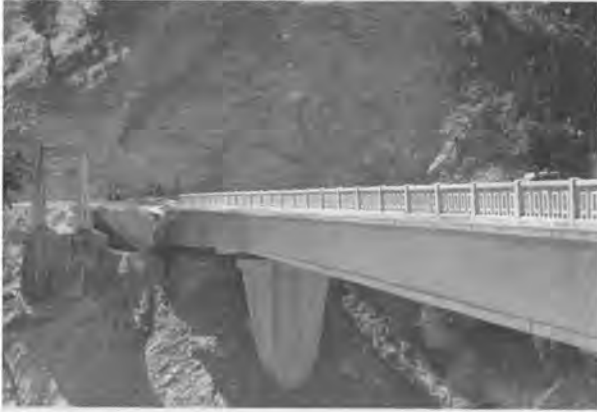
This is a newly constructed prestressed concrete bridge of about 200 feet span (Fig. 10), on river Kalej Khola near Legship Bazar town (about 58 miles from Gangtok). Hill slope on the Legship Bazar end failed and soil mass including huge boulders fell on to the bridge deck. Approximately half lane wide deck slab was completely smashed near abutments due to impact of the huge rocks (Fig. 11). The bridge however

FIG. 10 A View of the Legship Bazar Bridge, Sikkim.
