Failure of a Small Gravity Dam and the Repair

David F. McCarthy

SYNOPSIS Late in the summer of 1980, the dam for Snowbird Lake in Forestport, New York, U.S.A., experienced a serious foundation leak made evident by a suddenly erupting geyser near the downstream toe. Subsequent investigation indicated that a severe piping condition had occurred in the soil foundation. Some degree of erosion had effected the foundation earth for more than half of the dam length. Repairs were performed after dewatering the dam work area. The original dam was retained but provided with a new concrete foundation which included a constructed underdrain. A clay blanket was installed on the dam's upstream side to retard future underdam seepage. An emergency spillway circumventing the dam area was established to protect the dam abutments from being topped should the lake reach flood levels.

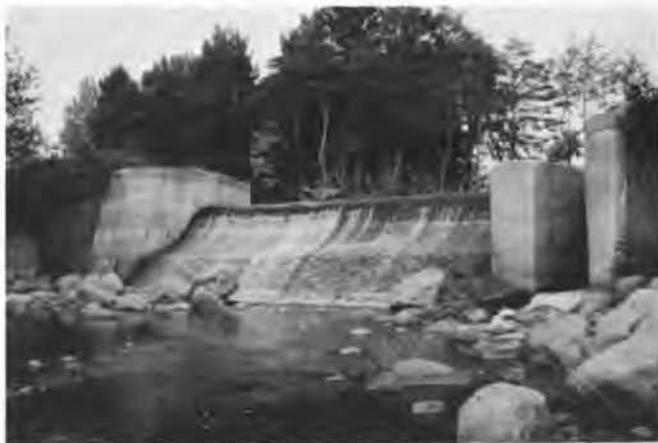
In early September of 1980, the dam creating Snowbird Lake in Forestport, New York, U.S.A., (Figure 1) developed a serious foundation leak made evident by a suddenly erupting geyser near

Fig. 1. Dam at Snowbird Lake.

the dam's downstream toe. The owners quickly drained the lake by opening the dam's sluice. Subsequent dewatering of the area in the vicinity of the dam foundation revealed that severe underground erosion and piping had occurred. What apparently was the original path for the piping had become a three-foot (one meter) deep channel beneath the base of

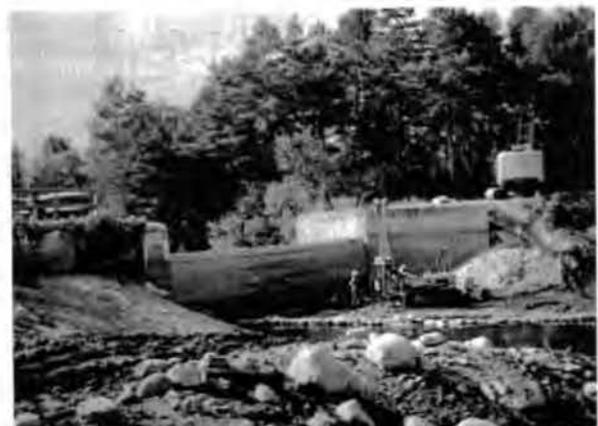
Fig. 5. Boring operations to explore foundation materials. Water in front of drill rig is lake flow being channelled to the dam sluice.
