Liquefaction of Soils in the 1989 Loma Prieta Earthquake

Raymond B. Seed

University of California, Berkeley, California

SYNOPSIS: The Loma Prieta Earthquake of October 17, 1989 was the most costly single natural disaster in U.S. history, resulting in losses of \$7 to \$9 billion, and claiming 63 lives. These damages were concentrated mainly at a number of distinct sites comprising a relatively small fraction of the affected region, as local site conditions and related geotechnical factors exerted a major influence on damage patterns and loss of life in this catastrophic event. This paper discusses one of these geotechnical factors, the widespread occurrence of soil liquefaction during the earthquake, as well as the associated damages and the resulting lessons learned. Additional significant geotechnical factors which exerted a strong influence on damage patterns during this event, including site-dependent dynamic response and seismically-induced slope instability, are discussed in companion papers in these proceedings.

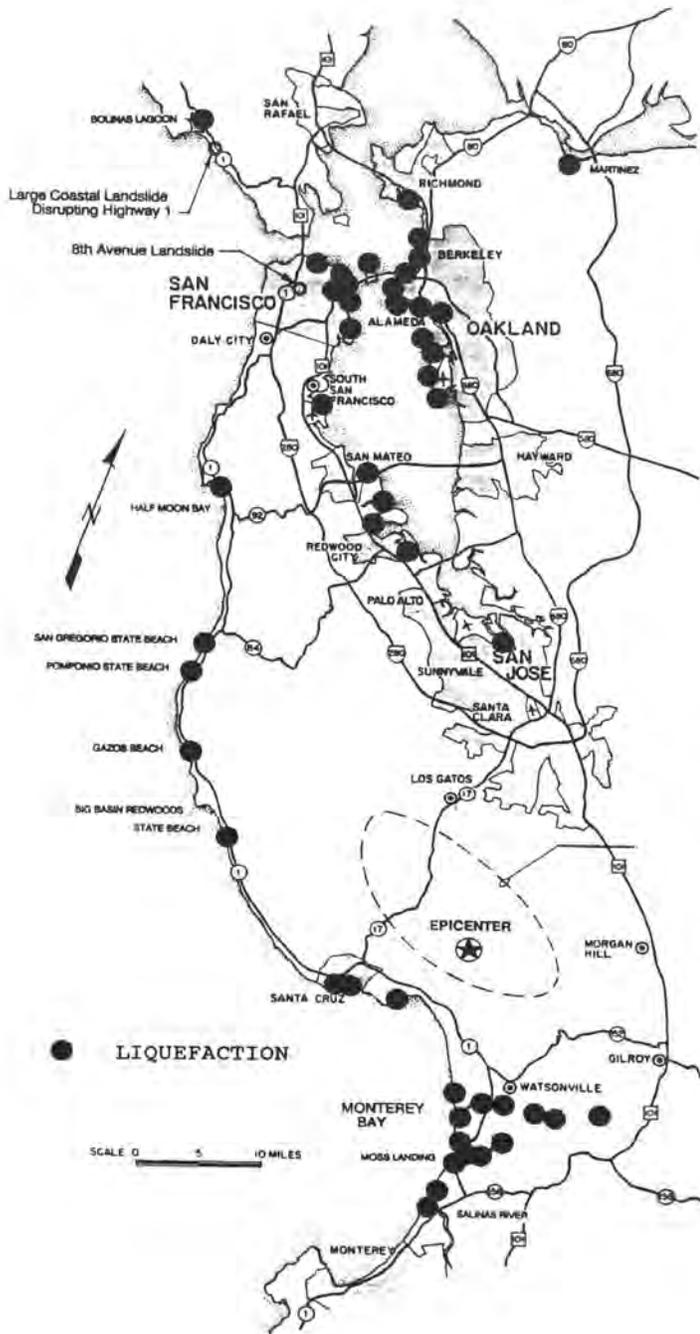
Fig. 1 Map of Affected Region Showing Sites of Soil Liquefaction

Soil liquefaction affected a widespread area during the Loma Prieta Earthquake, as shown in Figure 1. In addition to the well-publicized liquefaction-induced damage which occurred in the Marina District in northern San Francisco, considerable damage associated with liquefaction also occurred in areas of eastern San Francisco, on Treasure Island at the center of San Francisco Bay, and along the east San Francisco Bay shore in Oakland, Emeryville, and Alameda, as well as farther south along the Pacific coast in the Santa Cruz and central Monterey Bay regions. The two most northern sites found to show evidence of liquefaction were: (a) a sand soil adjacent to a pile supporting a pier on the south shore of Suisun Bay at Martinez, and (b) a series of sand boils observed and photographed in a lagoon at Bolinas, on the Marin Peninsula, with associated lateral spreading of the adjacent beach.

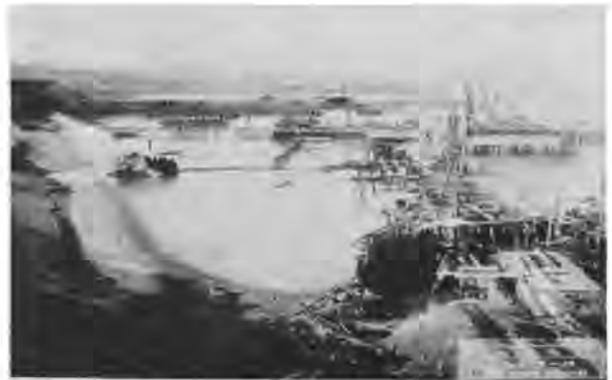
Fig. 2 View of the Marina District Looking West from Fort Mason in January of 1910. [Photo courtesy of the San Francisco Maritime Nat'l. Historic Park]

fill process typically results in a loose saturated fill which is vulnerable to potential soil liquefaction during earthquake shaking, and the Marina District was no exception to this. Figure 2 is a photograph of the Marina District viewed from Fort Mason, immediately to the east. Taken in January of 1910, this photograph shows conditions as they existed at an early stage of the hydraulic fill placement. Note the seawall at the right of the photograph, and the small barge and floating pipeline in the bay depositing hydraulic fill.

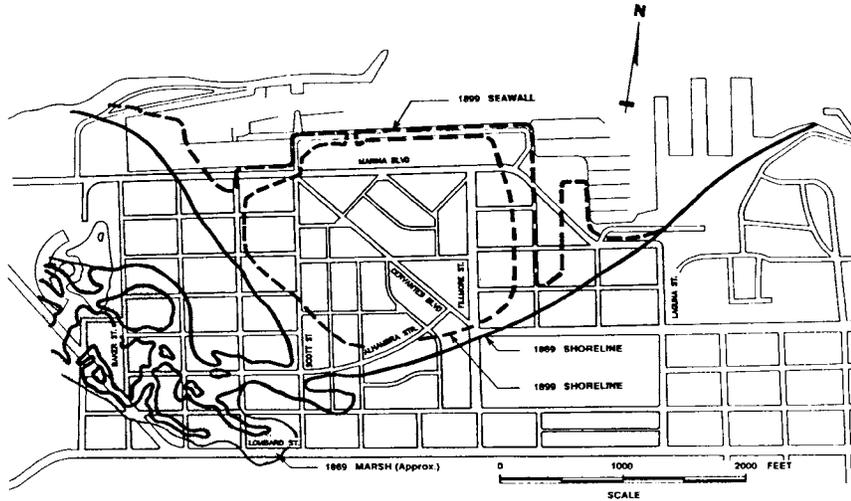
Fig. 3 Map of the Marina District in San Francisco Showing the Approximate Locations of the Earlier Coastlines and Marshes

Figure 3 is a map of the Marina District as it existed at the time of the Loma Prieta Earthquake of October 17, 1989. Super-imposed on this is the old 1869 shoreline and the associated marshy deposits occurring at the south-west limit of the small embayment which existed at that time. Much of the existing Marina District consists of landfill placed since 1869, both to reclaim the marshes and to infill the small baylet. This fill, which was placed in two general stages or periods, is composed primarily of uncompacted fine sands and silty sands. It was primarily within these loose, saturated cohesionless soils that widespread liquefaction occurred.

The first stage of fill placement occurred between about 1870 and the end of the 19th century, and consisted primarily of placement of loosely dumped fill around the perimeter of the small Marina bay and in the perimeter marshes. Most of this fill was dune sand taken from onshore dune deposits occurring adjacent to the southeast edge of the Marina District. A seawall was also constructed to provide a protected harbor. The heavy dashed line in Figure 3 shows the resulting coastline and seawall as they existed at the end of the 19th century.

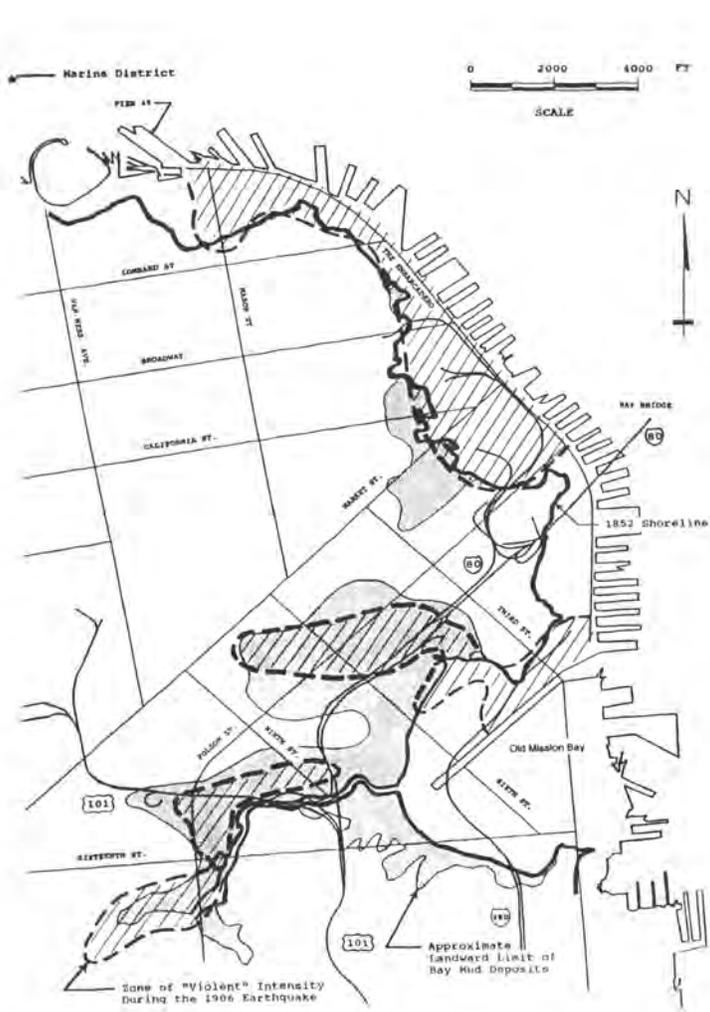
Fig. 7 Map of Eastern San Francisco Showing the Region Most Intensively Damaged During the 1906 Earthquake (Before the Post-Earthquake Fire), and the Historic Coastline and Marshes of 1852

Figure 7 presents a map of eastern San Francisco, showing the old historic shoreline (the heavy solid line) and the bay marshes (dark zones) which extended well inland prior to extensive fill placement during the latter half of the last century. Superimposed on this map are three zones outlined with dashed lines and shaded with cross-hatching; these were the regions of heaviest (pre-fire) damage intensity during the 1906 San Francisco Earthquake. This heavy damage intensity in 1906 was the result of both: (a) site effects on strong shaking, as a result of the soft clays underlying the surface fills, and (b) massive and widespread soil liquefaction inducing bearing failures, differential settlements and lateral spreading.

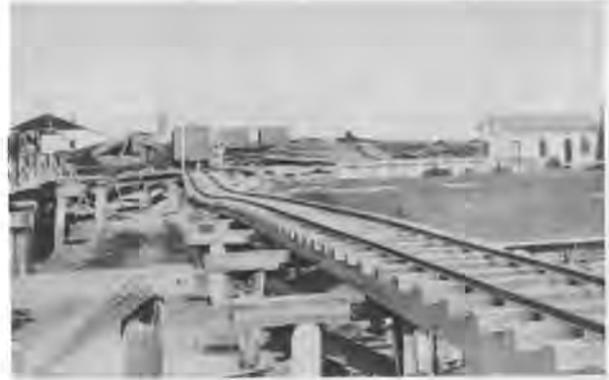
Fig. 21 Warehouse at Moss Landing Destroyed by Lateral Spreading in the 1906 San Francisco Earthquake [Lawson et al., 1908]

One of the clearest examples of the structural damage that can result from soil liquefaction was the destruction of the Marine Research Facility at Moss Landing. This facility was a group of low, modern 1- and 2-story structures founded on concrete slabs. The structures were grouped together to provide a series of classrooms and laboratories surrounding a central courtyard. The buildings do not appear to have been significantly damaged by shaking during the Loma Prieta Earthquake. This facility was, however, destroyed beyond repair by foundation displacements (settlement and lateral spreading) as a result of liquefaction of the foundation soils. The inboard roadway adjacent to this structure settled several feet, and lateral spreading deformations of the foundation soils stretched the facility by 6 feet, literally pulling it apart. Figure 20 presents an exterior view of this facility, clearly showing the massive damage caused by these foundation movements. Figure 21 shows a large warehouse which was destroyed at essentially this same site by similar lateral spreading in the great 1906 San Francisco Earthquake.
