On the breakage of rock drill steel

ON THE BREAKAGE OF ROCK DRILL STEEL

MASTER OF SCIENCE IN METALLURGY

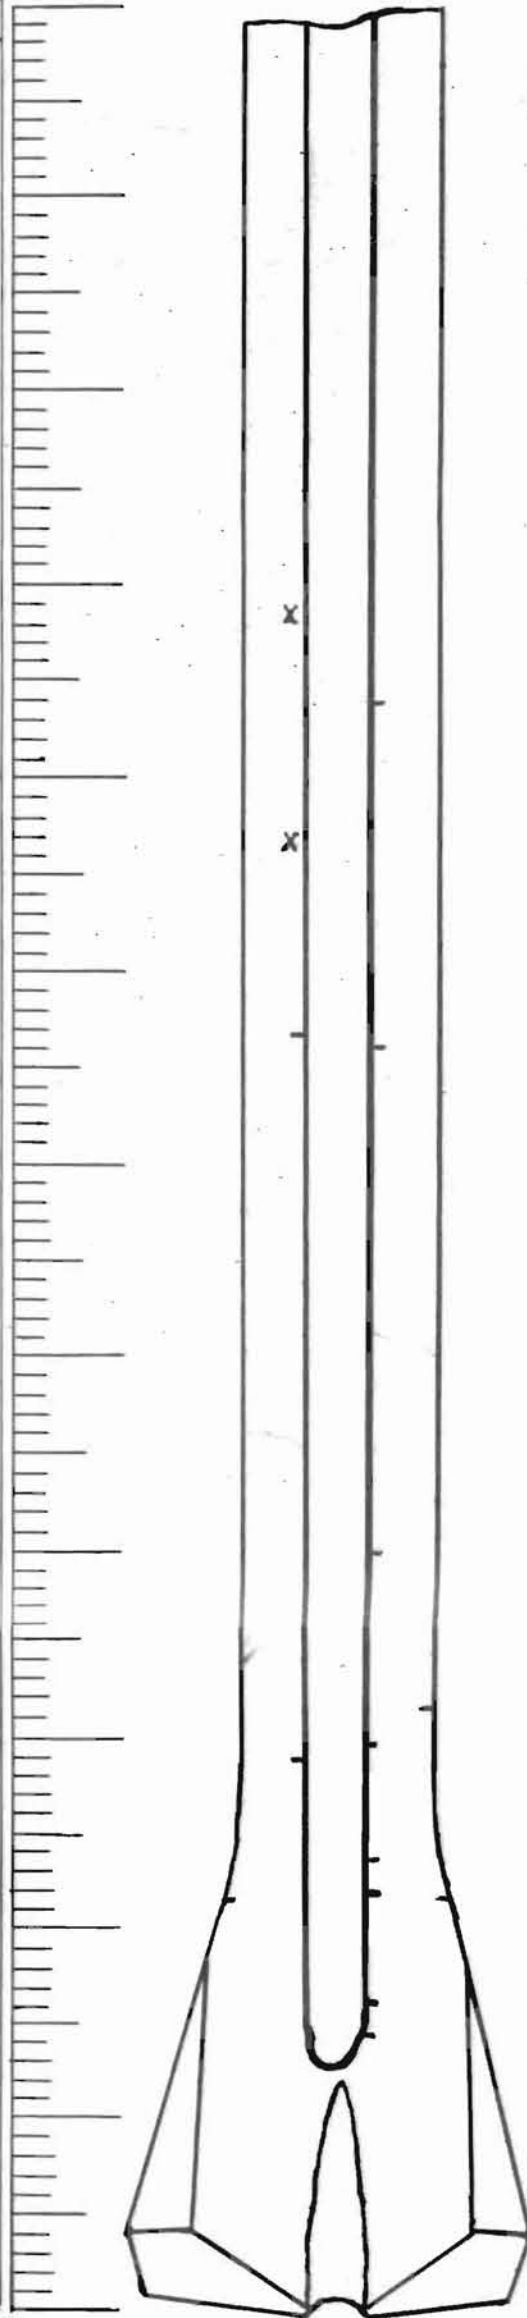
BIT No. 3.
Gage - 2 1/4 in.

INSIDE		OUTSIDE	
Angle	Depth mm.	Angle	Depth mm.
90	.146		
90	.294		
90	.064		
90	.146		
90	.146		
90	.420		
90	.168	30	.252
90	.168		
90	.168		
		45	.146
90	.168		
90	.084		
90	.840		
90	.252	Internal	
		90	.294
		90	1.344

Outside		Inside	
Angle	Depth mm.	Angle	Depth mm.
		90	.084
		90	.126
90	.126		
90	.378

Inside		Outside	
Angle	Depth mm.	Angle	Depth mm.
90	.142		
60	.060		
60	.084		
60	.168		
90	.126	90	.126
90	.084		
90	.504	45	.126
90	.084		
90	.126

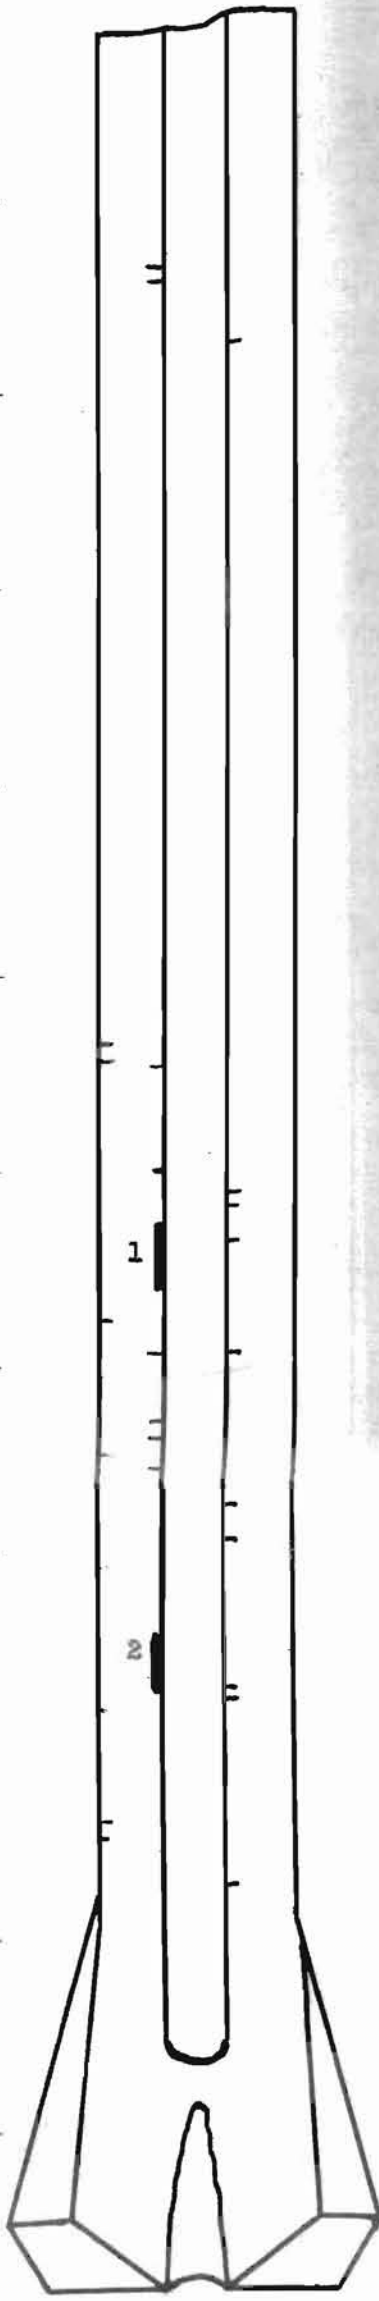
BIT NO. 4.
Gage—2 in.

OUTSIDE		INSIDE	
Angle	Depth mm.	Angle	Depth mm.
		90	.084
		90	.168
90	.160	90	.084
90	.588		
		90	.252
90	1.680	90	.084
		90	.084
		90	.084
		90	.168
90	.840		
90	.504

Angle	Depth mm.	Angle	Depth mm.
90	.042		
		Area No. 1.	
		90	.336
		90	.252
		90	.210
		90	.168
		90	.252
		Area No. 2.	
90	1.008	90	.084
90	.168	90	.084
90	.168	90	.084
		90	.084
		90	.168
90	.252		
90	.210		
90	.084		
90	.168		
90	.168		
90	.084

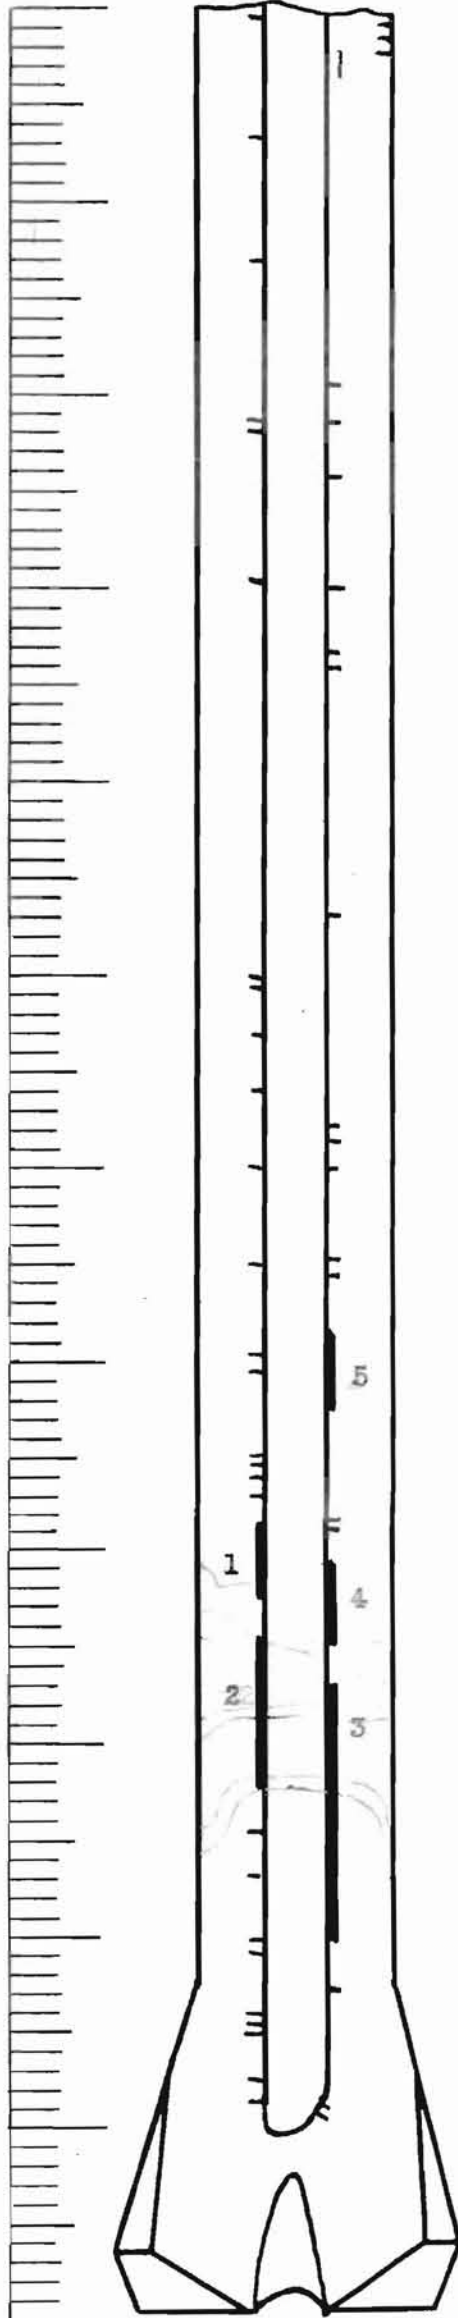
BIT NO. 5.
Gage—1 15/16 in.

Angle	Depth mm.
90	.084
90	.168
90	.084
90	.336
90	.336
90	.252
90	.126
90	.168
90	.168
90	.672
90	.420
90	.252
90	.378
90	.084
90	.252
90	.252
90	.336
90	.336
90	.084
90	.420
90	.588
90	.252
90	.084
90	.252
90	.252
90	.588
90	.672

Angle	Depth mm.	Angle	Depth mm.
Internal	2.100	Area No. 1.	
"	.640	90	.084
"	.672	90	.042
90	1.092	90	.042
		90	.021
		90	.063
		90	.908
		90	.420
		90	.126
		90	.168
90	.126	Area No. 2	
90	.126	90	.084
90	.126	90	.168
		90	.504
90	.084	90	.084
90	.588	90	.084
90	.252	90	.336
		90	.084
		90	.084
		90	.672
		90	.336
		90	.336
		90	.294
90	.336	90	.252
		Area No. 3.	
90	.336	90	.084
90	.420	90	.672
90	.420	90	.504
		90	.168
90	.588	90	.588
90	.126	90	.252
		90	.252
		90	.252
		90	.252
		90	.084
		90	.084
90	.336	90	.756
90	.504	90	.336
		90	1.008
		90	.336
		90	.252
		90	.084
		Area No. 4.	
		90	.210
		90	.336
		90	.084
		90	.084
		90	.084
90	.252	90	.420
		Area No. 5.	
90	.252	90	.252
90	.420	90	.252
		90	.252
		90	.294
		90	.084
		90	.084
		90	.210
		90	.336
		90	1.008

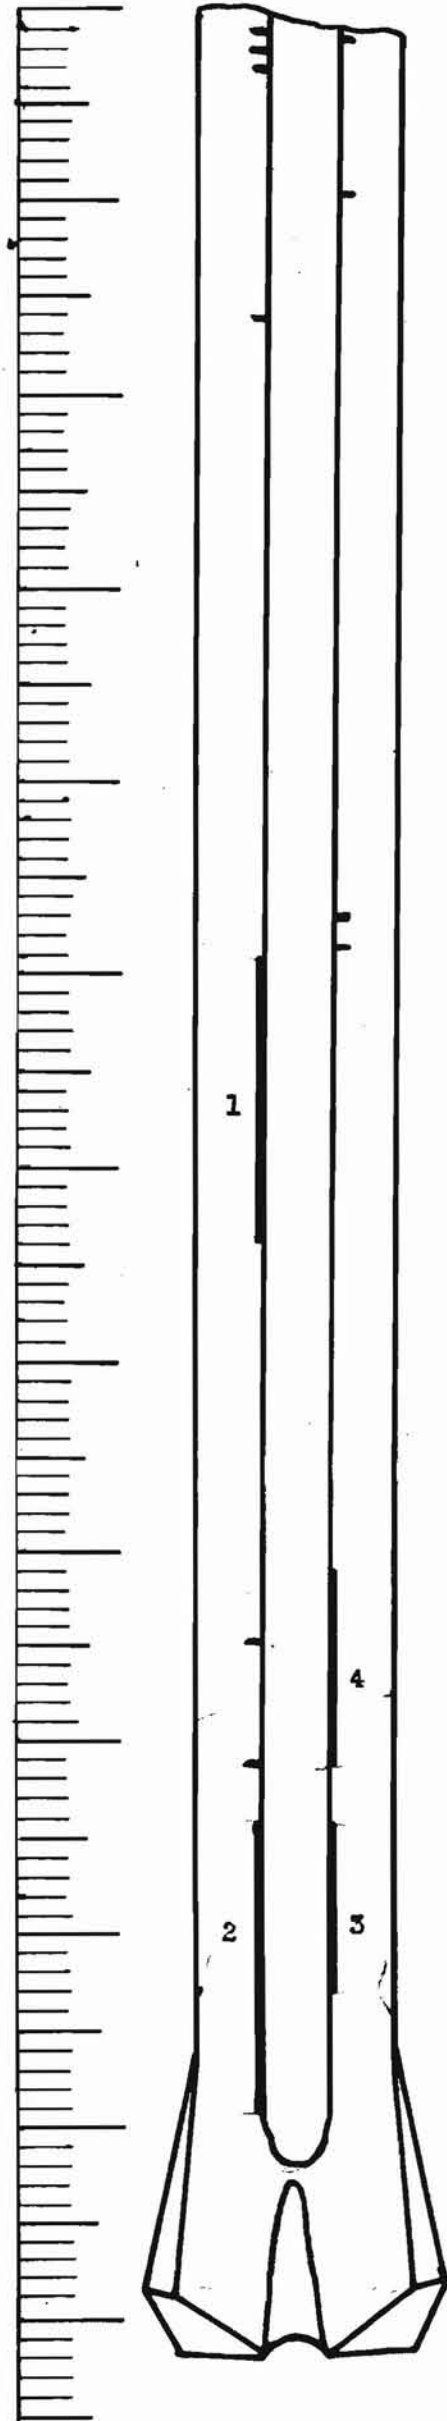
BIT NO. 7
Gage— 1 11/16 in.

Angle	Depth mm.
Area No. 1.	
90	.084
90	.084
90	.084
90	.084
90	.084
90	.168
90	.168
90	.168
90	.252
90	.168
90	.168
90	.168
90	.084
90	.084
90	.356
90	.084
90	.168
90	.168
90	.084
90	.084
90	.084
Area No. 2.	
90	.084
90	.084
90	.084
90	.084
90	.085
90	.084
90	.126
90	.168
90	.084
90	.084
Area No. 3.	
90	.168
90	.084
90	.168
90	.084
90	.168
90	.084
Area No. 4.	
Incipient cracks

LEFT-HAND		RIGHT-HAND	
Angle	Depth mm.	Angle	Depth mm.
90	.252	90	.210
90	.126		
90	.042		
		90	.252
90	.840		
		90	.084
		90	.084
90	.084		
90	.084

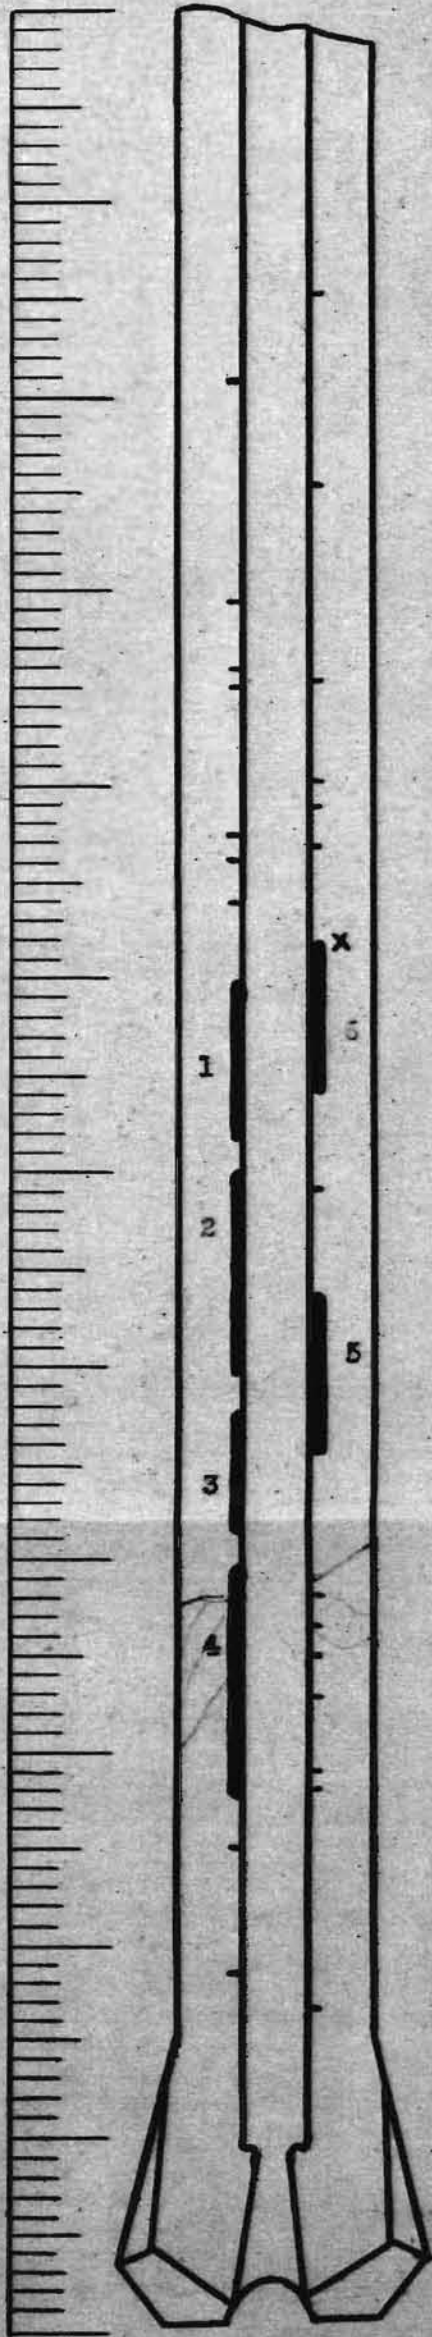
SIT No. 8.
Gage—1 9/16 in.

Angle	Depth mm.
90	.126
90	.126
90	.064
90	.168
90	.252
90	.252
90	.420
90	.168
90	.504

Angle	Depth mm.
60	.168
90	.168
90	.504
90	.252
60	.252
90	.252
90	.168
90	.210
90	.252
90	.336
90	.210
90	.064
90	.064
90	.168
