A Dangerous Place to Dig Excavation at the Toe of Saluda Dam

A DANGEROUS PLACE TO DIG EXCAVATION AT THE TOE OF SALUDA DAM

Saluda Dam located approximately 8 mi upstream of Columbia, South Carolina impounds 41 mi-long Lake Murray. With more than 500 mi of shoreline, water area covering about 78 sq mi and storage capacity of more than 2,100,000 ac-ft of water, Lake Murray is one of the largest lakes on the East Coast. Completed in 1930, the dam is 200 ft high and nearly a mile and a half long. Saluda Dam is a semi-hydraulic fill ("puddle fill") hydroelectric dam. It is regulated by the Federal Energy Regulatory Commission (FERC). Original design and construction did not include any provisions for seepage control.

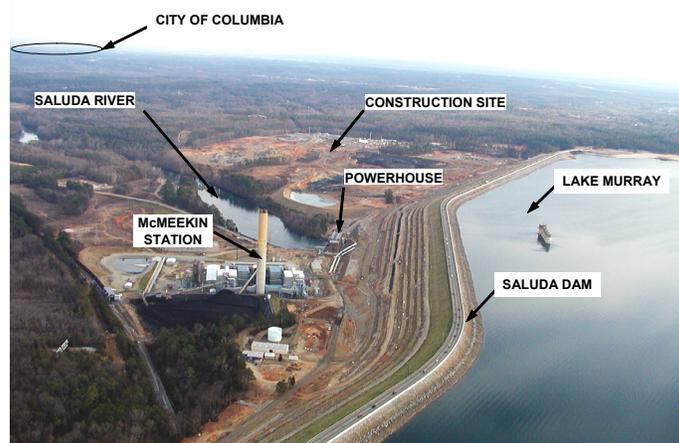
Figure 1 illustrates the dam's dimensions, geometry, and downstream hazard. The downstream hazard associated with Lake Murray is staggering. An uncontrolled breach through Saluda Dam would cause a downstream flood near the City of Columbia, probably entailing loss of life. Studies indicate that about 120,000 people would be at risk.

Fig.1. *Saluda Dam and Project Overview.*

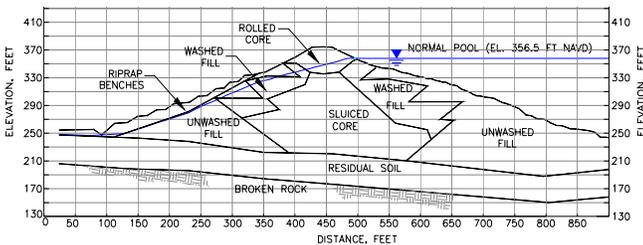
The dam is earth fill, with no internal seepage control (filter or drain protection), and no cut off. The dam was built by hauling fill to the embankment in rail cars, side dumped into piles on the upstream and downstream portions of the embankment (the two outer shells). These piles were sprayed by monitors, sluicing the fine material into a central sedimentation pool, where it deposited to form a core for the dam.

Figure 2 illustrates this construction method- showing in cross section the sluiced core and the washed soils used to form the core. Near the dam's crest, these sluicing operations were stopped. The final portion of the embankment, within 30 ft of the crest, was constructed of rolled fill. Riprap currently covering the downstream slope of the dam was placed as a remedial measure shortly after first filling to address seepage emerging on the face of the dam.

Fig.2. Typical Cross-Section, Existing Dam.

The dam's construction method comprises its problem- the sluiced fill materials. This material has a loose (or very loose) relative density. Consequently, the dam is susceptible to liquefaction during an earthquake. Figure 2 illustrates the different zones of the embankment distinguished by their placement - washed soils sprayed by monitor to form the sluiced core, the sluiced core itself, and the outer limits of the dumped fill soils that were not sprayed with water during sluicing. The top of the embankment is rolled fill.

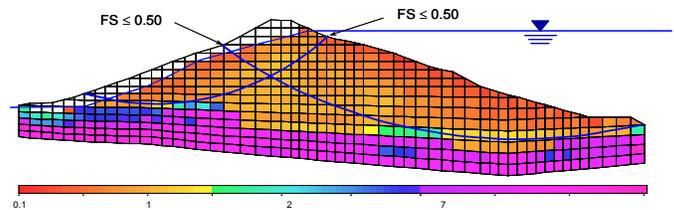
Fig.3. Liquefaction Potential Evaluation. Stability Analysis, Post-Seismic Conditions.

Paul C. Rizzo Associates (RIZZO) investigated the dam to evaluate the behavior during and immediately after a major earthquake. Based on the analysis, performed in accordance with the current Federal Energy Regulatory Commission (FERC) regulations, there is a significant potential for damage to the dam and potential for a breach under the dynamic forces caused by such an earthquake. Figure 3 illustrates the finite element liquefaction analysis of the dam and FS against slope failure in a post-earthquake condition.

Based on the results of the analyses, the dam requires remediation to comply with current FERC parameters for seismic loading—mainly because of predicted wide-scale liquefaction of the shells. As mentioned, the hazard posed by the dam is very high (the consequences of failure include loss of life). This hazard is the basis for the remediation, prevention of catastrophic flooding associated with failure. Accordingly, the Owner proceeded with remedial measures for

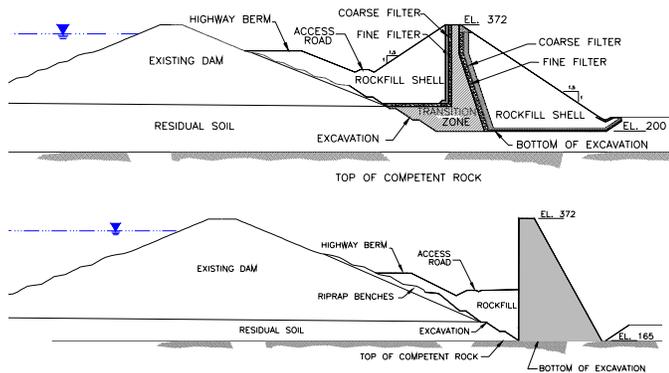
Engineers ultimately decided on the solution depicted on Fig. 4, a large new dam built immediately downstream of the existing dam. In this approach, the existing dam is left to impound Lake Murray. The new dam will be "dry," that is under normal conditions there will be a dry gap between the existing and new dams. The new downstream dam will impound water only if a sizeable earthquake were to cause the existing dam to breach (this event may never occur).

As Fig. 4 illustrates, engineers found that a combination of the rockfill and RCC Dams was required. For most of the alignment of the new dam there is sufficient room to build the design rockfill section. However, in vicinity of the powerhouse and the

Saluda River, there is insufficient space for the rockfill slope- its toe would cover the powerhouse and reach the river. Consequently, this portion of the dam compelled an RCC section for required renovation.

Fig. 4. Proposed Remediation: Rockfill Berm (top), and RCC Berm (bottom).

Construction of both the Rockfill and RCC sections shown on Fig. 4 entails excavation. However excavation requirements are different for these two structures. Rockfill excavation will reach a strong soil subgrade while RCC excavation will extend to rock subgrade. Engineers set up a main stipulation for design: No excavation into the existing dam.

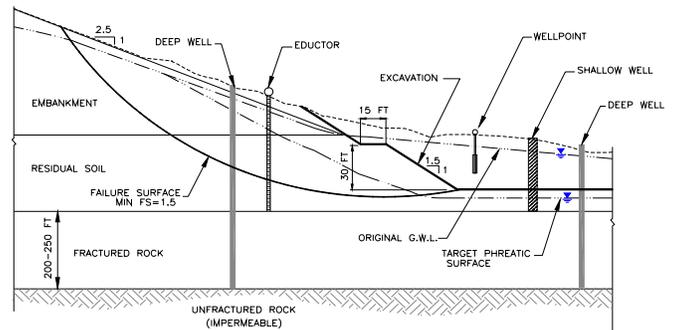
The typical dewatering system is illustrated on Fig 5. The components of this system are described below:

reason, eductors were a better choice than well points. Eductors on the project range in depth from roughly 30 to 70 ft. More than mile and a half of eductor lines is currently in operation.

3. Vacuum Wells. These wells have the same function as the eductors. They are installed in isolated places where lines of eductors cannot be placed (e.g. within the excavation), or where eductor lines are not as effective as required. Vacuum well depth is typically 20 to 30 ft.

Fig. 5. Typical Excavation Dewatering System.

The objective of dewatering is lowering head within the existing dam and foundation to the target levels determined from stability analysis. Knowing existing head in the different zones of the dam and foundation prior to excavation, and knowing the required drawn-down target levels from the stability analysis allowed engineers to decide on required methods to dewater the dam and its foundation. Dewatering design was set up around the idealized cross section shown on Fig 2. This idealized cross section has 3 layers: 1. broken rock foundation with artesian head; 2. foundation soil layer (residual soil for all but a small portion of the dam where alluvium is encountered near the river); 3. embankment fill.

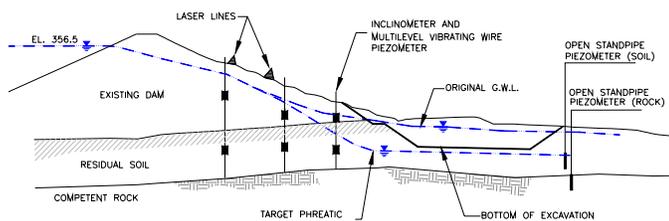
Typically, three rows of inclinometers are installed above each excavation cell, as shown on Figure 6, with a total of 65 for the entire dam. These instruments are used to measure subsurface deformations caused by slope movements. An inclinometer consists of a grouted-in grooved casing that is read using a level-sensing probe manufactured by Slope Indicator. Typical depth of inclinometers on the project varies from 50 ft to 140 ft. Most of them extend down to weathered rock. However where the residual soil layer is thick the casing is terminated in competent residual soil. Any movement shown in inclinometers can be verified by means of a laser shot through a line of targets or by GPS surveying of monuments.

Electric vibrating wire (vw) diaphragm piezometers were chosen to monitor pore water pressure within the dam during excavation. Vibrating wire piezometers “pluck” a wire attached to a diaphragm. As the tension in the wire and thus its vibrating frequency vary in proportion to the pore pressure against the diaphragm, the pore pressure can be determined. Engineers selected vw piezometers over other types (such as open standpipe), because of their quicker response time, ability to measure negative pore water pressure, and automating capability. Significant time and cost was saved by choosing to install spring-activated vw piezometers (Model 4500-MLP, Geokon, Inc.) without a sand pack using the “fully-grouted” installation method (Mikkelsen, 2002). Typically, two transducers are deployed per borehole as shown on Fig 6. In total, more than 100 multi-level vw piezometers are placed in this fashion within the dam. Engineers monitor water pressure within the embankment and residual soil layers to ensure dewatered status of the dam and to detect any changes in pore pressure that could indicate a developing failure.

Fig. 6. *Typical Instrumentation Installation.*
