A Dangerous Place to Dig Excavation at the Toe of Saluda Dam

Paul C. Rizzo Associates, Columbia, South Carolina

A DANGEROUS PLACE TO DIG EXCAVATION AT THE TOE OF SALUDA DAM

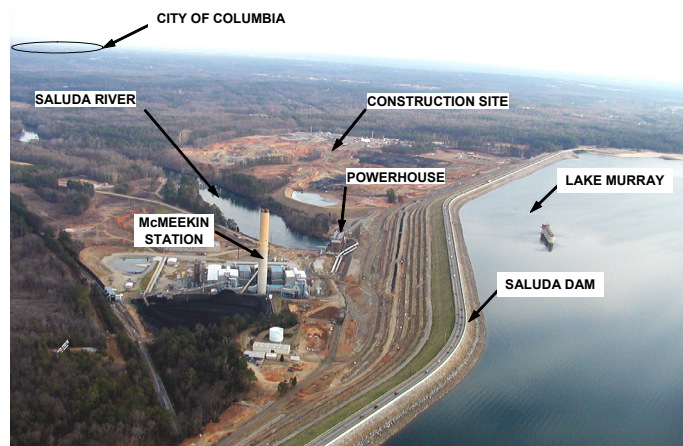
Figure 1 illustrates the dam's dimensions, geometry, and downstream hazard. The downstream hazard associated with Lake Murray is staggering. An uncontrolled breach through Saluda Dam would cause a downstream flood near the City of Columbia, probably entailing loss of life. Studies indicate that about 120,000 people would be at risk.

Fig.1. Saluda Dam and Project Overview.

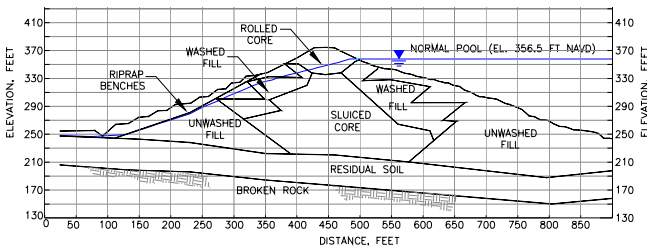
The dam is earth fill, with no internal seepage control (filter or drain protection), and no cut off. The dam was built by hauling fill to the embankment in rail cars, side dumped into piles on the upstream and downstream portions of the embankment (the two outer shells). These piles were sprayed by monitors, sluicing the fine material into a central sedimentation pool, where it deposited to form a core for the dam.

Figure 2 illustrates this construction method- showing in cross section the sluiced core and the washed soils used to form the core. Near the dam's crest, these sluicing operations were stopped. The final portion of the embankment, within 30 ft of the crest, was constructed of rolled fill. Riprap currently covering the downstream slope of the dam was placed as a remedial measure shortly after first filling to address seepage emerging on the face of the dam.

Fig.2. Typical Cross-Section, Existing Dam.

The dam's construction method comprises its problem- the sluiced fill materials. This material has a loose (or very loose) relative density. Consequently, the dam is susceptible to liquefaction during an earthquake. Figure 2 illustrates the different zones of the embankment distinguished by their placement - washed soils sprayed by monitor to form the sluiced core, the sluiced core itself, and the outer limits of the dumped fill soils that were not sprayed with water during sluicing. The top of the embankment is rolled fill.

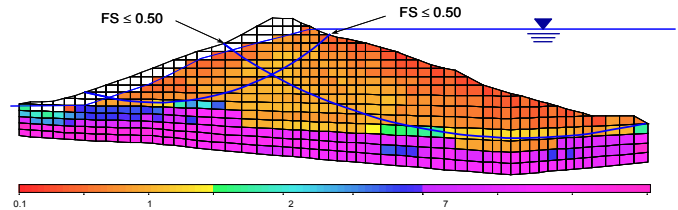
Fig.3. Liquefaction Potential Evaluation. Stability Analysis, Post-Seismic Conditions.

Paul C. Rizzo Associates (RIZZO) investigated the dam to evaluate the behavior during and immediately after a major earthquake. Based on the analysis, performed in accordance with the current Federal Energy Regulatory Commission (FERC) regulations, there is a significant potential for damage to the dam and potential for a breach under the dynamic forces caused by such an earthquake. Figure 3 illustrates the finite element liquefaction analysis of the dam and FS against slope failure in a post-earthquake condition.

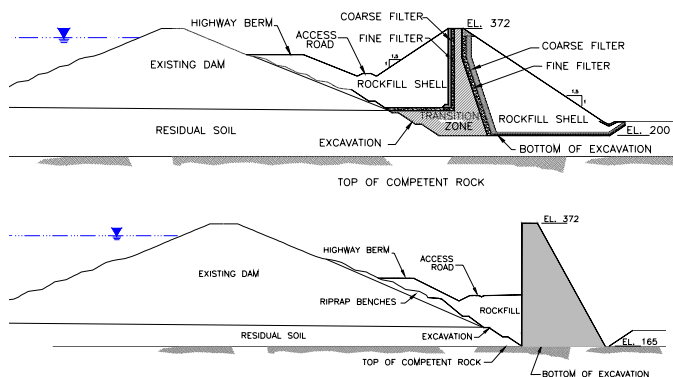
Engineers ultimately decided on the solution depicted on Fig. 4, a large new dam built immediately downstream of the existing dam. In this approach, the existing dam is left to impound Lake Murray. The new dam will be "dry," that is under normal conditions there will be a dry gap between the existing and new dams. The new downstream dam will impound water only if a sizeable earthquake were to cause the existing dam to breach (this event may never occur).

As Fig. 4 illustrates, engineers found that a combination of the rockfill and RCC Dams was required. For most of the alignment of the new dam there is sufficient room to build the design rockfill section. However, in vicinity of the powerhouse and the

Saluda River, there is insufficient space for the rockfill slope- its toe would cover the powerhouse and reach the river. Consequently, this portion of the dam compelled an RCC section for required renovation.

Fig. 4. Proposed Remediation: Rockfill Berm (top), and RCC Berm (bottom).

Construction of both the Rockfill and RCC sections shown on Fig. 4 entails excavation. However excavation requirements are different for these two structures. Rockfill excavation will reach a strong soil subgrade while RCC excavation will extend to rock subgrade. Engineers set up a main stipulation for design: No excavation into the existing dam.

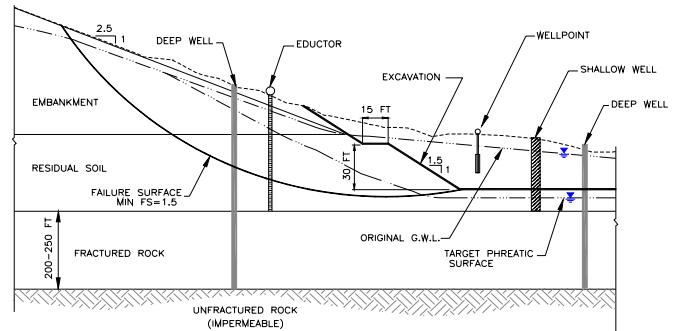
The typical dewatering system is illustrated on Fig 5. The components of this system are described below:

3. Vacuum Wells. These wells have the same function as the eductors. They are installed in isolated places where lines of eductors cannot be placed (e.g. within the excavation), or where eductor lines are not as effective as required. Vacuum well depth is typically 20 to 30 ft.

Fig. 5. Typical Excavation Dewatering System.

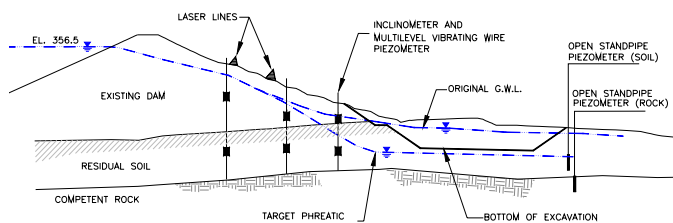
Typically, three rows of inclinometers are installed above each excavation cell, as shown on Figure 6, with a total of 65 for the entire dam. These instruments are used to measure subsurface deformations caused by slope movements. An inclinometer consists of a grouted-in grooved casing that is read using a level-sensing probe manufactured by Slope Indicator. Typical depth of inclinometers on the project varies from 50 ft to 140 ft. Most of them extend down to weathered rock. However where the residual soil layer is thick the casing is terminated in competent residual soil. Any movement shown in inclinometers can be verified by means of a laser shot through a line of targets or by GPS surveying of monuments.

Fig. 6. *Typical Instrumentation Installation.*

Electric vibrating wire (vw) diaphragm piezometers were chosen to monitor pore water pressure within the dam during excavation. Vibrating wire piezometers “pluck” a wire attached to a diaphragm. As the tension in the wire and thus its vibrating frequency vary in proportion to the pore pressure against the diaphragm, the pore pressure can be determined. Engineers selected vw piezometers over other types (such as open standpipe), because of their quicker response time, ability to measure negative pore water pressure, and automating capability. Significant time and cost was saved by choosing to install spring-activated vw piezometers (Model 4500-MLP, Geokon, Inc.) without a sand pack using the “fully-grouted” installation method (Mikkelsen, 2002). Typically, two transducers are deployed per borehole as shown on Fig 6. In total, more than 100 multi-level vw piezometers are placed in this fashion within the dam. Engineers monitor water pressure within the embankment and residual soil layers to ensure dewatered status of the dam and to detect any changes in pore pressure that could indicate a developing failure.
