Dual-Polarized Microwave Near-Field Reflectometer for Non-Invasive Inspection of Carbon Fiber Reinforced Polymer (CFRP) Strengthened Structures

Sergey Kharkovsky, Adam C. Ryley, Vivian Stephen and Reza Zoughi

Abstract – Carbon fiber reinforced polymer (CFRP) composites are increasingly being used in strengthening structures of civil infrastructures, aerospace and automotive industries. Subsequent to the application of CFRP, detection and evaluation of the structural integrity of the member becomes a critical issue. Microwave non-invasive inspection techniques have been successfully used for inspecting these structures. A novel inspection system with a dual-polarized microwave near-field waveguide probe for detecting defects such as disbond between CFRP laminates and strengthened structures is presented. It is shown that this system provides automatic removal of the influence of undesired standoff distance (or surface roughness) variations. It may simultaneously generate three images of defects: two at orthogonal polarizations and one after the influence of the undesired variations is removed. The novel measurement system provides for detection and evaluation of different types of

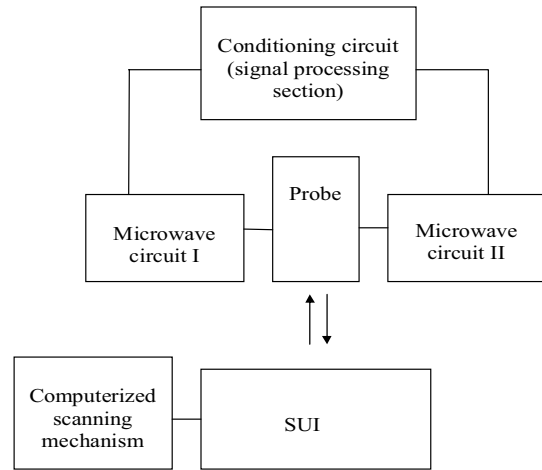
Fig. 1. Schematic of the inspection system with a dual-polarized microwave probe.

Figure 1 shows a schematic of a novel inspection system. This system consists of a computerized automated 2D scanning mechanism, two microwave circuits incorporated into a dual-polarized near-field waveguide probe, and a conditioning circuit (signal processing section). The open-ended dual-polarized waveguide probe simultaneously transmits two linear orthogonal polarized signals onto the structure under inspection (SUI) and receives two linear and orthogonal polarized reflected signals. These signals vary as a function of standoff distance, which is defined as the distance between the SUI and the probe aperture. However, if the electric field polarization vector of one of the transmitted signals is perpendicular to the fiber orientation of CFRP laminate the signal penetrates through this laminate and senses an interior defect, while the other signal is sensitive to standoff distance variation and SUI surface roughness since its electric field polarization vector is parallel to the fiber orientation causing the signal to totally reflect off of the CFRP laminate. Subsequently, the reflected signals are fed to two phase detectors (microwave circuits) providing for two corresponding DC output voltages which are proportional of phase (and/or amplitude) difference between the transmitted and reflected signals of each polarization. Then, these DC output voltages are applied to a conditioning circuit which includes a compensator, a means for signal processing and indicator or image display. The output of the conditioning circuit, which is also a DC voltage, is used to generate 2D image which provides information about the internal structure and defects (i.e., disbond, concrete damage, etc.) while removing the undesired influence of standoff distance (or surface roughness) variations from the measurements at the same location on SUI. A computerized scanning mechanism provides raster scan of the SUI by moving of the probe over it. The measured voltages from the output of the microwave circuits are also used to generate separate images for each polarization. Thus, three images of scanned area may be generated and used simultaneously for inspection. For instance, image for parallel polarization may be used for non-contact sensing of standoff distance variation and/or detecting surface defects (i.e. fiber misalignment, fiber breakage, cracks, etc.). Consequently, this novel inspection system

provides detection and evaluation of different types of defects in CFRP reinforced structures, reducing the time required for data acquisition due to an automatic removal of undesired variations.
