## Missouri super duty refractories and their probable application for blast furnace linings

MISSOURI SUPER DUTY REFRACTORIES AND THEIR PROBABLE APPLICATION  
FOR BLAST FURNACE LININGS

submitted to the faculty of the  
SCHOOL OF MINES AND METALLURGY OF THE UNIVERSITY OF MISSOURI  
in partial fulfillment of the work required for the  
Degree of  
CERAMIC ENGINEER  
Rolla, Missouri  
1943

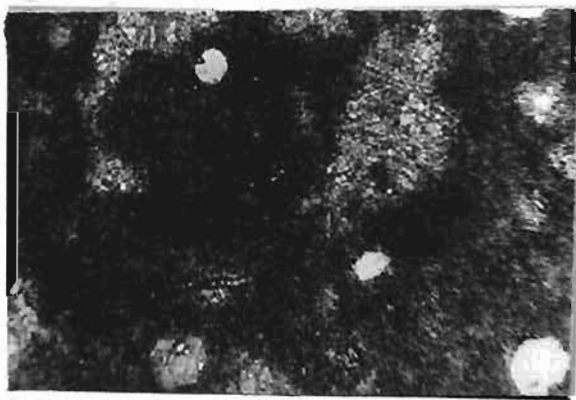
Fig. 4 - Thin Section of  
first quality  
Missouri fire brick  
(140 X)

Fig. 5 - Thin section of  
first quality Missouri  
fire brick (220 X)

Note: the very clear spots are holes in the thin section which were torn out during grinding.

In figures 4 and 5 it can readily be seen that the mullite crystals (the long needle-like crystals) are rather large, well defined ones, imbedded and interlaced in the clearer areas. The clearer areas are the glass which has been formed and it can be seen that it is present in rather large amounts.

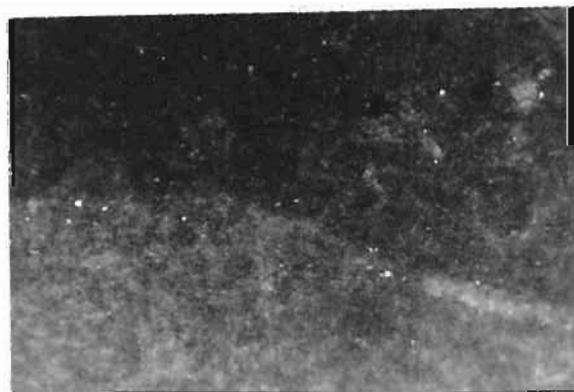
Fig. 10 - Thin section of  
Hard Burned, Super Duty  
Missouri fire brick  
(140 X)

Fig. 11 - Thin section of  
Hard Burned, Super  
Duty Missouri fire  
brick (220 X)

Figures 10 and 11 show the same characteristic opaque, fine-grained, mullite development in super duty refractories which gives the maximum resistance to heat and chemical reaction.

Petrographic analysis of the scab interface between the slag of the blast furnace and the refractories, shows that the flint grains are always the last to go into solution with the slag of the furnace. These grains, therefore, are more resistant to blast furnace slags than the less refractory bond clay. The well developed sections of figure 10 and figure 11 show why this is so.

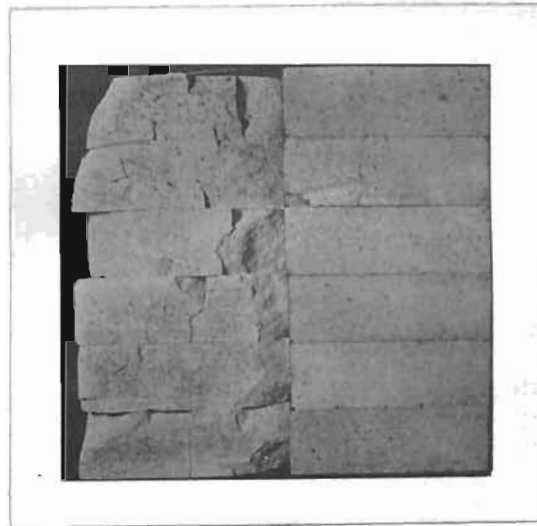
Fig. 15 Column of Standard Top Quality Blast Furnace Refractory at the left shows a 9% loss after being subjected to spalling test. The Hard Burned Super Duty material at the right subjected to the same spalling test shows a loss of only three tenths of one per cent.

Hard burned super duty fireclay brick, as shown, displays outstanding resistance to spalling. During the hard firing which the brick undergoes in manufacture, it becomes exceedingly well bonded by the action of the heat, but due to its chemical purity, the glass phase which is developed and which produces the bond is of a high type that has great resistance to reversible thermal changes, imparting high spalling resisting properties to the brick. Therefore, less cracking and breaking of super duty refractories may be expected than is usually found in brick used to line this portion of the furnace.

In order to get the inherent resistance to spalling of super duty refractories in comparison to standard "Top Quality" refractories, a special spalling test was adopted in which the standard spalling procedure was used, eliminating the preheat. More than one series of spallings was required to produce an appreciable loss in either type of refractories. Twelve cycles of spalling are used in the standard A.S.T.M. Test while Figure 15 shows the appearance of both types of brick after being subjected to fifty-nine cycles.

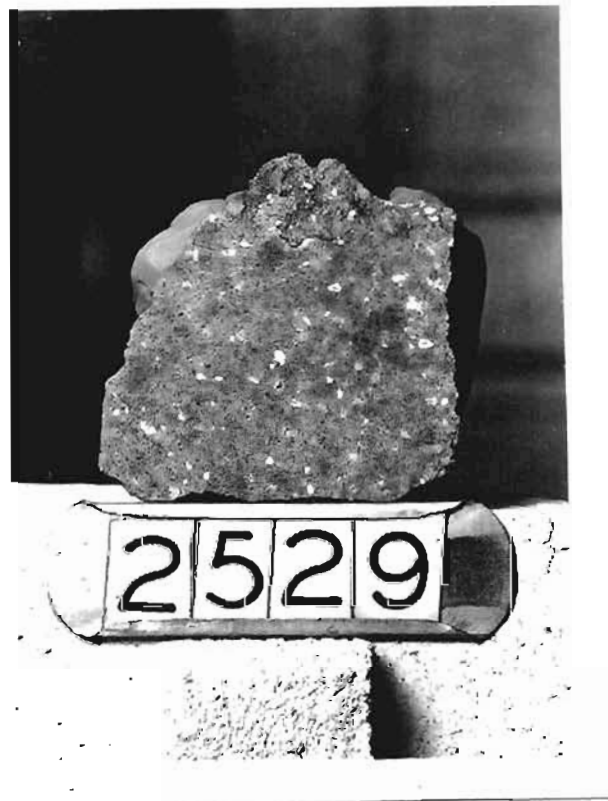
Fig. 41 - Polished Section of "B" Hearth & Bosh Quality fire brick After Reheat 2X

Missouri	Missouri	Kentucky	
	Hard Burned Super Duty	Super Duty	Blast Furnace Refractories	
			"A"	"B"
Volume change in 2912°F. Reheat 5 Hrs.	Cont. 3.0%	Exp. 1.7%	Exp. 7.4%	Exp. 22.5%
App. Porosity Before 2912°F. Reheat	12.4%	15.7%	14.7%	13.8%
True Porosity Before 2912°F Reheat	16.95%	17.45%	16.05%	18.65%
App. Porosity After 2912°F. Reheat	8.8%	8.8%	14.0%	13.6%
True Porosity After 2912°F. Reheat	13.63%	18.19%	36.0%	32.0%
P.C.E.	33-34	33-34	32-33	32 $\frac{1}{2}$ -33
Cold Abrasion	.175	.300	.080	.150
Polished Section Before Reheat	Fig. 27	Fig. 26	Fig. 31	Fig. 32
Polished Section After Reheat	Fig. 36	Fig. 35	Fig. 40	Fig. 41
Resistance to CO	Fig. 21	Fig. 25	Fig. 23	Fig. 20

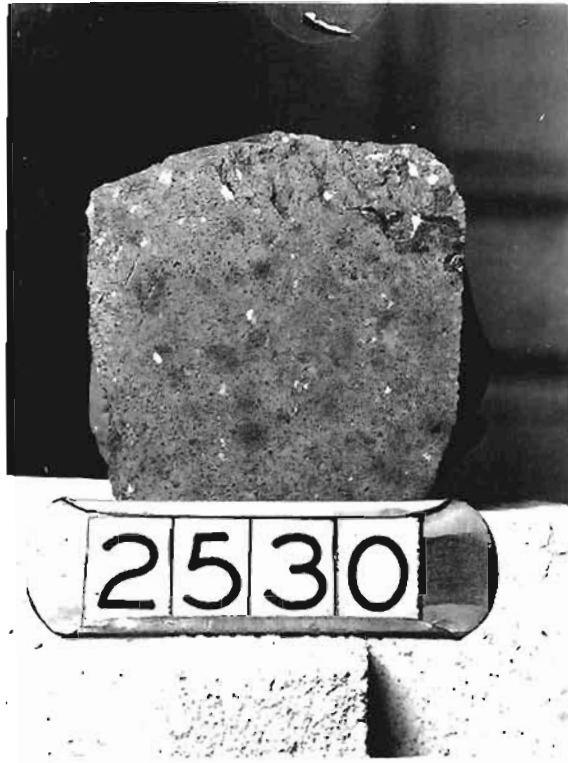
Fig. 42 - Polished Section of "B" Inwall Quality fire brick After Reheat - 2X

Missouri	Missouri	1st Qual. <u>Missouri</u>	Kentucky Blast Furnace Refractories	
	<u>Hard Burn.</u> <u>Super-Duty</u>	<u>Super</u> <u>Duty</u>		<u>"A"</u>	<u>"B"</u>
Volume Change in 2912°F., 5 Hr. Reheat	Cont. 3.0%	Exp. 1.7%	Exp. 3.6%	Exp. 23.5%	Exp. 11.1%
App. Porosity Before 2912°F. Reheat	12.4%	15.7%	14.9%	11.8%	16.8%
True Porosity Before 2912°F. Reheat	16.95%	17.45%	17.8%	14.22%	18.65%
App. Porosity After 2912°F. Reheat	8.8%	8.8%	2.6%	8.7%	10.4%
True Porosity After 2912°F. Reheat	13.63%	18.19%	14.23%	30.30%	27.30%
P.C.E.	33-34	33-34	32-33	32-33	32 $\frac{1}{2}$ -33
Cold Abrasion	.175	.300	.200	.100	.125
Polished Section Before Reheat	Fig. 27	Fig. 26	Fig. 34	Fig. 30	Fig. 33
Polished Section After Reheat	Fig. 36	Fig. 35	Fig. 43	Fig. 39	Fig. 42
Resistance to CO	Fig. 21	Fig. 25	Fig. 24	Fig. 17	Fig. 19

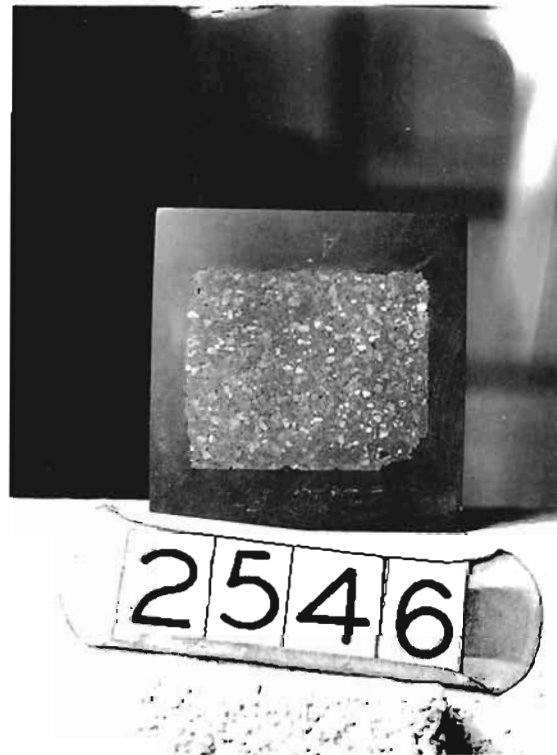
Fig. 47 - Polished Section of  
"A" ( $4\frac{1}{2}$  x 9 x 18")  
After Reheat - 2X

Missouri	Missouri Super Duty	Kentucky Blast Furnace Refractories		
	Hard Burned Super Duty				
			"B"	"C"	"A"
Volume Change in 2912°F. Reheat 5 Hrs.	Cont. 2.4%	Exp. 1.4%	Cont. 5.4%	Cont. 3.0%	Exp. 3.0%
App. Porosity Before 2912°F. Reheat	13.6%	16.1%	16.6%	21.5%	16.2%
True Porosity Before 2912°F. Reheat	17.2%	16.5%	-	-	-
App. Porosity After 2912°F. Reheat	5.5%	9.6%	.7%	10.9%	1.5%
True Porosity After 2912°F. Reheat	11.85%	16.4%	-	-	-
2642°F. Hot Load Test	Cont. 3.2%	Cont. 6.0%			
P.C.E.	33-34	53-34	32 $\frac{1}{2}$ -33	32-33	33
Cold Abrasion	.125"	.800"	.300"	.500"	.175"
Polished Section Before Reheat	Fig. 29	Fig. 28	Fig. 45	Fig. 46	Fig. 44
Polished Section After Reheat	Fig. 38	Fig. 37	Fig. 48	Fig. 49	Fig. 47
Resistance to CO	Fig. 22	Fig. 25	Fig. 19	Fig. 20	Fig. 16

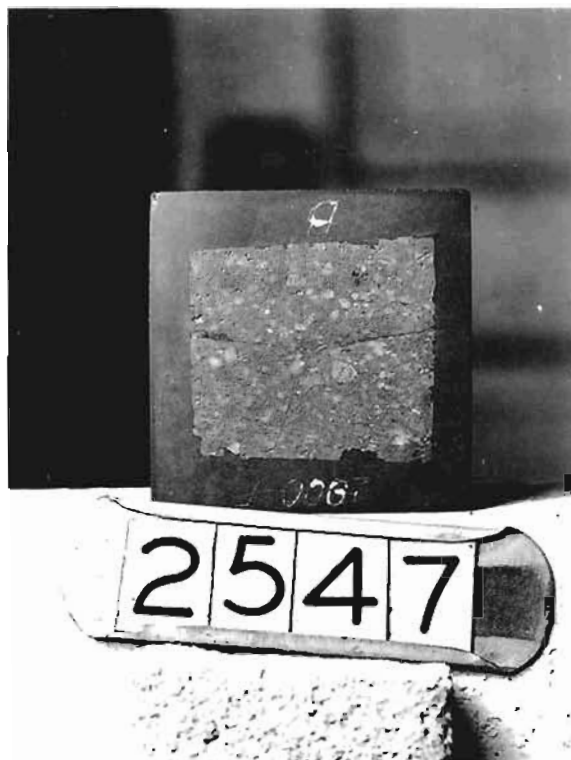
Fig. 48 - Polished Section  
of "B" ( $4\frac{1}{2}$  x 9 x  
18") After Re-  
heat - 2X

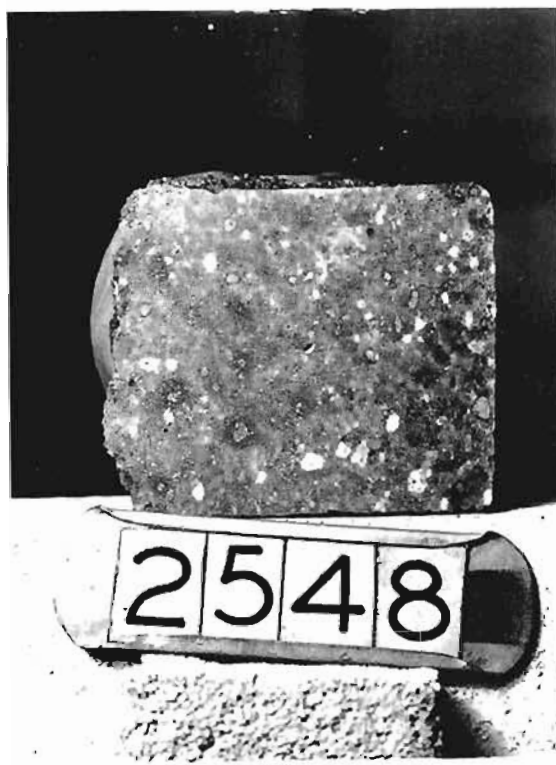
Fig. 49 - Polished Section of  
"C" ( $4\frac{1}{2}$  x 9 x 18")  
After Reheat - 2X
