# CONSIDERATION OF THE EARTHQUAKE RESISTANCE OF LARGE FILL DAMS

**Shigeru TANI**

National Research Institute of Agricultural Engineering  
Tsukuba, Ibaraki-Japan (305-8609)

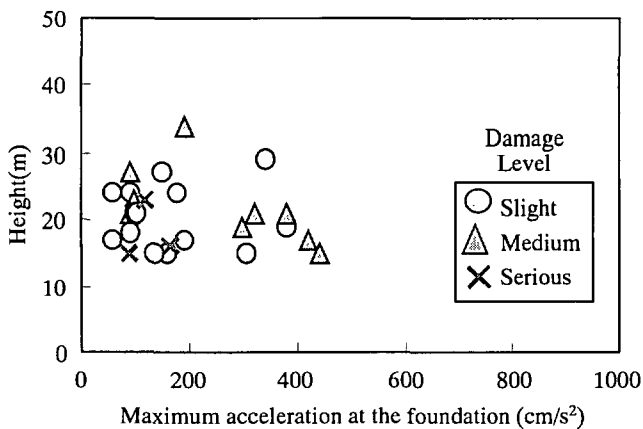
Fig.1 Earthquake damage to large fill dams constructed before 1953 in Japan

or Settlement >100cm. Since there were no fill dam design standards before 1953, the technical background was completely different from those built since 1953. While fill dams constructed after 1953 have scarcely been damaged, some of the dams built before then have been very seriously affected. However, only one dam has failed. The figures, which also include estimated values, show maximum accelerations around 600 gal. Fill dams in Japan that have been constructed based on the modern design method, should sufficiently resist earthquakes that cause such maximum acceleration. Official records (or sometimes estimates) of earthquake motion at dam sites in Japan have shown that at maximum input acceleration of about 600 gal, earthquakes do not seriously affect modern fill-type dams. All fill-type dams that were destroyed or seriously damaged had been built before 1918.

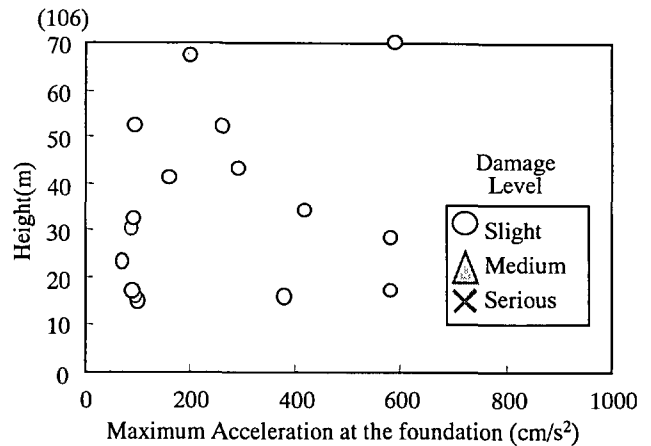
Fig.2 Earthquake damage to large fill dams constructed after 1953 in Japan

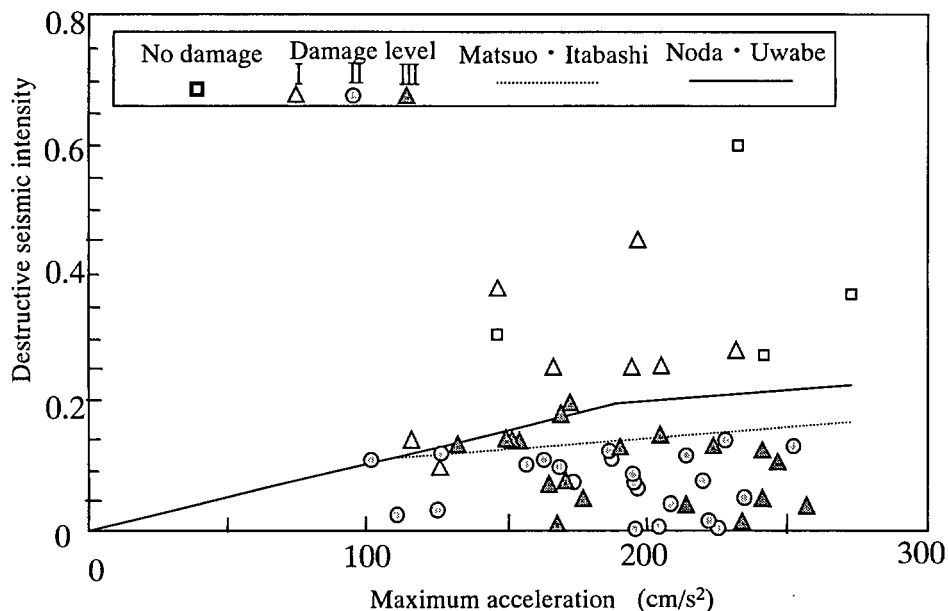
Fig.4 Relationship between maximum acceleration and seismic intensity (T. Uwabe, 1991)

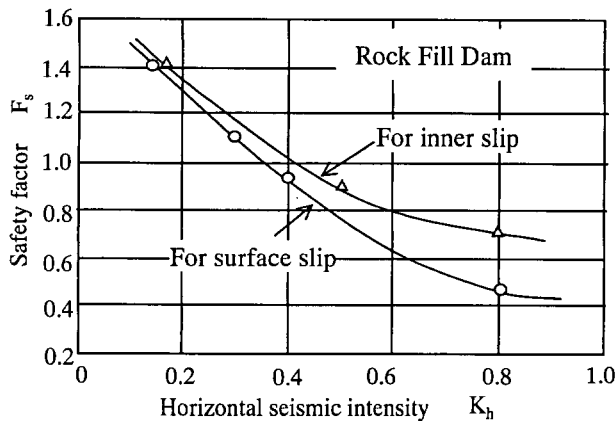
Fig. 5 Relationship between safety factor  $F_s$  and horizontal seismic intensity  $K_h$  (One, 1985)

The relationship between horizontal intensity and slide safety factor, which One et al. calculated for a rock fill dam is shown in Fig. 5. The figure shows that the horizontal intensity  $K_h$  is 0.20 when the safety factor is 1.35 and  $K_h$  is 0.40 when the safety factor is 1.0. This relationship likely varies with crest height, sectional form, the strength of the materials used, and other factors. Since not all data could be acquired, we could not determine the seismic intensity for the safety factor of 1.0 from slide analysis. Therefore, we approximated the  $K_{ds}$  value for the safety factor of 1.0 ( $\square$ ,  $\blacksquare$  in the Fig. 7) by using the relationship for the inner slide of rock-fill dams between the change in horizontal intensity  $K_h$  and slide safety factor  $F_s$ . The data ( $K_{ds}$  values for the safety factor of 1.0) for undamaged and damaged earth dam are also shown in the figure with  $\triangle$  and  $\blacktriangle$  by using the relationship between for an earth dams between the change in horizontal intensity  $K_h$  and slide safety factor  $F_s$  shown in Fig. 6. Fig. 7 show the relationship between the maximum acceleration (either measured or estimated from the seismic intensity and epicentral distance) and the destructive horizontal seismic intensity shown in Table 1. Assuming that the destructive intensity is the value at safety factor = 1.0, the design and destructive intensities are different

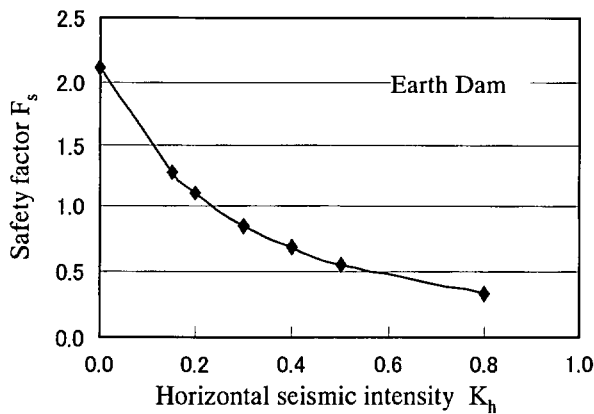
Fig. 6 Relationship between safety factor  $F_s$  and horizontal seismic intensity  $K_h$  (Tani, 2000)

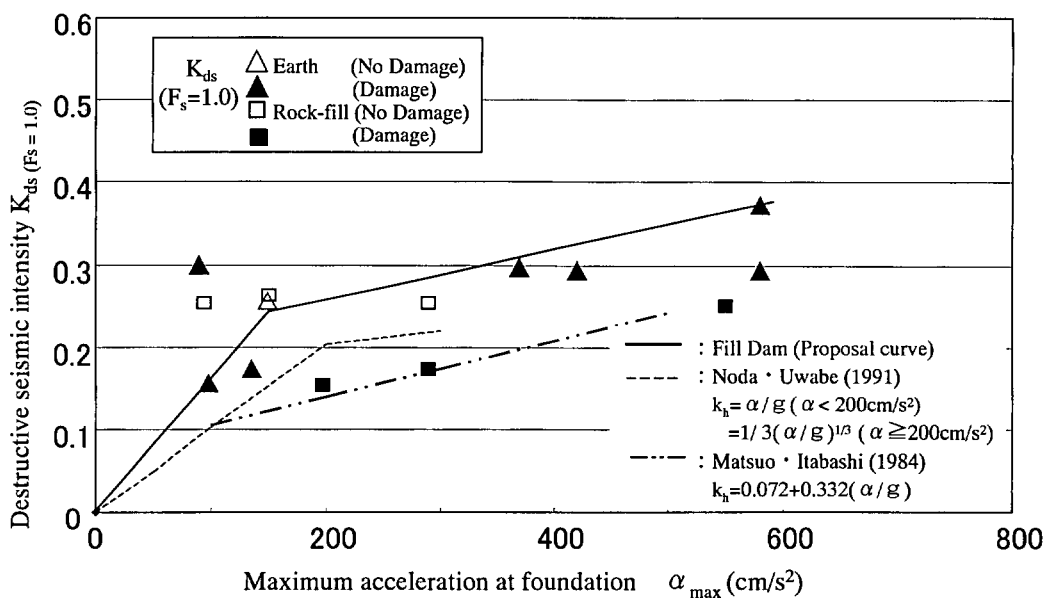
Fig. 7 Relationship between destructive seismic intensity and maximum acceleration at foundation

An approximate curve derived by Noda and Uwabe method is shown in Fig.7. The upper limit of damage is shown with a solid line in the Fig.7. Fill dams showed a tendency similar to that of other civil structures. The data for Fill dam were different from others due to the difference of height. Although the number of data is few, the solid line in Fig.7 is believed to show the relationship between the destructive intensity and the maximum acceleration for fill dams. We will collect more data and further study the relationship between destructive intensity and maximum input acceleration to the foundation.
