International Conference on Case Histories in Geotechnical Engineering (2004) - Fifth International Conference on Case Histories in Geotechnical Engineering

## Case History Illustrating the Challenges of Foundation Design and Construction in Karst Terrain

Frederick A. Brinker  
*SITE-Blauvelt Engineers, Inc., Mt. Laurel, New Jersey*

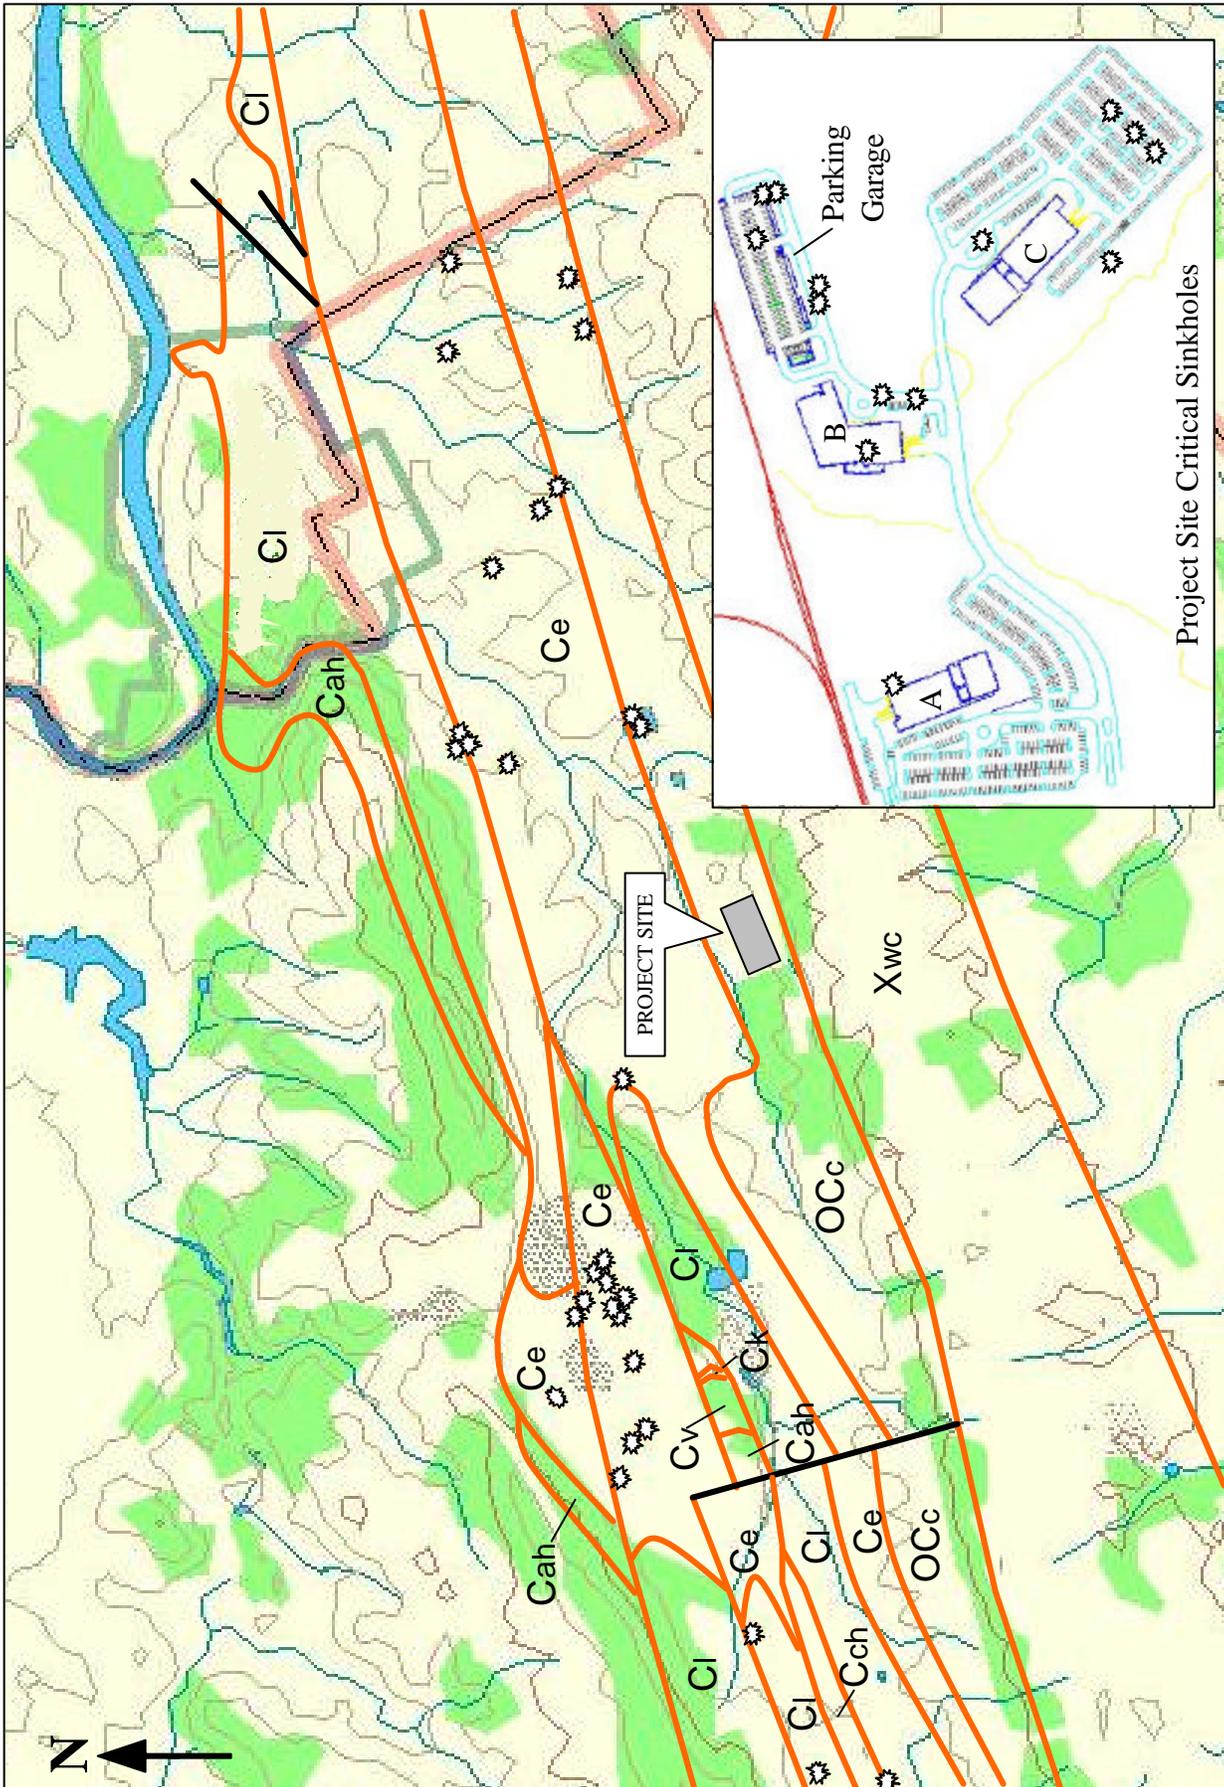
Fig. 1. Sinkhole Location Map

Figure 1 presents the location of sinkholes as reported by the Pennsylvania Geologic Survey as well as critical sinkholes observed onsite. Of note is the trend of sinkhole activity observed in this area. The drawings clearly show a southwest to northeast trend of sinkhole activity through the project site that generally follows the strike of the formation.

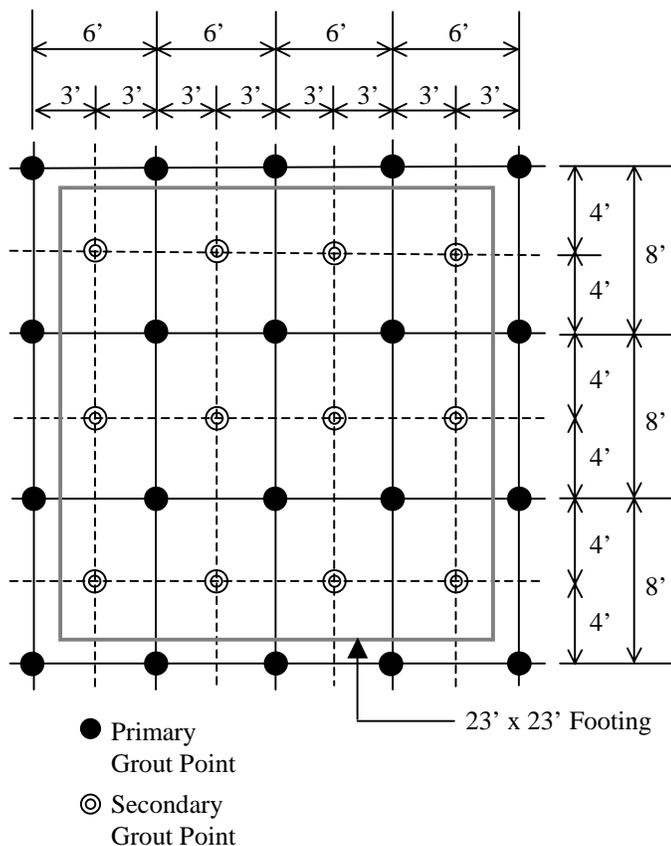
Fig. 2. Typical Compaction Grouting Layout.

A typical grouting layout consists of a series of primary, secondary, tertiary, and if necessary a fourth series of grout points over the treatment area. Grouting operations began after the building pad was constructed and a layer of stone was placed over the pad as a working surface. Typically, the compaction grouting operations were conducted in a grid pattern over an area that generally extended over the spread footing location and approximately 10 percent beyond the footing limits. Figure 2, located on the following page, presents a typical grouting layout.

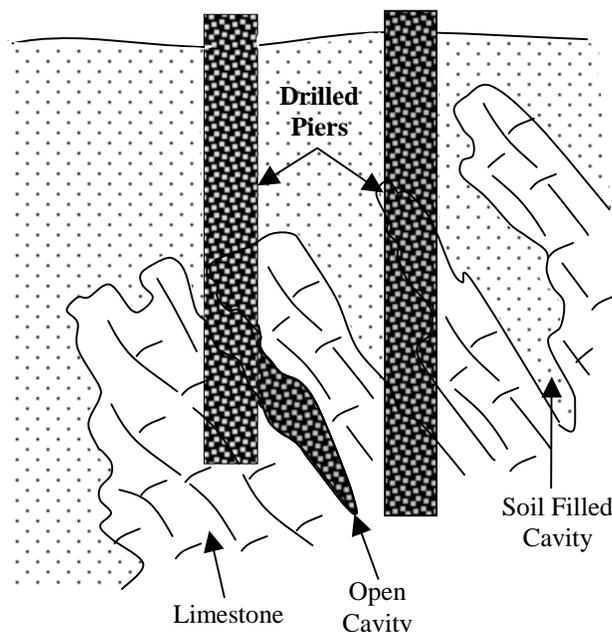
Fig. 3. Sketch of a Typical Cross-Section in Karst Terrain.

The selected foundation system for this building was drilled piers founded in limestone bedrock. At the very early stages of construction, the impact of the pinnacled, fractured and uneven nature of the bedrock became apparent to the Contractor, Construction Manager and our field inspection personnel. The pier construction schedule, while aggressive, was set for completion of the drilled piers within 35 days. Figure 3 depicts a general cross-section image of the subsurface conditions typical of the limestone bedrock.

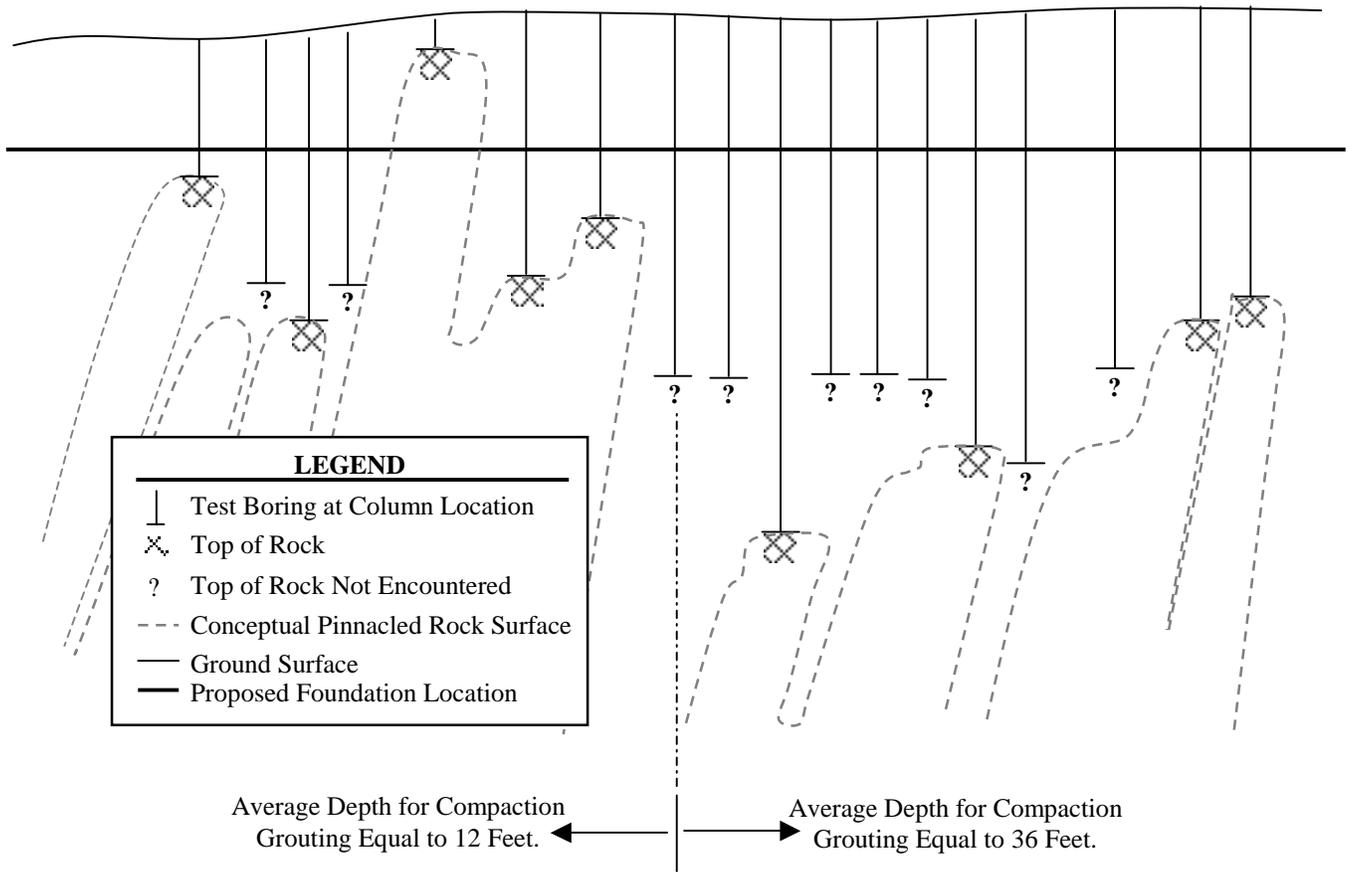
Fig. 4. Longitudinal Cross-Section of Subsurface Conditions Along One Column Line of the Parking Structure.

The design of the compaction grouting program was further modified to ensure coverage of areas where solution activity may be more prevalent. The initial compaction grouting design focused on areas where "very soft" to "soft" soil zones were encountered. The depth of the grouting zones varied as the depth to bedrock and soft zones varied. Because the initial test boring program did not provide for coverage at each individual column location, a series of supplementary test borings were advanced after the site was cut to subgrade level to fill data gaps. Figure 4, located on the following page, presents a typical longitudinal cross section of the building along a column line. As depicted in
