Ground Improvement by Stone Columns and Surcharge at a Tank Site

GROUND IMPROVEMENT BY STONE COLUMNS AND SURCHARGE AT A TANK SITE

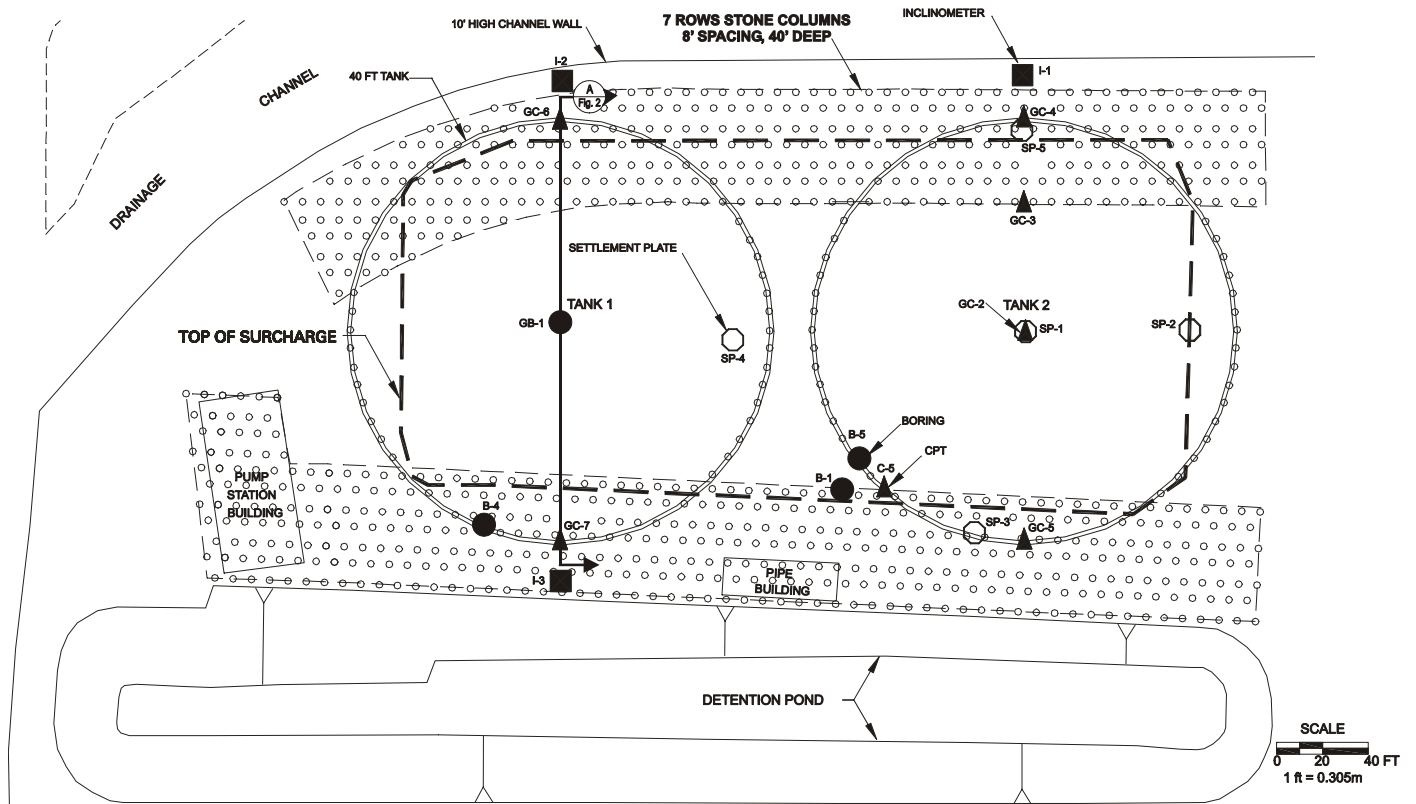
Fig. 1. Site Layout

- The lot is roughly rectangular in shape, measuring about 560 ft (171 m) in the east-west direction and 330 ft (101 m) in the north-south direction. Site layout is shown in Fig. 1. The tank site has grades ranging between El. 33 to El. 35 feet (10.1 to 10.7 m).
- A new detention pond with a depth ranging from 6 to 10 ft (1.83 to 3 m) and 3:1 (horizontal to vertical) side slopes was planned to be constructed about 25 ft (7.6 m) south of the reservoirs.
- The site is bounded on the north, and along the northwest corner, by a 10-ft (3-m) deep concrete-lined drainage channel with vertical side retaining walls.

The vertical 10-ft (3-m) high wall of the drainage channel is located about 25 ft (7.6 m) north of the two reservoirs (Fig. 1). Tank foundations were proposed at roughly 10 ft (3 m) above channel invert elevation. In addition, a detention pond was proposed about 25 ft (7.6 m) south of the two reservoirs. The detention pond was proposed with 3:1 (horizontal to vertical) side slopes and the bottom of the pond was up to 10-ft (3m) below the tank foundations. The presence of these low-lying areas results in reduced lateral stability compared to tanks on level ground. Results of stability analyses performed by PCSTABL/5M are shown in Fig. 3. For seismic stability, we used a pseudo-static coefficient of 0.15, and we reduced the shear strength of the soft to firm clay to 80% of the static shear strength. The calculated factors of safety for static and seismic conditions are 1.3 and 0.9, respectively, and are lower than the normally used values of 1.5 and 1.1, respectively. Since the calculated factor of safety for pseudo-static analysis was less than 1.1, we estimated that potential for large lateral movements using simplified Newmark-type analysis (Blake et al., 2002) was present during the design earthquake.

Three inclinometers were established along the north and south sides of the tanks near the channel and detention pond to measure lateral movements due to stone column installation and surcharge. Four survey points were set on the top of the channel wall to monitor both settlement and lateral movement of the channel wall. Five settlement plates, SP-1 through SP-5, were installed before placement of the surcharge to monitor settlement. The locations of these instruments are shown in Fig. 1.

- Inclonometers were installed at the locations shown in Fig. 1.
- Stone columns were installed along the northern and southern tank boundaries, adjacent to the drainage channel and detention pond. To minimize lateral movement and damage to the channel wall, the closest stone columns were kept at a minimum distance of 12 ft (4 m) from the wall. A total of 908 stone columns were installed in 54 days.

- Installed settlement plates SP-1 through SP-5.
- After completion of the stone columns, import fill was placed to preload the site to the boundaries shown in Fig. 1. The placement of about 80,000 cubic yards (61,210 cubic meters) of fill was completed from April 16, 2001 through May 30, 2001 a period of about 45 days.

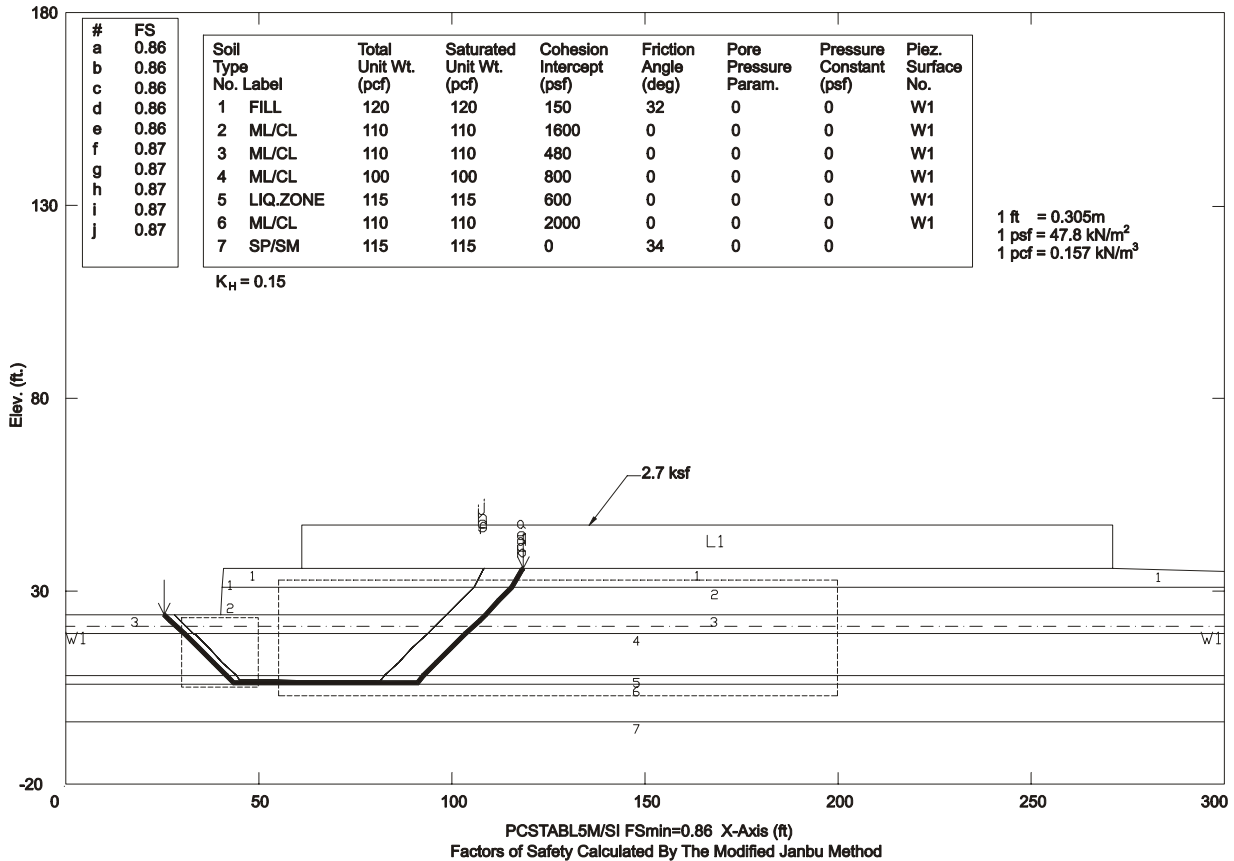
WATER TANK, H=40FT, SEISMIC, BLOCK SURF., UND. COND.

Fig. 3. Stability Analyses
