## Dual-Polarized Microwave Near-Field Reflectometer for Non-Invasive Inspection of Carbon Fiber Reinforced Polymer (CFRP) Strengthened Structures

Sergey Kharkovsky

S. Kharkovsky et al., "Dual-Polarized Microwave Near-Field Reflectometer for Non-Invasive Inspection of Carbon Fiber Reinforced Polymer (CFRP) Strengthened Structures," *Proceedings of the IEEE Instrumentation and Measurement Technology Conference (2006, Sorrento, Italy)*, pp. 2108-2111, Institute of Electrical and Electronics Engineers (IEEE), Apr 2006.

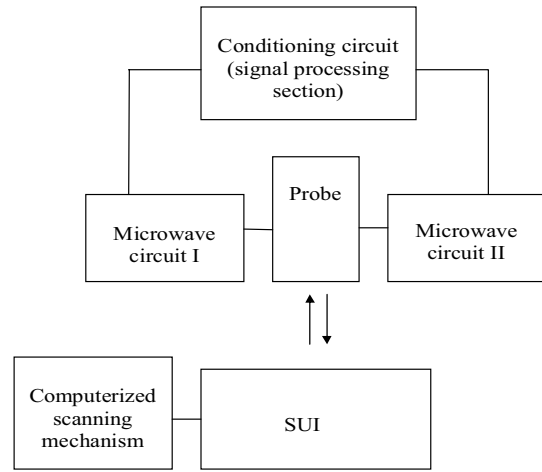
Fig. 1. Schematic of the inspection system with a dual-polarized microwave probe.

Figure 1 shows a schematic of a novel inspection system. This system consists of a computerized automated 2D scanning mechanism, two microwave circuits incorporated into a dual-polarized near-field waveguide probe, and a conditioning circuit (signal processing section). The open-ended dual-polarized waveguide probe simultaneously transmits two linear orthogonal polarized signals onto the structure under inspection (SUI) and receives two linear and orthogonal polarized reflected signals. These signals vary as a function of standoff distance, which is defined as the distance between the SUI and the probe aperture. However, if the electric field polarization vector of one of the transmitted signals is perpendicular to the fiber orientation of CFRP laminate the signal penetrates through this laminate and senses an interior defect, while the other signal is sensitive to standoff distance variation and SUI surface roughness since its electric field polarization vector is parallel to the fiber orientation causing the signal to totally reflect off of the CFRP laminate. Subsequently, the reflected signals are fed to two phase detectors (microwave circuits) providing for two corresponding DC output voltages which are proportional of phase (and/or amplitude) difference between the transmitted and reflected signals of each polarization. Then, these DC output voltages are applied to a conditioning circuit which includes a compensator, a means for signal processing and indicator or image display. The output of the conditioning circuit, which is also a DC voltage, is used to generate 2D image which provides information about the internal structure and defects (i.e., disbond, concrete damage, etc.) while removing the undesired influence of standoff distance (or surface roughness) variations from the measurements at the same location on SUI. A computerized scanning mechanism provides raster scan of the SUI by moving of the probe over it. The measured voltages from the output of the microwave circuits are also used to generate separate images for each polarization. Thus, three images of scanned area may be generated and used simultaneously for inspection. For instance, image for parallel polarization may be used for non-contact sensing of standoff distance variation and/or detecting surface defects (i.e. fiber misalignment, fiber breakage, cracks, etc.). Consequently, this novel inspection system

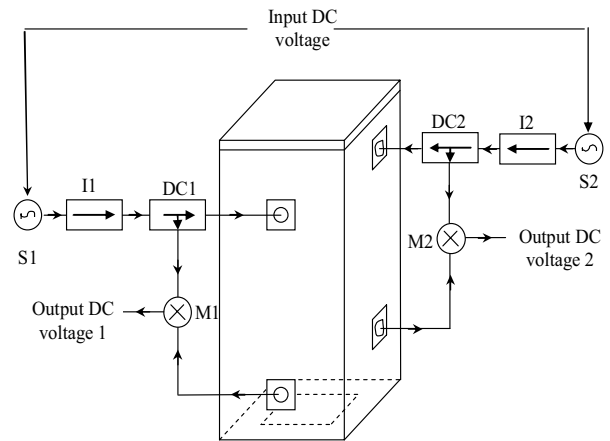
Fig. 2. Schematic of microwave circuits and a square waveguide dual-polarized probe.

Such a dual-polarized inspection system with a square waveguide probe was designed and constructed at X-band (8.2–12.4 GHz). This frequency range was chosen because of successful previous investigations of CFRP reinforced cement-based structures [5-8]. Figure 2 shows a schematic of two microwave circuits and an open-ended square waveguide probe. Each microwave circuit consists of a microwave source (S), an isolator (I), a directional coupler (DC) and a mixer (M). Portions of the transmitted and reflected signals of each polarization are combined in the mixer to produce DC

output voltages which are proportional of their phase (and/or amplitude) difference. Frequency dependency of coupling between the two orthogonally polarized ports was investigated for providing minimum unwanted coupling and increased internal isolation between them. As a result, two microwave signals of different polarizations with corresponding frequencies, 9.4 GHz and 11.2 GHz, were used for the reflectometer. Microwave 2D images of CFRP reinforced cement-based (mortar, concrete) structures were produced by making raster scans of the structures.

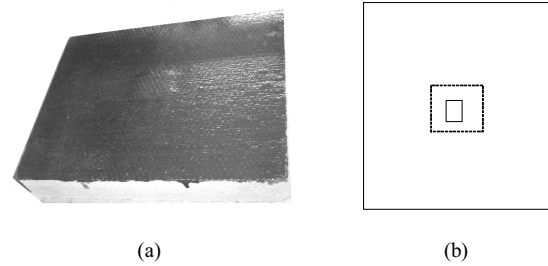
Fig. 3. (a) Picture of the CFRP mortar sample and (b) its schematic with marked disbonded region (solid line) and scanned area (dash line).

Several CFRP cement-based samples were investigated for the purpose of detecting and evaluating of disbonds and other defects. One of the samples used in this investigation was a 380 mm by 520 mm-wide and 90 mm-thick mortar slab adhered with CFRP laminate as shown in the Figure 3a. A 60 mm by 80 mm rectangular disbonded region was intentionally produced by inserting a thin foam slab between the CFRP laminate and the substrate mortar. Figure 3b shows a schematic of the sample with marked disbonded region and scanned area. To better demonstrate the utility of this system, the sample was intentionally tilted, with respect to the probe scan plane, to produce a relatively severe standoff distance variation over the scan area. Subsequently, an area of 140 mm by 140 mm including the disbonded region was imaged using the measurement system. Figure 4 shows the microwave images of the scanned area. As expected, the disbonded region is clearly visible in the image for perpendicular polarization (Fig. 4a). However, the indication of the disbonded region is also clearly visible in the image for parallel polarization (Fig. 4b). The image in Fig. 4b is an indication of the slight surface bulging due to the presence on the thin foam insert. The image obtained by using perpendicular polarization shows non-uniform structure of the disbond in contrast to image for parallel polarization in which the presence of the thin foam insert as well as the slight surface bulge are detected in the image. Moreover, both images show a gradual intensity change mostly along the horizontal axis representing the intentionally induced standoff distance change. Figure 4c shows the image obtained after compensation of the standoff distance variation using the image data for both polarizations. It can be seen from Fig. 4c that the disbonded region is clearly visible and it is non-uniform. The non-uniformity of the disbonded region was confirmed by results of taping and may be explained by the changes in thickness of the foam during the process of bonding the CFRP laminate, the foam slab and the mortar structure. The black area around the disbonded region is uniform. This is in contrast to the non-uniform area around the foam insert in Fig. 4a. It must be noted that the dimensions of the disbonded region associated with its image

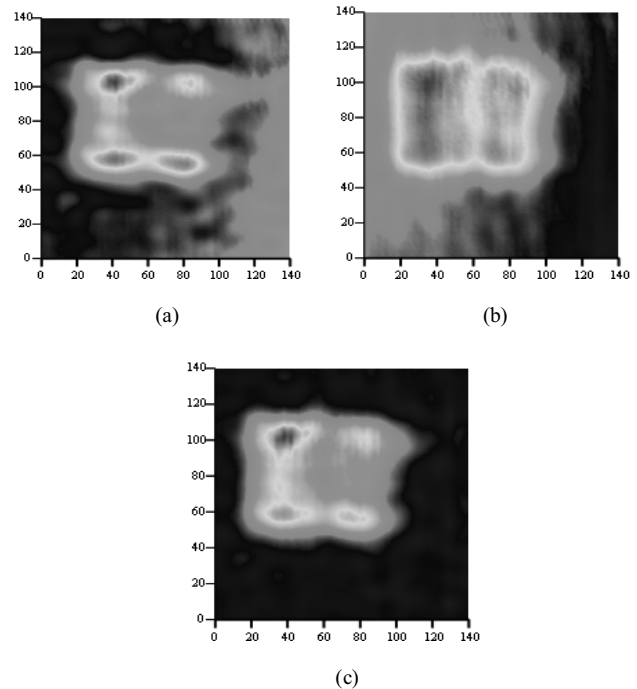
Fig. 4. Microwave images of the disbond in CFRP mortar sample (a) at perpendicular polarization, (b) at parallel polarization, and (c) compensated image.

in Fig. 4c correspond well with its actual dimensions. It means that the effect of bulging is also removed.

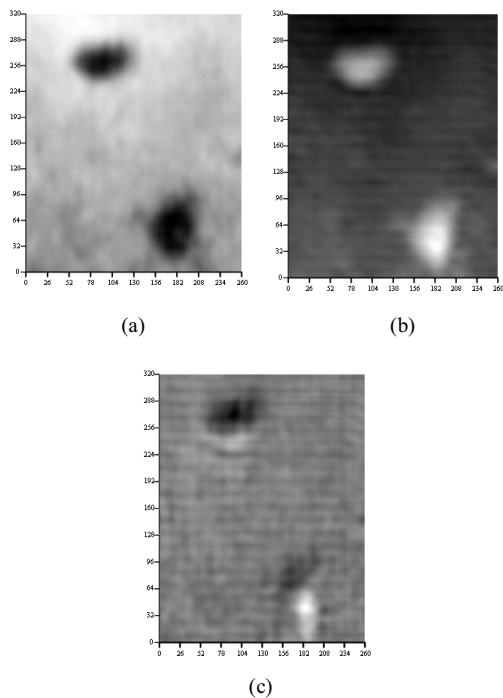
Fig. 5. Microwave images of the abutment CFRP patch (a) at perpendicular polarization, (b) at parallel polarization, and (c) compensated image.

In-field inspection and monitoring of CFRP-strengthened concrete members was conducted on the structures of an actual bridge [7]. Several 600 mm by 600 mm CFRP patches were bonded to the abutment and the bent of the bridge. A number of artificial disbonds (intentional defects) were manufactured by injecting air between CFRP patches and concrete members. Figure 5 shows the microwave images of the 260 mm by 320 mm scanned area of the bonded CFRP patch in the abutment of the bridge. The black spots in the image for perpendicular polarization (Fig 5a) represent the areas of two disbonds. The indications of the slight surface

bulging due to the presence of air between CFRP and concrete are also clearly visible in the image for parallel polarization (white spots in Fig. 5b), The compensated image (Fig.5c) was generated automatically after the influence of the standoff distance variation was removed from the data for the perpendicular polarization using data for the parallel polarization. The locations and sizes of the detected disbonds, indicated by this compensated image, agree well with their locations and sizes on the bonded CFRP patch. These features were verified using tap testing.
