FIELD TESTING OF CRUSHED IGNIMBRITE FOR SEISMIC RETROFIT OF MATAHINA DAM

Lelio H. Mejia, PhD, PE
URS Corporation
Oakland, California, USA

ABSTRACT

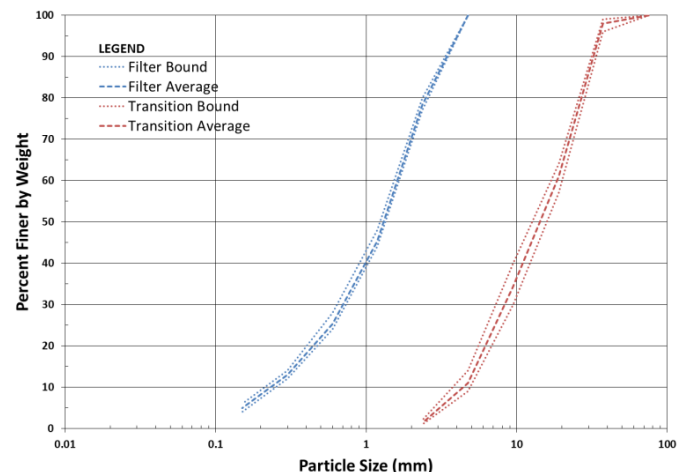
Fig. 1. Gradations of filter and transition materials in the stockpiles

A coarse to medium sand of suitable durability was used for the filter zone. Figure 1 shows the range of gradations obtained for the material from the crushing plant. The fraction of flat and elongated particles in the material was less than 1% indicating equidimensional, yet angular particles. The durability characteristics and minimum and maximum densities of the material are listed in Table 1. Slight particle breakdown occurred in the material during the laboratory compaction test, and the maximum density obtained in that test was slightly larger than that from the relative density test (Table 1).

The transition material was a durable, coarse to medium gravel with less than 15% of flat and elongated particles. The gradation range of the materials produced by the crushing plant is shown on Figure 1. Particle shape tests revealed sub-angular fragments and a fraction of flat and elongated particles less than 6%. Table 1 lists the durability characteristics and the minimum and maximum densities of the material. The maximum density obtained in the laboratory compaction test was significantly larger than that obtained in the relative density test due to particle breakdown, which was characterized by an increase from about 5% to 15% in the amount of material passing the No. 8 sieve.

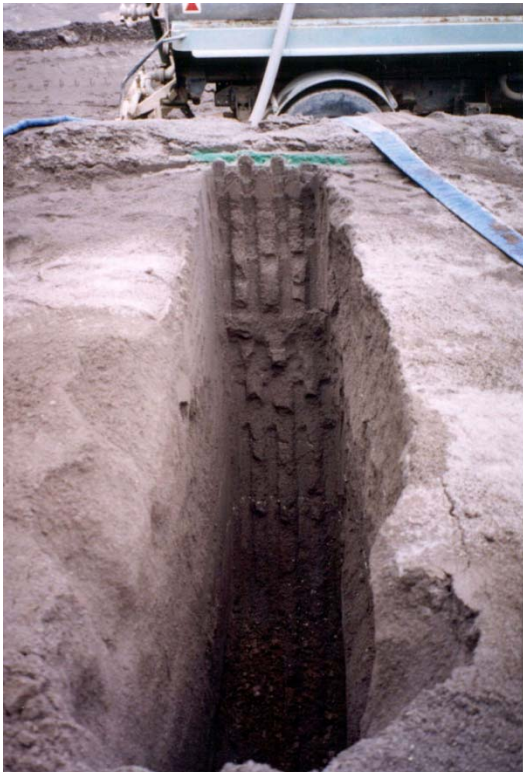
Fig. 6. Trench walls in filter embankment after excavation

Filter Embankment. One layer at a time, the trench along gridline 6 was excavated the full depth of the filter embankment, until the base pad material was exposed at the bottom. As shown in Figure 6, the trench walls stood vertical, without significant collapse, for approximately one-half hour. Water was then introduced at the trench floor at a rate of 200 liters/min, resulting in minor sloughing of the walls. Once the water reached the top of layer 2, seepage into the embankment balanced the inflow rate, preventing further rise of the water level in the trench.

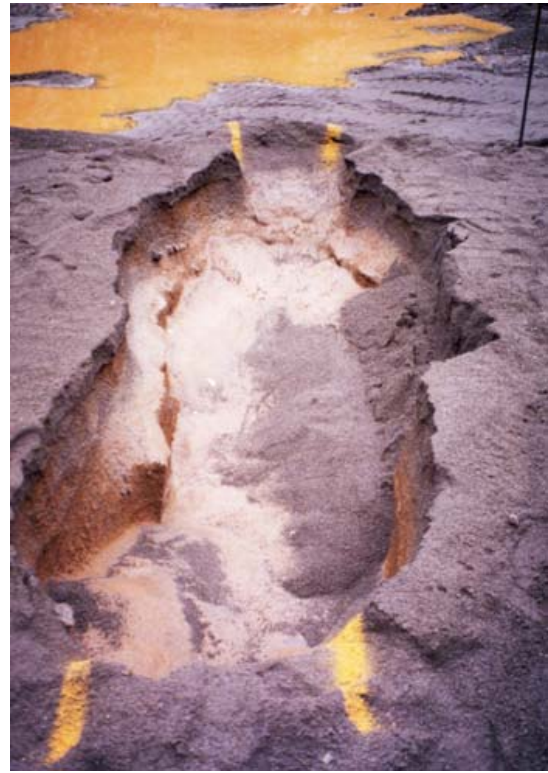
Fig. 7. Trench wall collapse in filter embankment after flooding

As material collapsed, the fines in the materials dispersed and increased the water turbidity, preventing observation of the failure mechanism in the submerged trench walls. In two hours, the trench had widened to about 1 m at the surface and the water level dropped to a depth of 0.6 m. Inspection several hours later revealed that the trench had collapsed and was filled to about half height along its entire length. The remaining pit was up to 1.3 m wide and less than 1 m deep, with near vertical walls, as shown in Figure 7. A thin layer of fines coated the base of the trench and the lower portion of the pit walls.

Excavation of the second trench also reached the full height of the embankment without collapse. The trench was flooded immediately after excavation, at a rate of 600 liters/min. A slow, controlled collapse mechanism was observed, with small wedges of material sloughing off the sides at increasing intervals. The final configuration of the pit after material collapse was similar to that of the first trench (see Figure 7).
