Remanufacturing of precision metal components using additive manufacturing technology

REMANUFACTURING OF PRECISION METAL COMPONENTS USING
ADDITIVE MANUFACTURING TECHNOLOGY

PAPER**I. EXPERIMENTAL CHARACTERIZATION OF A DIRECT METAL DEPOSITED COBALT-BASED ALLOY ON TOOL STEEL FOR COMPONENT REPAIR****Xinchang Zhang¹, Tan Pan¹, Wei Li¹, and Frank Liou¹**¹Department of Mechanical and Aerospace Engineering,

II. DEVELOPMENT OF PRE-REPAIR PROCESSING STRATEGIES FOR LASER-AIDED METALLIC COMPONENT REMANUFACTURING

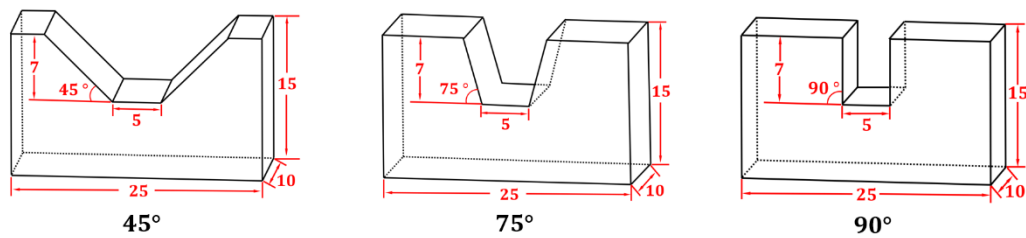
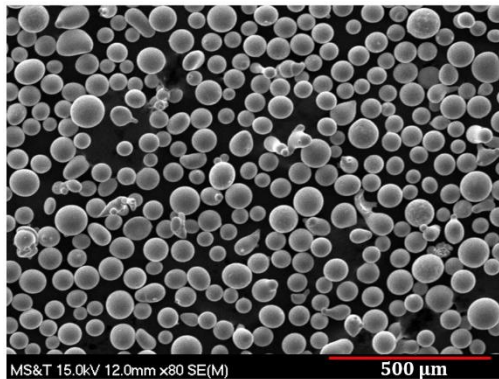
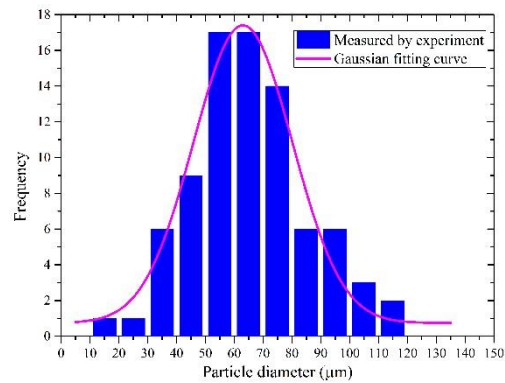
Figure 1. (a) Dimensions of the prepared substrates with V-shaped grooves of 45° , 75° , and 90° sidewall inclination angle; SEM micrograph (b) and particle size distribution (c) of Wallex 50 alloy powder

To perform repair experiments, several V-shaped grooves with varied sidewall inclination angles were machined on each substrate. Three sidewall inclination angles of 45° , 75° , and 90° were chosen, which are depicted in Figure 1a. The depth of each groove is 7 mm, and the width of defects at the bottom is 5 mm.

protection. Wallex 50 alloy has high contents of Co, Ni, Cr, and W to guarantee a high hardness as well as good corrosive resistance. Wallex 50 alloy can be coated on the easy-to-wear surface on H13 tool steel dies to improve resistance to wear. The chemical composition of Wallex 50 and H13 tool steel is collected in Table 1. Wallex 50 alloy powder was characterized to analyze particle shape and size distribution. An SEM micrograph of Wallex 50 alloy powder was obtained in Figure 1b. The image shows that most particles are spherical although a few irregular shaped powders are detected. Particle size distribution in Figure 1c analyzed using ImageJ shows the average particle diameter is 65 μm .

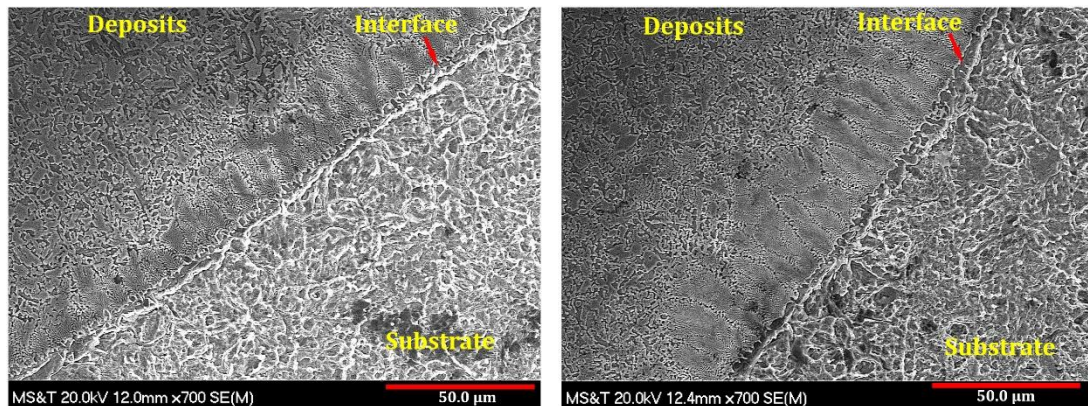
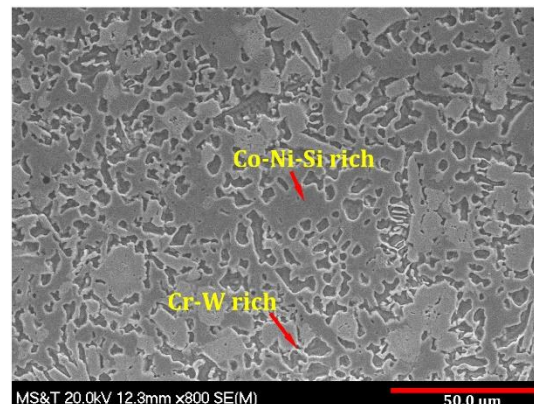
Figure 4. SEM micrographs of the boundary area of samples with 45° (a) and 75° (b) sidewall damage; (c) micrograph of top layers of the sample with 45° sidewall damage

The SEM micrographs in Figure 4 depict that the microstructure of the as-deposited Wallex 50 near the interface show mostly a columnar structure stretched toward the center of deposits perpendicular to the bonding line. These grains were growing parallel to the heat flow direction during solidification. At the deposition starting stage for the first few

The microstructure of the top layers of as-deposited Wallex 50 alloy is presented in Figure 4c, which consists of mostly interdendritic eutectics. It was observed that the gray region was enveloped by bright phases. The EDS spectrum shows the bright region was rich in Cr and W and the gray area is dominated by Co, Ni, and Si.

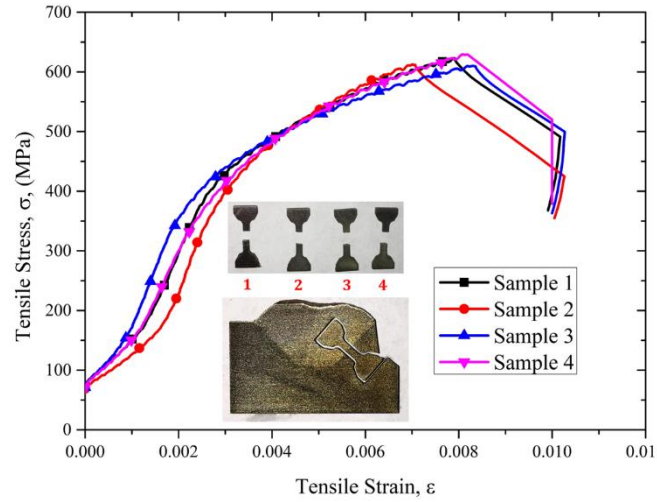
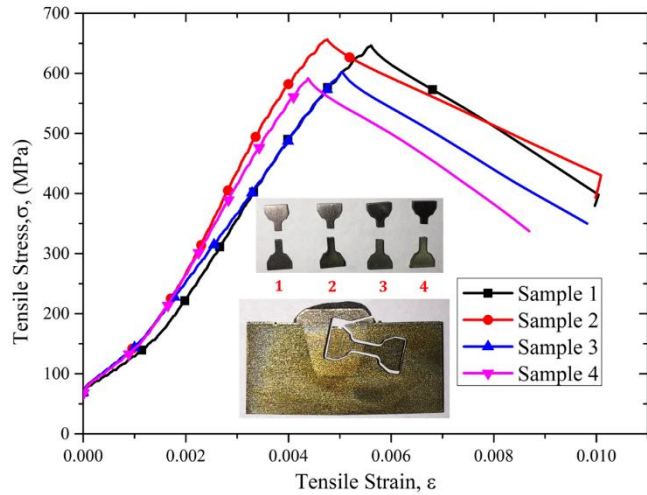
Figure 6. Tensile stress-strain curves for samples with 45° (a) and 75° (b) damage

Four tensile specimens were cut from each repaired sample. The tensile stress-strain curves were plotted in Figure 6, the ultimate tensile strength (UTS) is summarized in Table 3, and the tensile fracture surface is in Figure 7. The tensile stress-strain curves reveal that the tensile stress increased with the increase of tensile strain to a peak stress of approximately 620 MPa. Then the tensile samples fractured abruptly. The stress-strain curves did not reveal yielding phenomenon during the tensile testing. The ductility of the tensile samples was extremely low. Further investigation reveals all samples fractured at the as-deposited Wallex 50 region. Therefore, the as-deposited Wallex 50 alloy shows a brittle fracture mechanism.

influence of sidewall inclination angle on the UTS is barely recognizable. This result shows that as long as the deposited material bonded well with the substrate, the tensile strength of the repaired sample is relatively consistent. There is a substantial variation of UTS in the tensile result. This variation was possibly attributed to the unevenly located defects in the deposited regions. Some micropores in deposits may affect the UTS and result in the large standard deviation. The strain at UTS for 45° sample is slightly higher but not more substantial than the strain at UTS for 75° sample.

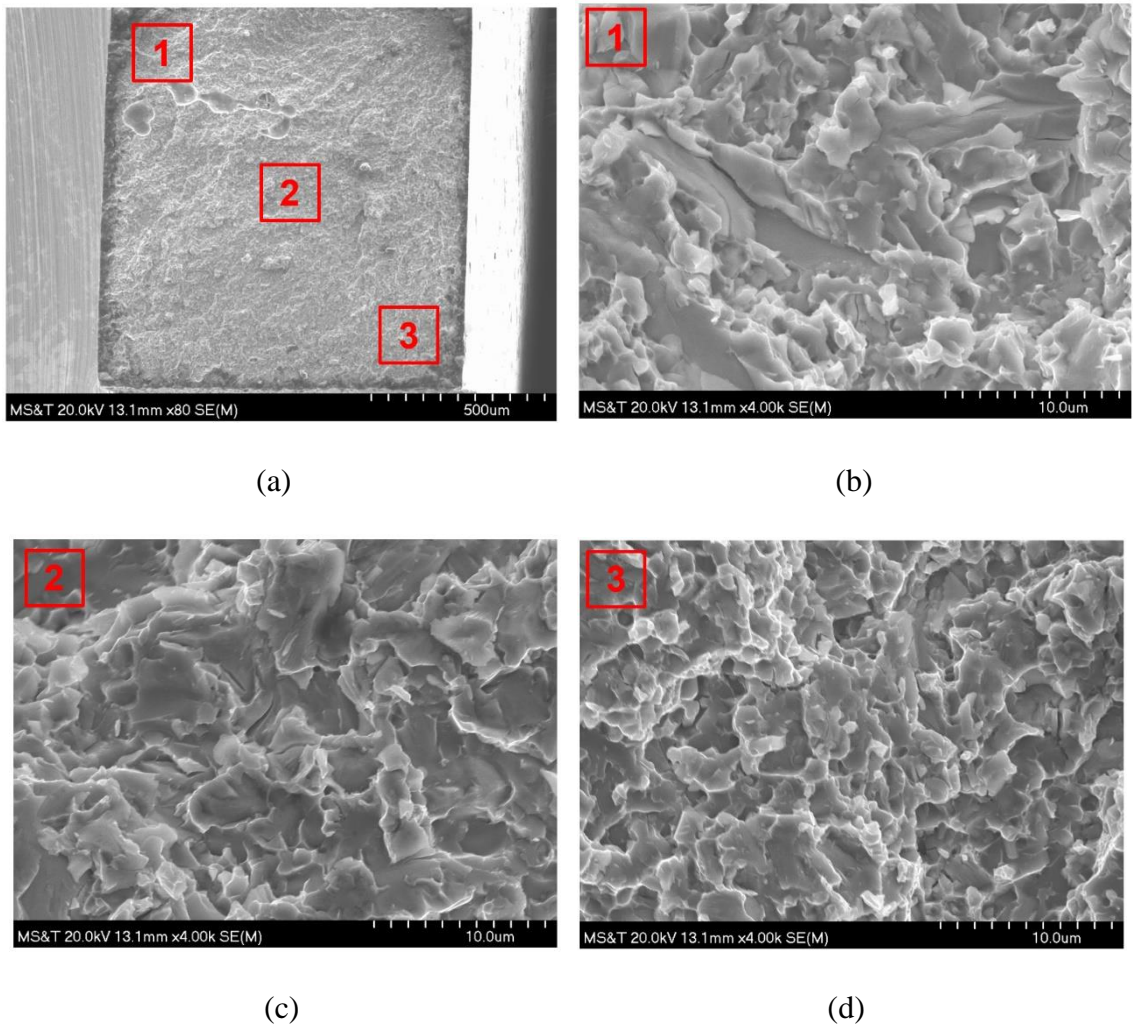
Figure 7. Tensile fracture morphology. (a) Overview of the fracture surface; (b) Magnified view of area 1 in (a), (c) Magnified view of area 2 in (a), (d) Magnified view of area 3 in (a)

The micrographs of the tensile fracture surface are depicted in Figure 7a-d. The overview image in Figure 7a reveals a flat surface that is perpendicular to the tensile loading direction. Magnified view in Figure 7b-d shows microscopically unsmooth areas. Microcracks were observed at such magnified micrographs. A very limited population of

voids and dimples were observed, indicating the brittle fracture of the tensile specimens. The brittle mechanism of as-deposited Wallex 50 can be caused by the chemical composition of the material. Wallex 50 is a cobalt-based alloy that consists of a large number of hard elements including Cr, W, Si that can form very hard phases, resulting in the brittle failure mechanism.

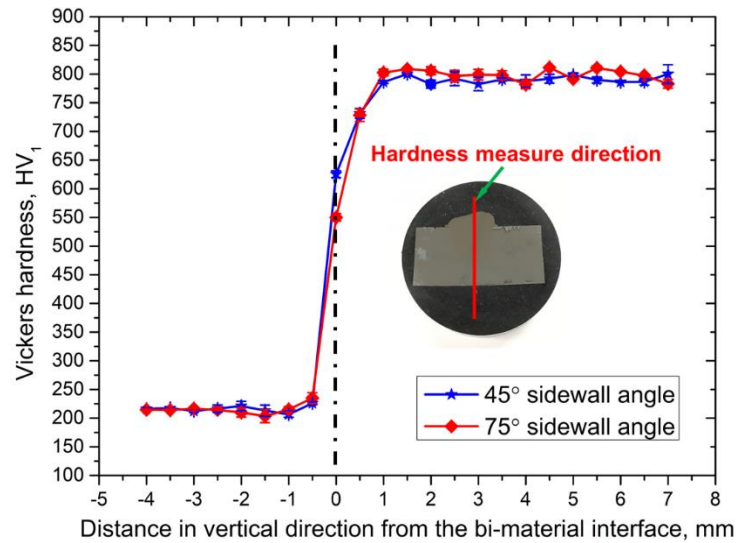
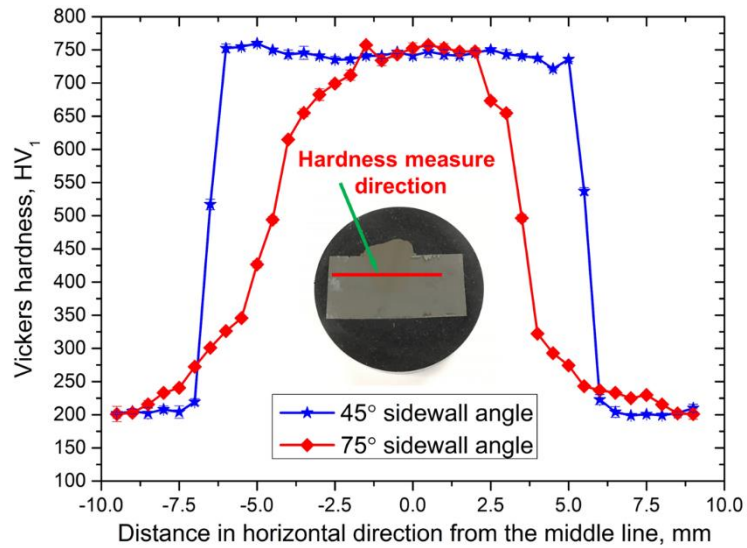
Figure 8. Vickers hardness distribution. (a) Microhardness measurement in a vertical direction; (b) Microhardness measurement in a horizontal direction

Vickers hardness along two paths was measured on the cross sections of the repaired samples. One is in the vertical direction from as-deposited Wallex 50 to substrate as shown in Figure 8a. Another one is in the horizontal direction passing through substrate, deposits, and substrate, which is shown in Figure 8b.

It is obvious to find out that the hardness of deposits is much higher than the hardness of the substrate. The hardness of the H13 tool steel substrate is approximately 210 HV, while the hardness of as-deposited Wallex 50 is 800 HV, which is almost four times the hardness of the substrate. H13 tool steel used for casting dies is in quenched and tempered condition and usually has a hardness range of 480 – 520 HV. The as-received H13 tool steel used in this research is in an annealed condition that results in the lower hardness of only 210 HV. However, it can be seen that the hardened of H13 tool steel also shows lower hardness values compared with the deposits.

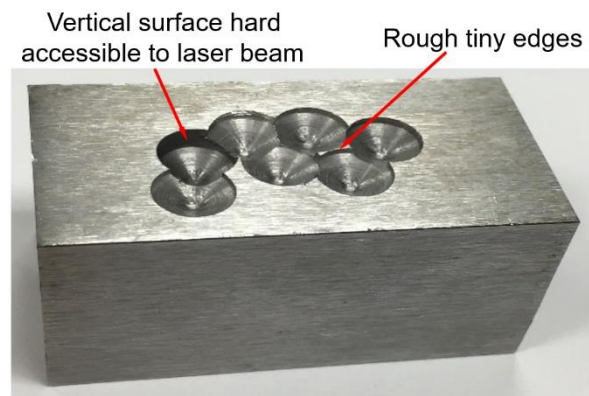
Figure 2. An H13 tool steel substrate with ball-indented damage on the top surface

One can see in Figure 2 that the damaged substrate cannot be repaired directly without pre-repair machining due to at least two reasons. One is that the vertical surfaces on the side of the holes are not accessible to the laser beam and powder feed nozzle for 3-axis system. Directly depositing materials on such areas cannot guarantee the sound bi-material bonding. Therefore, materials surrounding vertical surfaces need to be machined to reveal a tilt surface to guarantee accessibility. Another reason is that the rough tiny edges in the damaged area not only complicate the toolpath planning for material deposition but also may distort during deposition due to heat input that ruins the accuracy of deposited

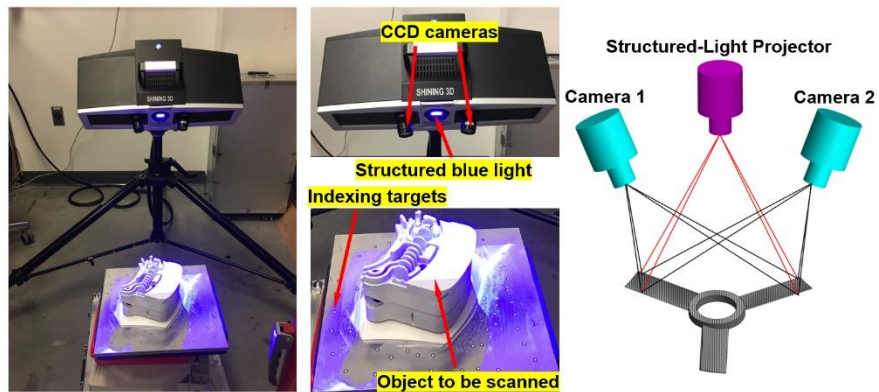
Figure 3. Structured-light 3D scanner for model reconstruction

Recreating the model of the worn part is required for planning the pre-repair machining. In this research, models of damaged parts were reconstructed using a structured-light optical 3D scanner as shown in Figure 3 (Shining3D OptimScan-5M). The scanner has a blue light projector that emits structured-light patterns on an object and two CCD cameras on the scanner measure the distorted dimensions of the pattern. The alteration in dimensions provides the three-dimensional coordinates of the object. In order to acquire a complete model, multiple scans are demanded to capture different orientations of the object. For registering point cloud from different scans to a single model, indexing targets need to be randomly put around the object to be scanned. Figure 4a depicts the point

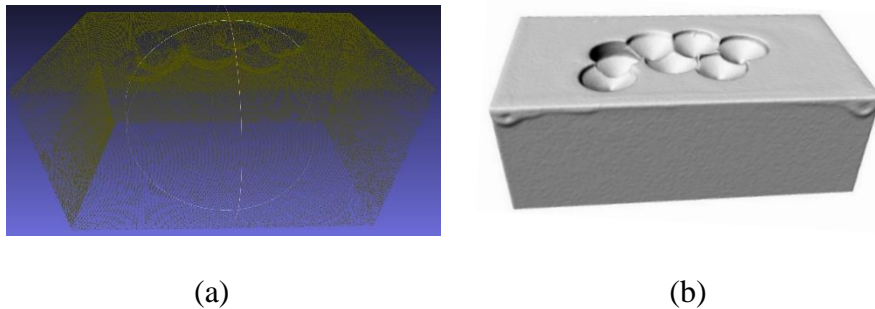
Figure 4. Point cloud (a) and reconstructed STL model (b) of the substrate

cloud of the substrate and the point cloud was further processed to create the STL model shown in Figure 4b.

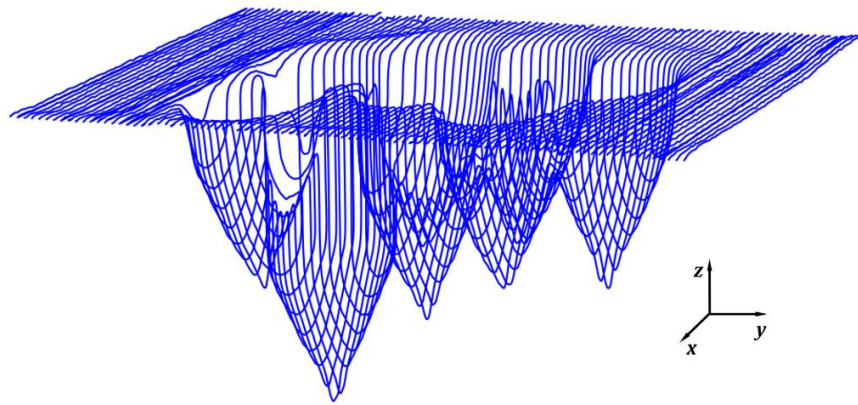
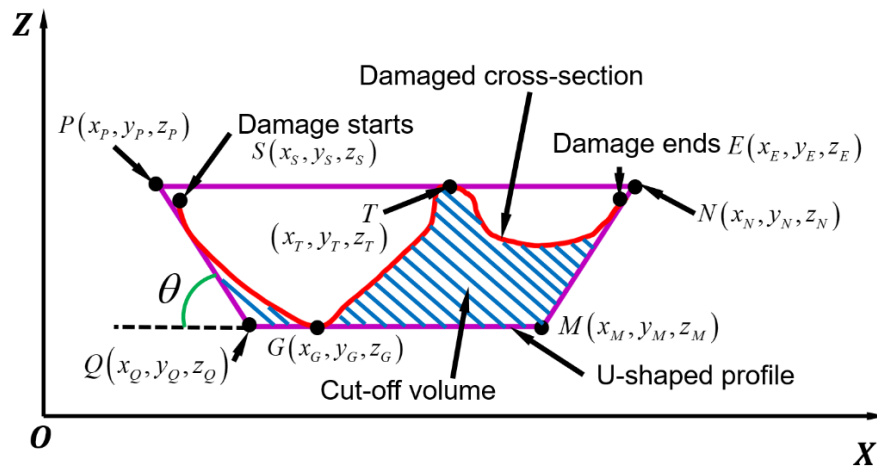
Figure 5. Model slicing and enveloping boundary determination. (a) Cross-sections of the damaged model; (b) U-shaped enveloping boundary

The model of the damaged part was sliced into a number of layers along the y-axis with a layer thickness of 0.5 mm as shown in Figure 5a. The slicing outputs a series of

2.3.2. Convex-Hull Boundary Definition. One can see in Figure 5b that for U-shaped boundary, the bottom connecting line QM is parallel to the x-axis, and this may result in extra material cut-off in the polygon $GMETG$. This material over-cut comes worse when one deep defect is presented while majority defects are shallow because the depth of the bottom line QM is determined by finding the minimum z-coordinate across the damaged cross-sections. If a deep damage was presented, materials located between the bottom plane and the shallow defects also need to be machined. Because such material has to be deposited back through additive manufacturing process, this machining methodology will consume more time and efforts.

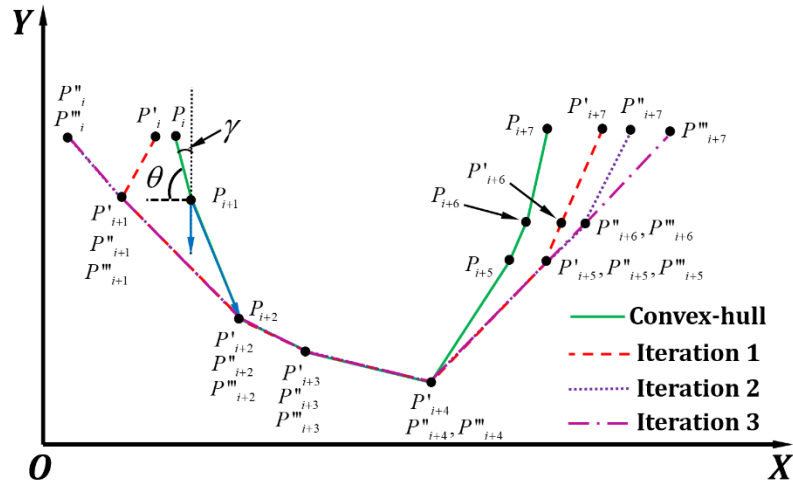
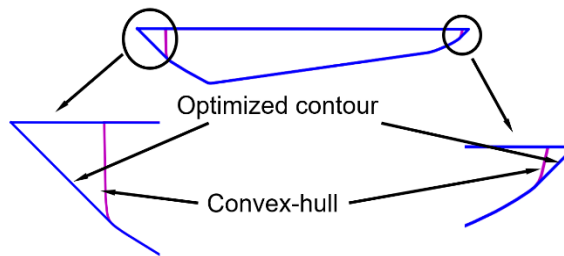
Figure 7. Convex-hull boundary definition. (a) Convex-hull processed on a cross-section; (b) Sidewall inclination angle optimization for convex-hull boundary; (c) Optimized contour

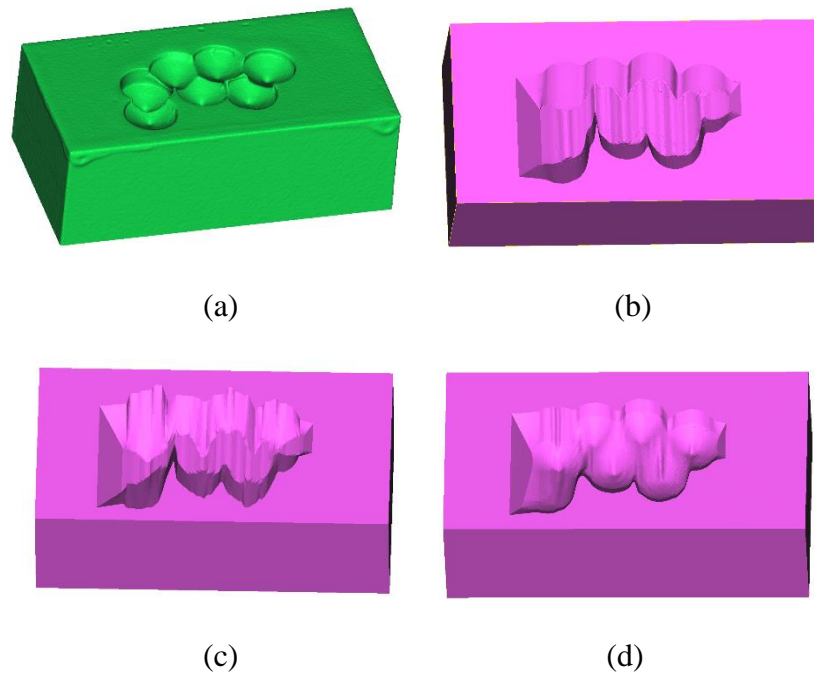
Figure 8. Unprocessed and processed models. (a) Model of the damaged substrate; Model pre-machined using U-shaped strategy (b), U-shaped strategy with an optimized sidewall inclination angle (c) and convex-hull strategy (d)

U-shaped and convex-hull strategies were processed on the STL model with ball-indentations as shown in Figure 8a. For U-shaped strategy, sidewall with fixed inclination angle $\theta = 45^\circ$ and optimized angle were both conducted, and the target models were

shown in Figures 8b and 8c, respectively. The model processed using convex-hull strategy was presented in Figure 8d.

The volume of the unprocessed damaged model (Figure 8a) and volumes of processed models (Figures 8b-d) using proposed strategies were summarized in Table 1. The volumes of machined models are different based on the strategies for target geometry acquisition. It can be observed from Table 1 that the U-shaped strategy with optimized sidewall inclination angle will machine off less material compared with non-optimized U-shaped strategy. However, the convex-hull strategy results in the least amount of cut-off

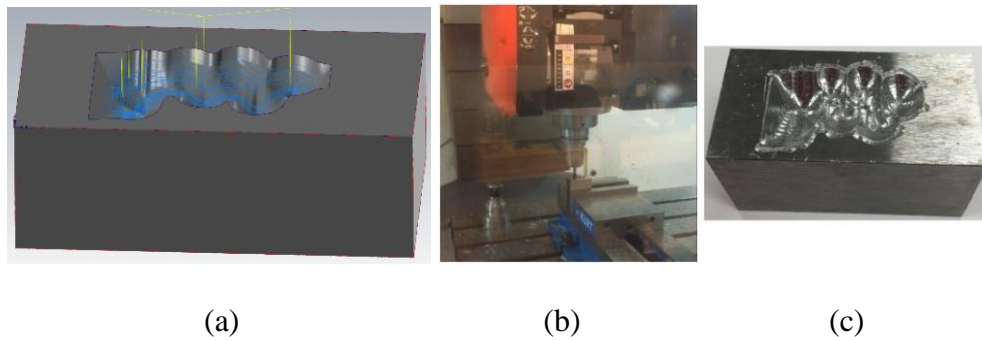
Figure 9. (a) Machining toolpath; (b) Machining setup; (c) Machined substrate

Once the target geometry was obtained, it was loaded to CAM software to generate the machining toolpath as shown in Figure 9. NC code was generated to drive the CNC mill. The milling parameters are listed in Table 2. The damaged substrate was clamped on a fixture and machined on a Fryer MC-30 CNC machine with the setup shown in Figure 9b. The machined part is shown in Figure 9c.

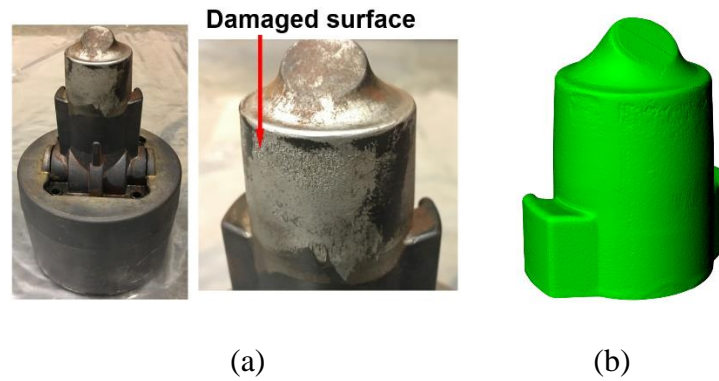
Figure 10. (a) A casting die with surface erosion, wear, and corrosion; (b) STL model of the damaged region of the casting die

A die shown in Figure 10a has damage on the convex area. Such defects are common in dies due to corrosion and heating-cooling cycles in the casting process. To machine off a thin layer of material from the part, the model of the die was generated using the configuration in Figure 3 and the recreated model is shown in Figure 10b. It should be pointed out that creating the model of the whole part is not necessary for pre-repair machining. This is because only the surface with defects needs to be targeted and other regions are not necessarily required. Generating the whole model not only dramatically slow down the 3D scanning process, but also sophisticate the toolpath generation process due to the large size of the model. Therefore, only the area requires machining was scanned.

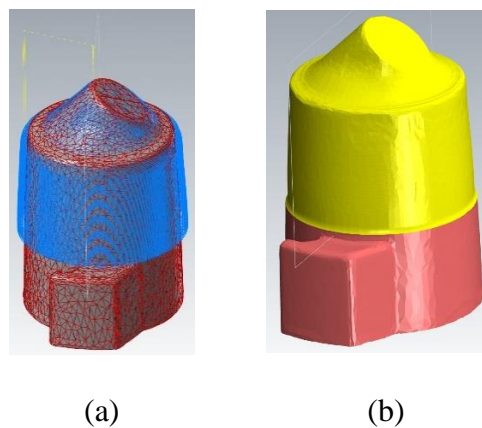
Figure 11. (a) Machining tool path generation; (b) Machined model

The cut depth for machining can be determined based on the condition of damaged components. For the part in Figure 10, materials with 0.5 mm layer thickness were machined. The toolpath was generated as shown in Figure 11a and the simulated machined part is shown in Figure 11b.

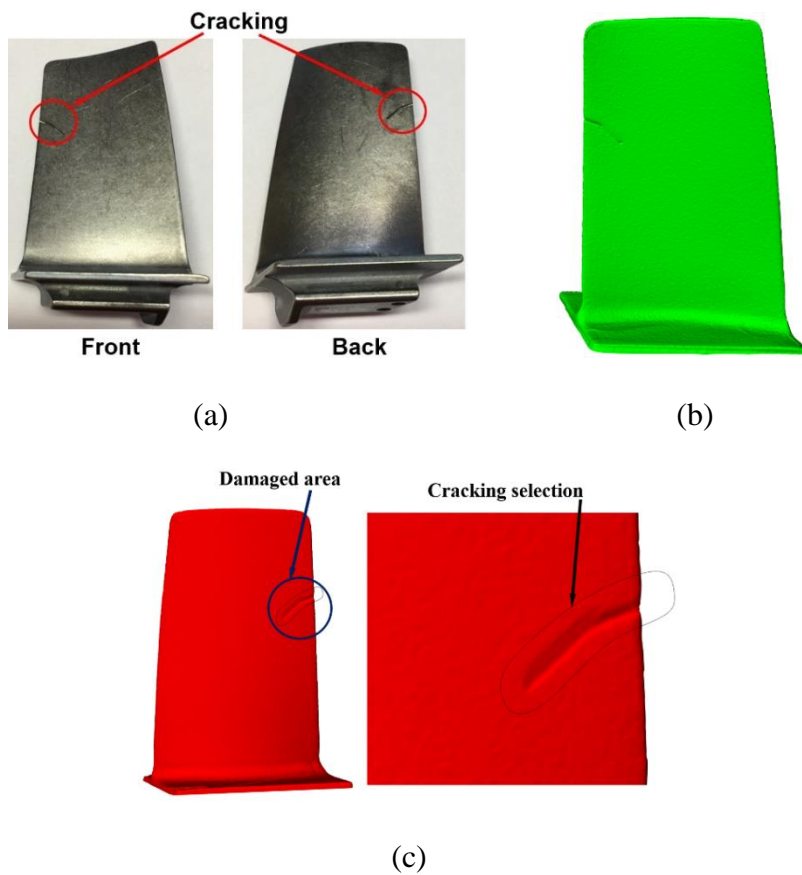
Figure 12. (a) Titanium blade with cracks; (b) Reconstructed model of the blade; (c) Selection of points located at the damaged area

To perform pre-machining, the blade as shown in Figure 12a was digitally scanned to acquire its 3D model as shown in Figure 12b. After that, the defective area was selected as shown in Figure 12c. By selecting the damaged area, the points located at the worn domain can be easily extracted which is shown in Figure 13a, and subsequently, the convex-hull of the point set was obtained. However, the convex-hull cannot be directly used for pre-machining because the bottom portion of the convex-hull blocks the accessibility. In order to create an open V-shaped geometry, the line segments of the convex-hull were tilted according to the algorithm illustrated in 2.3.2. The maximum sidewall inclination angle θ is limited at 60° . The finally optimized contour was shown in Figure 13b. EDM wire then followed the optimized contour for machining and the pre-machined blade is shown in Figure 13c. This machining approach provides a feasible shape for material deposition as the original cracking was removed and the repair volume is clear and accessible to additive equipment.

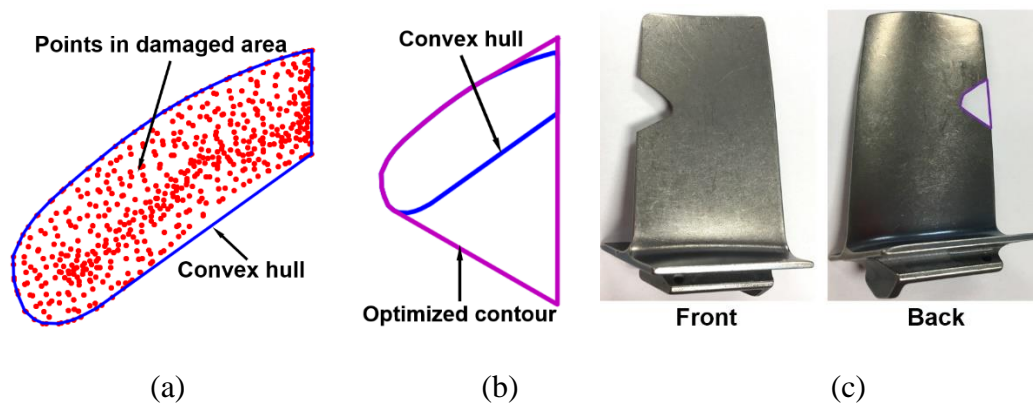
Figure 13. (a) Damaged point set extraction and its convex-hull; (b) Optimized contour; (c) Blade after pre-machining

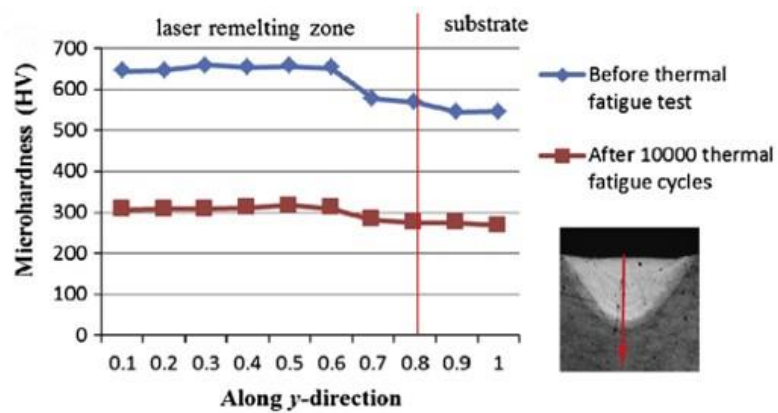
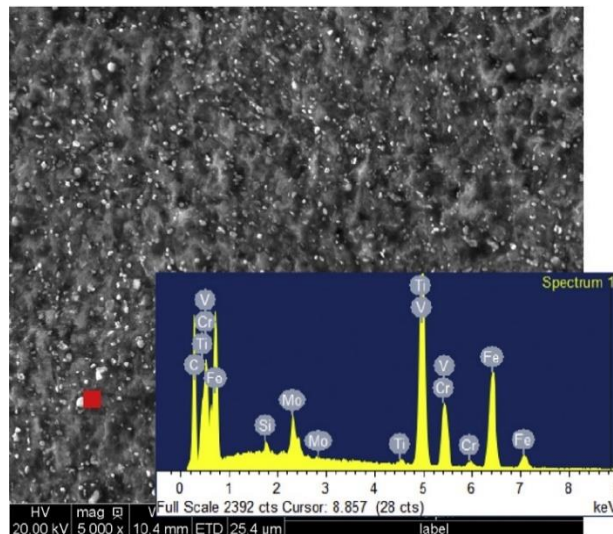
Figure 14. (a) The hardness of H13 tool steel before and after thermal fatigue cycles [41];
(b) Microstructure of H13 tool steel after thermal fatigue cycles [41]

Many parts such as H13 tool steel dies/molds undergo heating and cooling cycles in service and will finally result in thermal fatigue failure. It is reported in [41] that with increasing numbers of thermal cycles, the hardness and microstructure of H13 tool steel can change, which eventually results in loss of mechanical strength and plastic deformation. As shown in Figure 14, the hardness of H13 tool steel after 10000 thermal fatigue cycles decreased from 650 HV to 300 HV. The microstructure became coarser and lots of carbides with V and Cr appeared. Without re-hardening the material, its nominal mechanical properties cannot be restored even the geometry is repaired. Therefore, the re-hardening process should be conducted on the worn material before laser metal deposition.

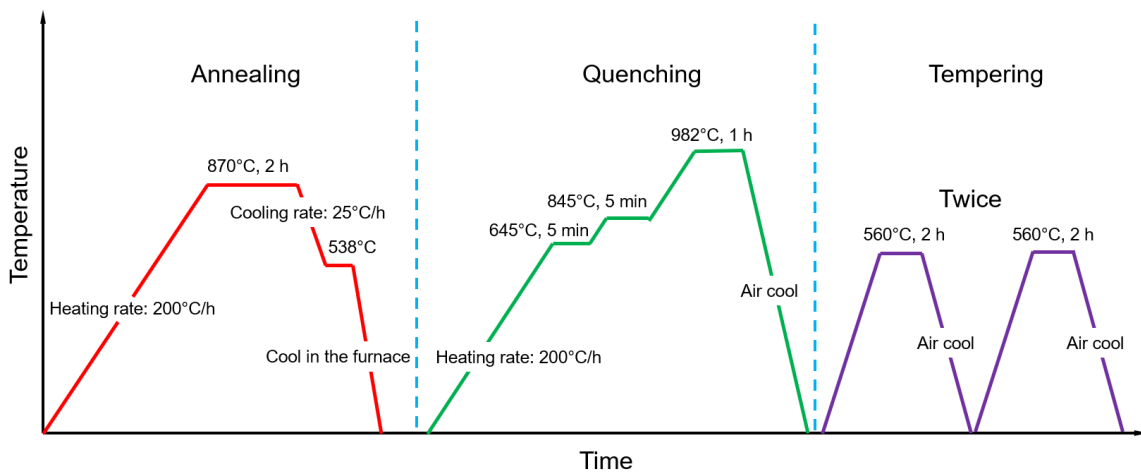
Figure 15. Schematic diagram of the re-hardening process for H13 tool steel

Figure 15 depicted the re-hardening procedure for H13 tool steel. It should be noted that H13 tool steel for die/mold applications is already in quenched and tempered condition. In order to re-harden it, annealing must be conducted at first.

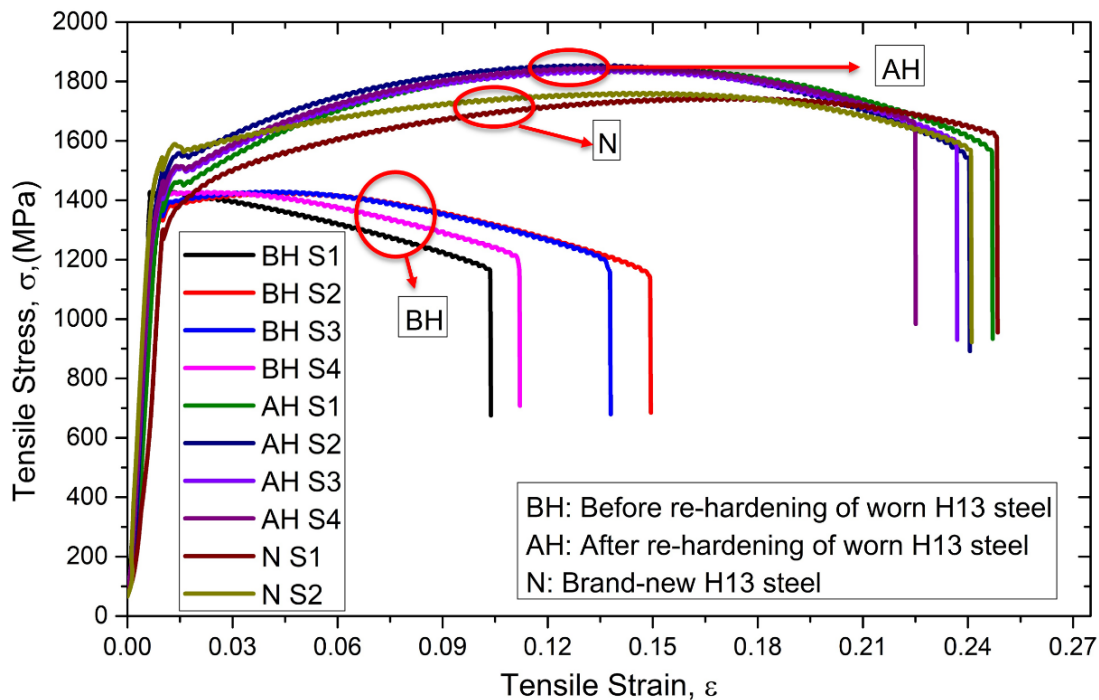
Figure 16. Tensile testing data of worn H13 tool steel (BH), re-hardened H13 tool steel (AH) and brand-new H13 tool steel in quenched and tempered condition

Figure 16 shows the tensile testing data of worn H13 tool steel (BH), re-hardened H13 tool steel (AH) and new quenched and tempered H13 tool steel (N). It can be observed that the UTS of worn H13 tool steel before re-hardening is 1427.9 MPa. By re-hardening it, the UTS can be increased to 1846.7 MPa and the ductility is also increased a lot. The tensile properties of re-hardened H13 tool steel are comparable with that of the new H13 steel in quenched and tempered condition. Therefore, it can be concluded that re-hardening can restore the tensile strength of worn H13 tool steel.

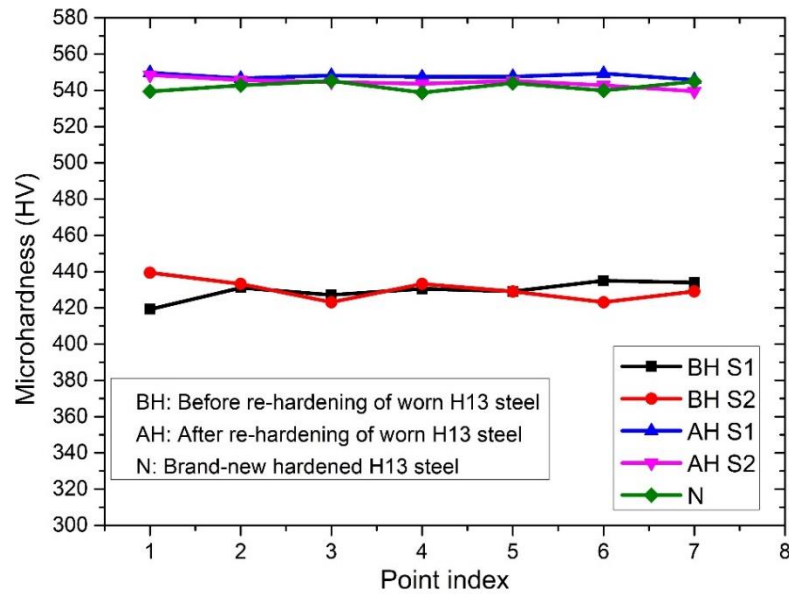
Figure 17. The hardness of worn H13 tool steel (BH), re-hardened H13 tool steel (AH) and brand-new H13 tool steel in quenched and tempered condition

Figure 17 shows the hardness measurements of worn H13 tool steel (BH), re-hardened H13 tool steel (AH) and new quenched and tempered H13 tool steel (N). In terms

of hardness, the worn H13 tool steel has a hardness of around 420 - 440 HV while the re-hardened H13 steel is about 540 - 550 HV which is similar to the hardness of new quenched and tempered H13 tool steel. Therefore, by re-hardening the worn H13 tool steel, its hardness can be increased.

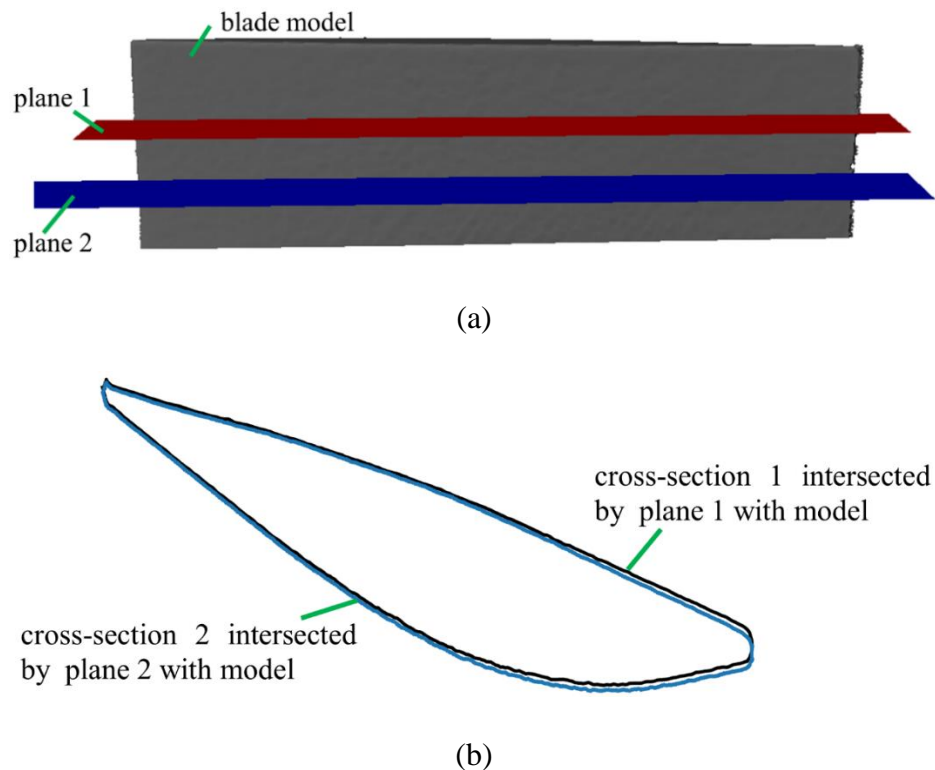
Figure 1. Cross-section comparison showing the curved profile of a blade. (a) The intersection of plane 1 and plane 2 with the blade; (b) Comparison of cross-section 1 with cross-section 2

Figure 1b shows a comparison of two cross-sections obtained by two parallel planes intersecting with the curved blade in Figure 1a. Because of a curved profile, the cross-sections at different levels are different and therefore, the model cannot be simply defined by one cross-section. Because of the complex shape of engine blades, an algorithm to automatically restore the damaged geometry is critical to provide accurate repair volume for repair.

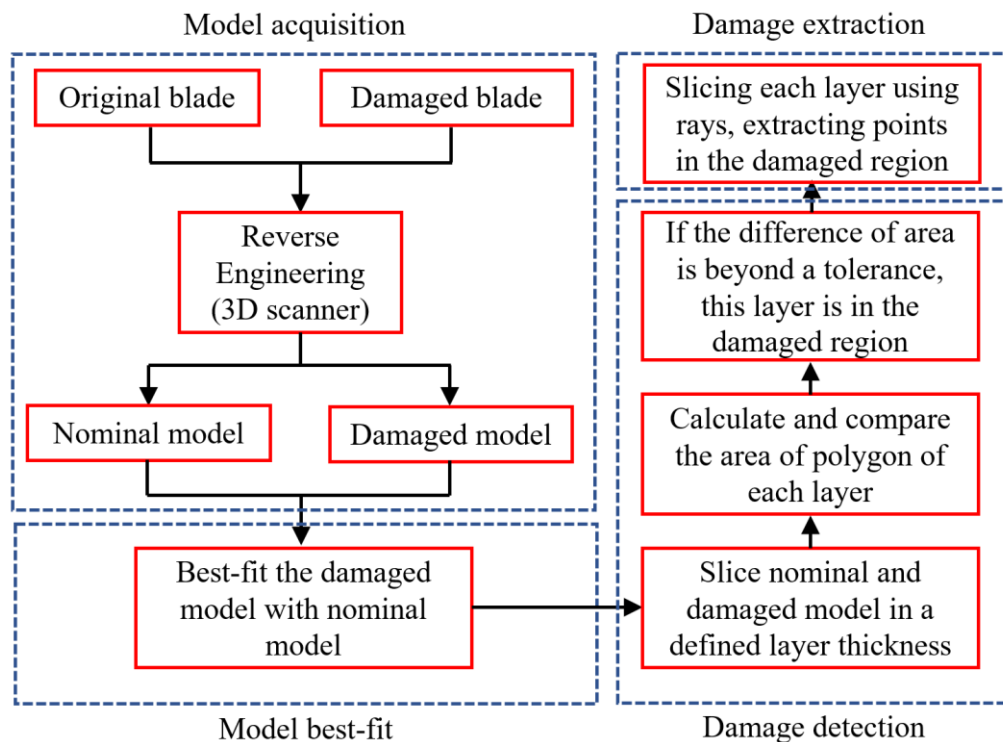
Figure 2. General structure of damage detection and reconstruction algorithms

Figure 2 shows the general structure of damage detection and reconstruction algorithms proposed in this paper. The method includes four sections: (1) Model acquisition, (2) Model best-fit, (3) Damage detection, and (4) Damage reconstruction. The general procedure is illustrated in this section and detailed information is presented in the following sections.

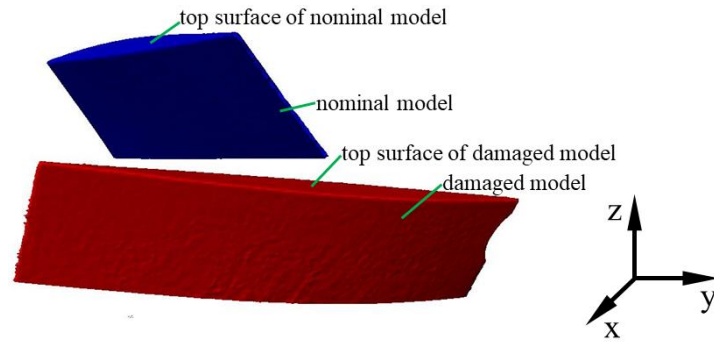
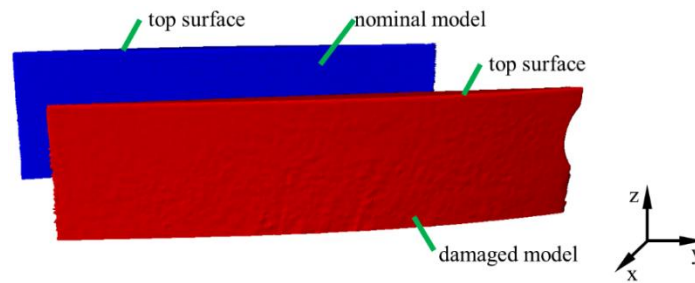
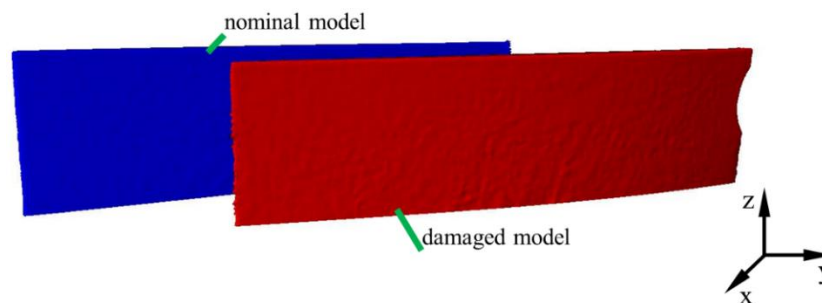
Figure 5. Surface best-fitting process. (a) The initial position of the reconstructed nominal model and damaged model; (b) Aligned position with a paralleled top surface; (c) Aligned position after surface best fit

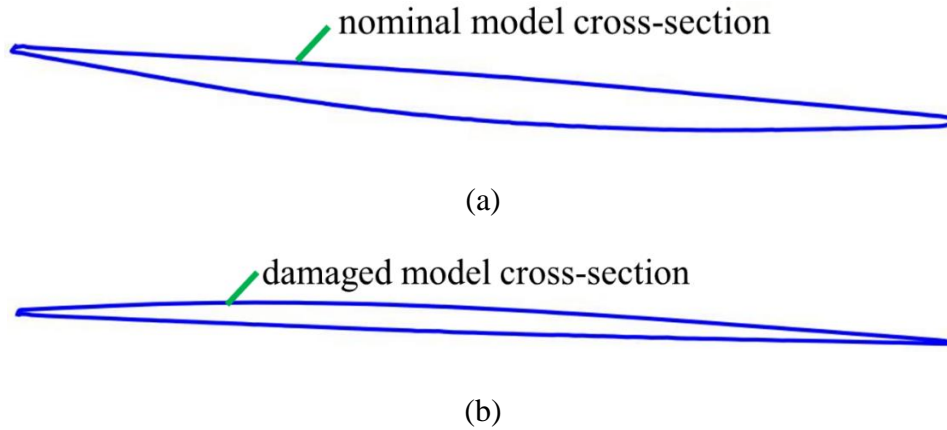
Figure 6. A cross-section of the nominal model (a) and damaged model (b)

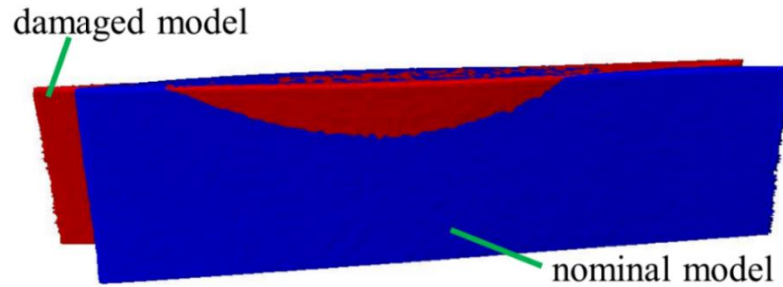
Figure 7. Aligned position after convex-hull centroid best fit

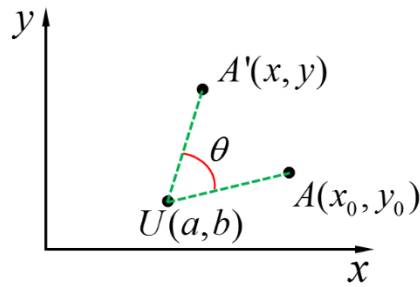
Figure 9. Schematic diagram showing the relationship between A and A'

The equation for obtaining point A' after A rotating around a reference point U is obtained as follows. As shown in Figure 9, (x_0, y_0) is the coordinates of the point A and (x, y) is the coordinates of point A' after point A rotating a degree θ around point $U(a, b)$. Equation (7) can be obtained from the depicted geometrical relationship.

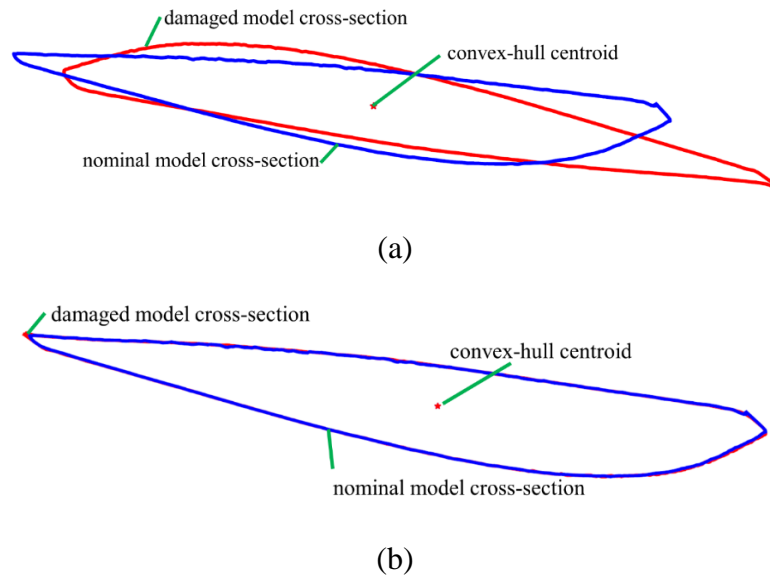
Figure 11. Nominal and damaged profiles before (a) and after (b) cross-section best-fit

Figures 11a and 11b show two cross-sections of nominal and damaged models before and after cross-section best-fit. It can be found that the cross-section of the damaged model was best-fitted with the cross-section of the nominal model after cross-section best-fit process.

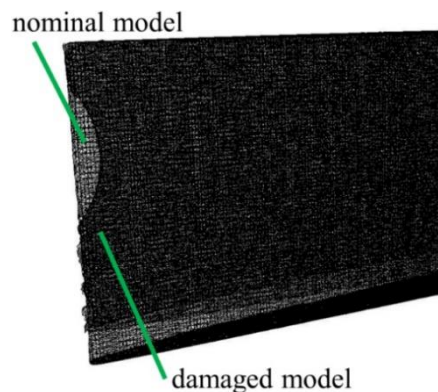
Figure 12. Best-fitted position of the damaged model with nominal model

After the degree θ was converged, the damaged model rotated degree θ around the vertical vector $(0,0,z_n)$, where z_n is the z coordinate of the convex-hull centroid. After that, the damaged model was best fitted with the nominal model as shown in Figure 12. It can be found in Figure 12 that there is a missing volume on the damaged model and it is required to extract the points from the defective region. These extracted points can be used to reconstruct the model of the missing volume to provide a build-up tool path and machining tool path. Then the laser can follow the build-up path to deposit material in this region. CNC machining tool path can be used to remove the extra deposited material to regain the designed dimensions.

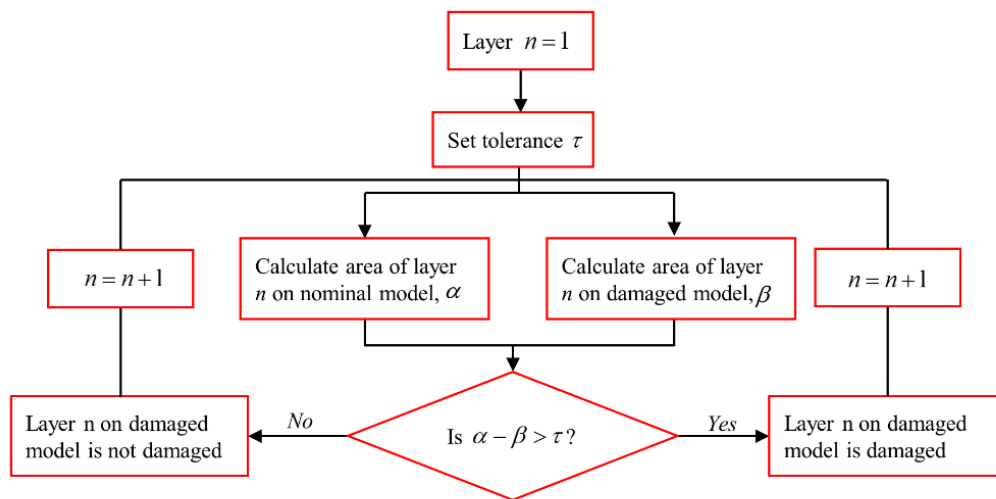
Figure 14. Defect detection process

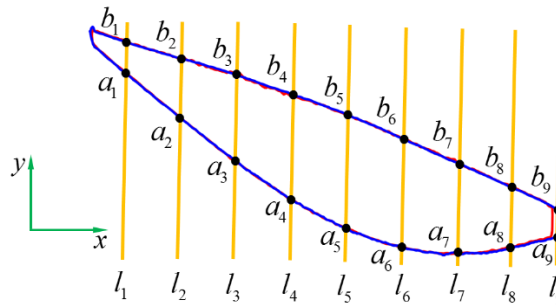
Figure 16. Cross-sections of blade models and intersections with casting rays

The method for extracting the repair volume is using ray casting method. As shown in Figure 16, two cross-sections at the same layer, one from the damaged model and another one from the nominal model, were sliced by a set of parallel and equidistant rays. Each ray intersects with the cross-section at two intersections. Due to the presence of missing volume, the intersections of casting lines with the cross-section of the damaged model was from a_1b_1 to a_8b_8 . For the corresponding layer from the nominal model, because of no defective area, the intersections of lines with the cross-section was from a_1b_1 to a_9b_9 . It can be seen that the intersections a_9 and b_9 only belong to the defective area, forming

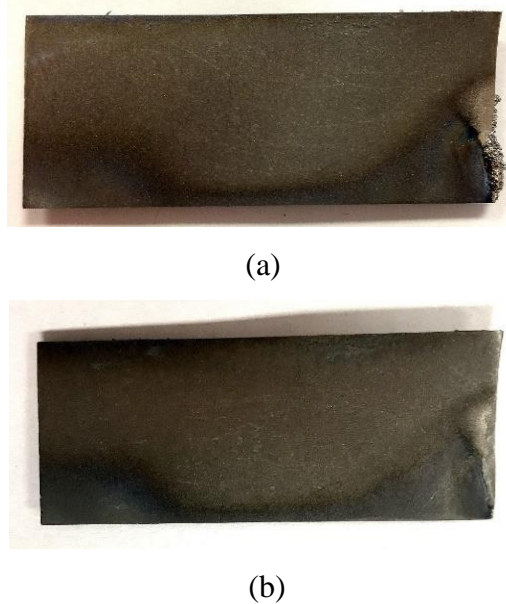
Figure 19. Compressor blade after the DMD process (a) and after machining (b)

The images of the blade after metal deposition and after post-machining is depicted in Figure 19. The microstructure of deposits was analyzed to evaluate the repair quality. The blade was sectioned to prepare samples for microstructure analysis. The cross-section of the sample was ground using sand papers from 120 silicon carbide grids to 1200 grids

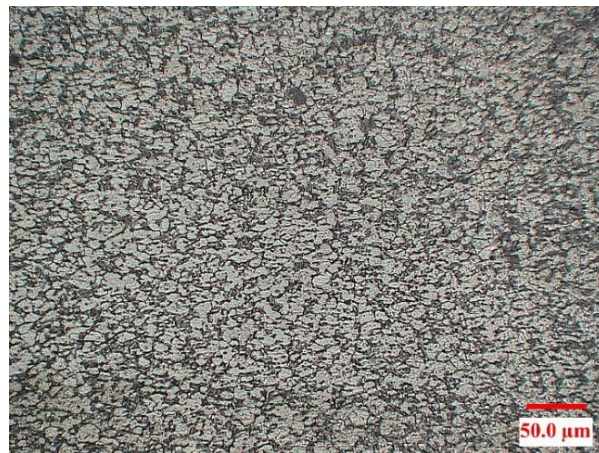
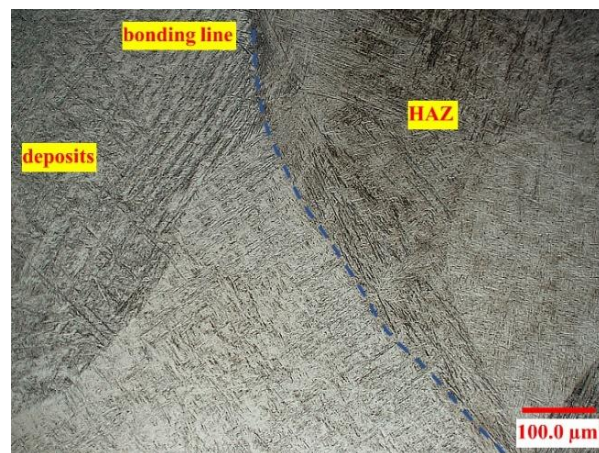
Figure 20. Microstructure of substrate (a) and as-deposited titanium alloy (b)

The microstructure of the substrate in Figure 20a shows equiaxed alpha grains in the beta matrix, which is a common structure for forged and annealed Ti-6Al-4V alloy. The microstructure of deposits exhibited Widmanstätten pattern [3]. Further analysis reveals a mixture of alpha and beta phases in the deposits, which is a typical structure observed in DMD-fabricated titanium alloys [30]. Beta transit was initiated by solidification from melting temperature to room temperature, passing through beta transit temperature (800 °C - 1000°C). Very thin lamellar structure was caused by the high cooling rate associated in the DMD process. Alpha acicular phase near the interface grows

perpendicular to the laser scanning direction and along the direction of solidification. It can also be seen that the as-deposited material is fully dense and free of defects. The interface between deposits and substrate is defect-free. This good metallurgical bonding guarantees the functionality of repaired blades.

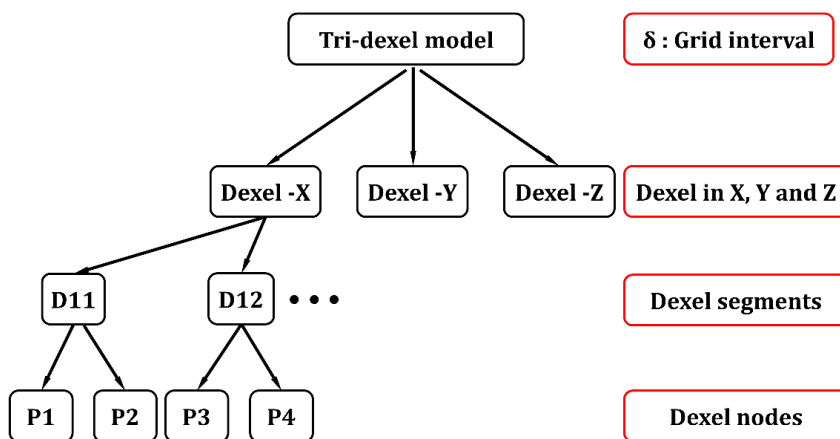
Figure 1. (a) Single dixel representation; (b) Data structure of a tri-dixel model
