Remanufacturing of precision metal components using additive manufacturing technology

REMANUFACTURING OF PRECISION METAL COMPONENTS USING
ADDITIVE MANUFACTURING TECHNOLOGY

PAPER**I. EXPERIMENTAL CHARACTERIZATION OF A DIRECT METAL DEPOSITED COBALT-BASED ALLOY ON TOOL STEEL FOR COMPONENT REPAIR****Xinchang Zhang¹, Tan Pan¹, Wei Li¹, and Frank Liou¹**¹Department of Mechanical and Aerospace Engineering,

II. DEVELOPMENT OF PRE-REPAIR PROCESSING STRATEGIES FOR LASER-AIDED METALLIC COMPONENT REMANUFACTURING

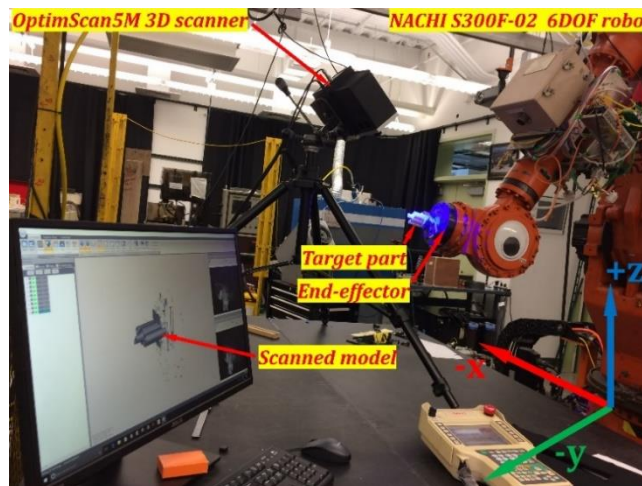
Figure 3. The Nachi robot and 3D scanner setup

In order to reconstruct damaged geometry, it is necessary to recreate the model of a worn part using scanners. Model of the nominal part can be regenerated by scanning the original part or from the CAD database. In this study, models of objects were recreated using a structured light metrology 3D scanner (OptimScan 5M, Shining 3D Co., Figure 3).

To automate the scanning process, a scanning system assisted by a 6-axis robot (NACHI SC300F-02) was proposed as shown in Figure 3. In the process, an object is clamped on the robot end-effector. The scanner is fixed while the position of the end-effector is precisely manipulated in the view of the 3D scanner cameras so that all surfaces of the object can be captured. The robot eliminates the time-consuming process of manually turning the object to find appropriate angles to capture all surfaces.

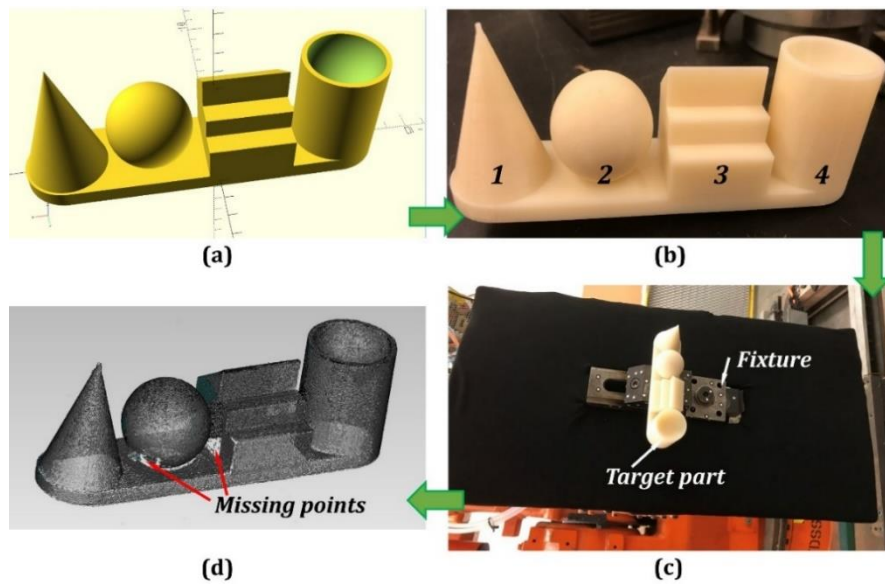
Figure 4. Evaluation of the robot-assisted part scanning process. (a) 3D model designed in OpenSCAD; (b) 3D printed ABS plastic part; (c) Part clamped to Nachi end-effector; (d) A complete scan of the test model

A model is used to assess the configuration to find general scanning procedures and common problems (Figure 4a). The test model was designed in OpenSCAD and printed on the Stratasys uPrint SE plus FDM 3D printer. The dimensions of the model are 120 mm × 23.24 mm × 49.41 mm.

The model was designed with features to simulate common scenarios. (1) Cone: to test the ability to generate accurate point cloud at fine tips and curved surfaces of conical geometries. (2) Sphere: to test the ability to scan points at the boundary of the sphere and the base. (3) Stairs: to test the ability to scan depth accurately and fine edges of stairs. (4) Cylinder: the bowl in the top is to test the ability to scan an object with interreflections.

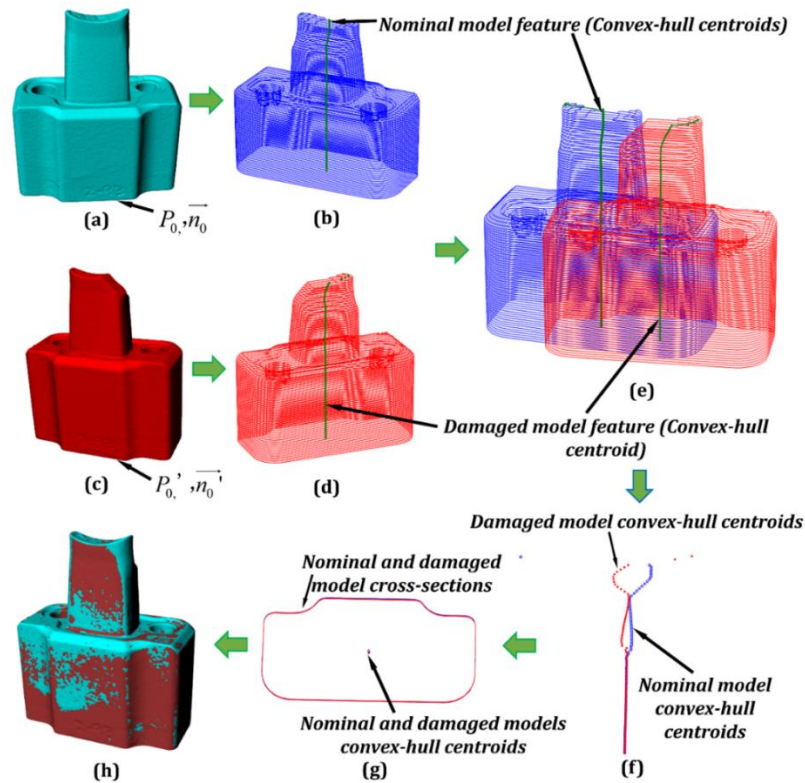
Figure 5. Model alignment. (a) Nominal model; (b) Nominal model cross-sections and convex-hull centroids; (c) Damaged model; (d) Damaged model cross-sections and convex-hull centroids; (e) Models before alignment; (f) Aligned convex-hull centroids; (g) Aligned cross-sections; (h) Aligned models

The aligning process is presented in Figure 5. The nominal and damaged models were sliced into a number of layers and the convex-hull centroid of each layer was

After that, the slicing plane moved to slice another layer according to a layer thickness (0.6 mm for the current model). The slicing process continues through the model. The sliced nominal and damaged models are shown in Figure 5b and 5d, respectively.

Step 3: The convex-hull centroids of the nominal and damaged models were calculated and obtained as shown in Figure 5b and 5d, respectively.

The model alignment algorithm is to align the associated features (e.g. convex-hull centroids, cross-sections) of the nominal and damaged models [35]. The damaged model can be aligned with the nominal model via three translation values x, y, z and three rotational variables α, β, γ . The least-squares method was used to acquire x, y, z and α, β, γ . The objective of the least-squares method is to minimize the distance of the transformed points $P_d^t = (x_d^t, y_d^t, z_d^t)$ to the points of the nominal model $P_n = (x_n, y_n, z_n)$. The models before and after alignment are depicted in Figure 5e and 5h, respectively.

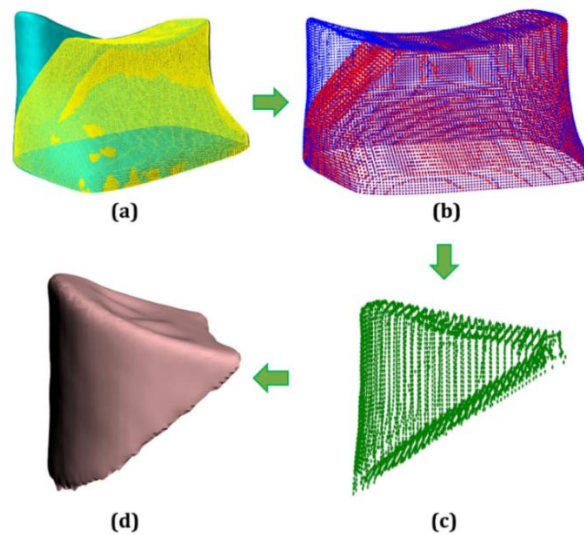
Figure 8. Damage reconstruction for a fractured die. (a) Selected area for damage extraction; (b) Intersections of casting rays with selected area of nominal and damaged models; (c) Extracted points; (d) STL model of the damage

Figure 8 depicts the damage reconstruction process using tri-dexel data for the die part. Figure 8a shows the selected area for damage extraction. The intersections of casting rays with the selected region of nominal and damaged models were shown in Figure 8b. The grid interval is 0.2 mm. The points that enveloping damaged zone were extracted as shown in Figure 8c. The STL model of the damage was reconstructed using the Screened Poisson Surface Reconstruction with reconstruction depth of 10 (Figure 8d) [36].

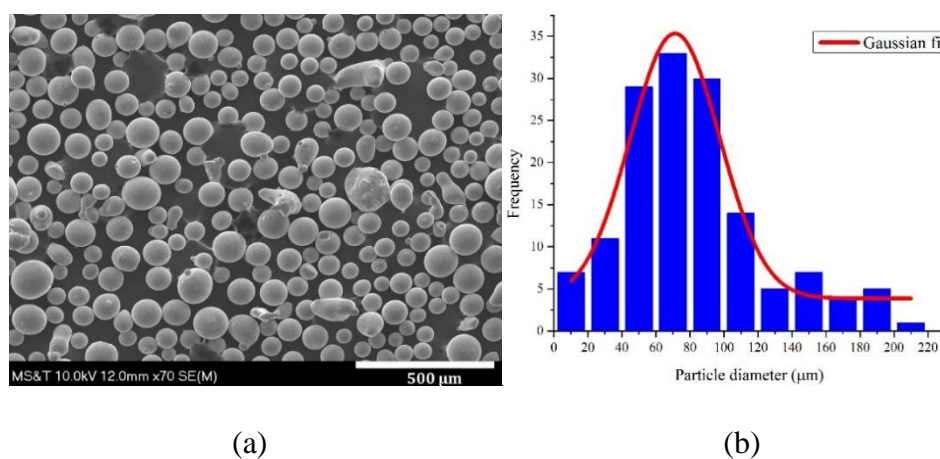
Figure 9. (a) SEM micrograph (a) and particle size distribution (b) of Wallex 40 powder

The material of the die is AISI H13 tool steel. To improve the corrosion and abrasive resistance of the repaired sample, Co-based alloy Wallex 40 from Wall Colmonoy Limited was selected as the filler material. SEM micrograph and particle size distribution of Wallex 40 powder are depicted in Figure 9. The average particle diameter was 71 μm . The chemical composition of Wallex 40 and H13 tool steel is listed in Table 1.

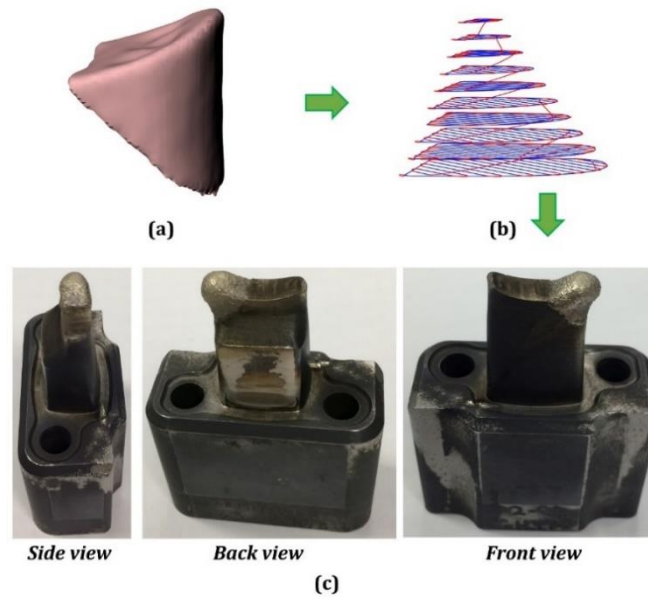
Figure 10. Tool path generation and repair result. (a) Reconstructed STL model of the damage; (b) Deposition tool path; (c) Die after material deposition

The reconstructed damage as shown in Figure 10a was sliced into 10 layers with a layer thickness of 0.5 mm. Then raster deposition tool path was generated as shown in Figure 10b. Repair experiment was conducted according to the processing parameters listed in Table 2. Images of the repaired die are shown in Figure 10c.

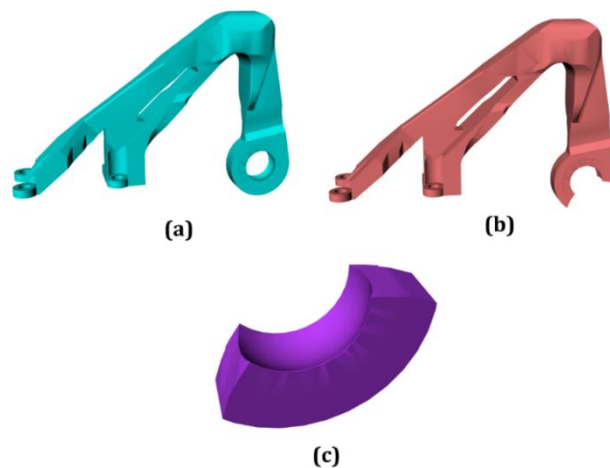
Figure 11. (a) A bracket nominal model; (b) Damaged model; (c) Defects

High accuracy of the reconstructed damage is critical to assure a successful repair. Only the reconstructed damage is precise enough can the missing geometry be accurately restored. To evaluate the accuracy level of reconstructed damage from the tri-dexel data, a bracket model was designed in SolidWorks and output as the STL model (Figure 11a). Damage was created on the bracket model to obtain a damaged model as shown in Figure 11b. Because the bracket was designed in CAD software, the damaged geometry can be precisely obtained as shown in Figure 11c.

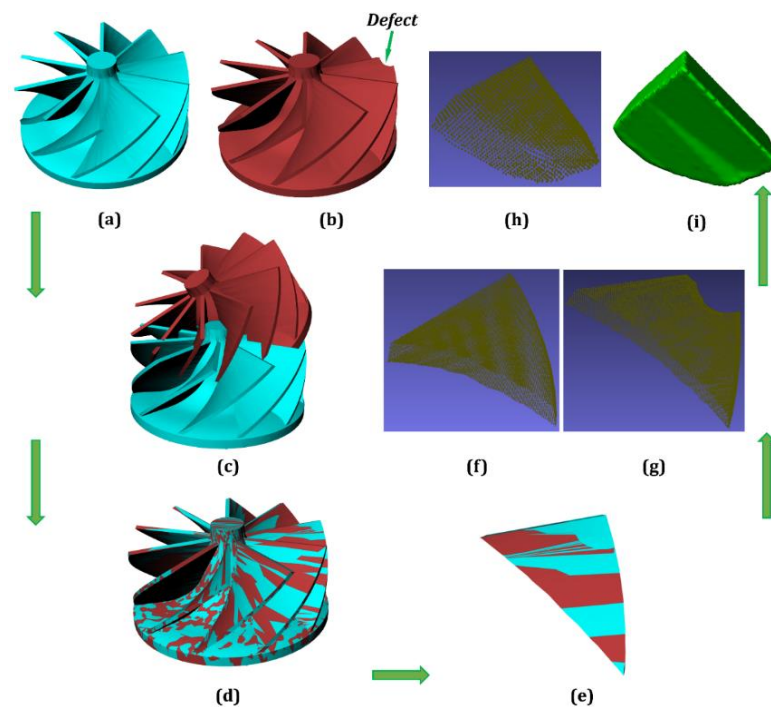
Figure 13. Damage reconstruction for a damaged turbine rotor. (a) Nominal CAD model; (b) Damaged CAD model; (c) Initial relative position of nominal and damaged STL models; (d) Aligned models; (e) Selected area for damage reconstruction; Intersections of casting rays with selected area of nominal (f) and damaged (g) models ($\delta=0.2$ mm); (h) Extracted damaged points; (i) Reconstructed STL model of the damage

Two examples as shown in Figure 13 and Figure 14 were conducted to test the functionality and reliability of damage reconstruction from tri-dexel data. A defect was

created on a model as shown in Figure 13b. The damaged model was aligned with the nominal model (Figure 13d) and the damage was reconstructed as shown in Figure 13i.

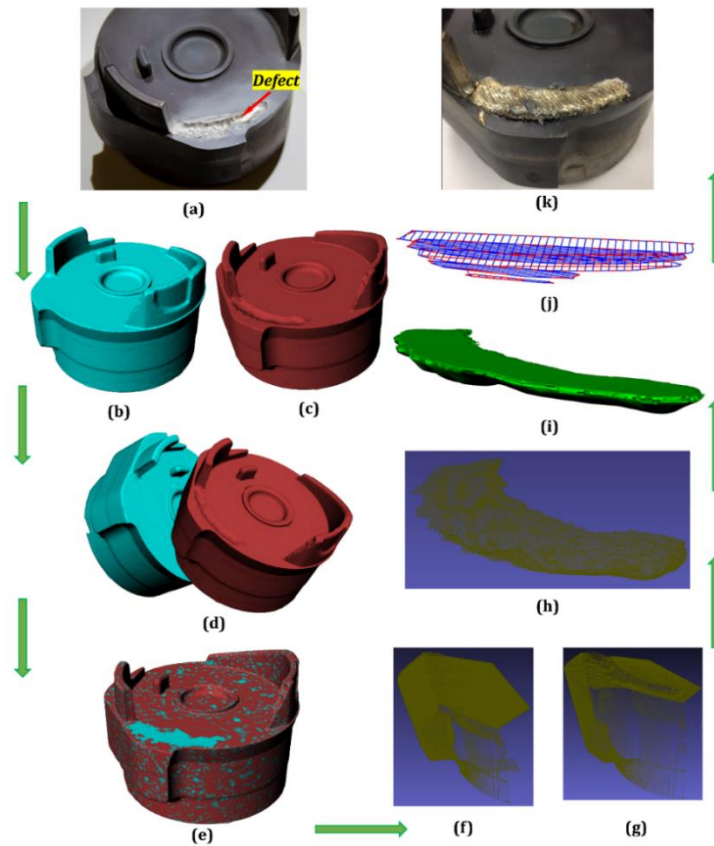
Figure 14. Damage reconstruction for a damaged die. (a) Damaged die; (b) Nominal model; (c) Damaged model; (d) Initial relative position of nominal and damaged models; (e) Aligned models; Intersections of casting rays with selected area of nominal (f) and damaged (g) models ($\delta=0.2$ mm); (h) Extracted damaged points; (i) Reconstructed STL model of the damage; (j) Deposition tool path; (k) Die after deposition

Ball indentation defect was machined on the surface of an H13 tool steel die as shown in Figure 14a. After that, the damaged model was obtained through scanning and then aligned with the nominal model (Figure 14e). Tri-dexel method was applied to define the damaged geometry as shown in Figure 14h-i. Deposition tool path was generated by

slicing the damaged geometry into 5 layers and the part after deposition is shown in Figure 14k. The parameters for repairing the sample in Figure 14 are listed in Table 3.

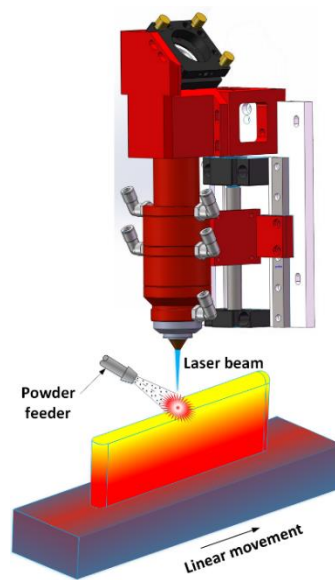
Figure 1. Schematic diagram of the laser-aided direct metal deposition process

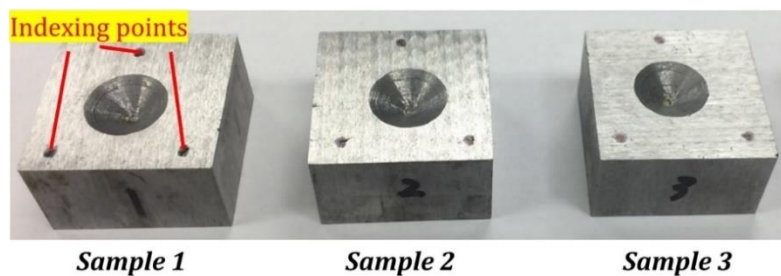
Figure 2. H13 tool steel substrates with hemispherical-shaped defects

H13 tool steel was selected as substrate due to the widespread application of such material in manufacturing molds, dies, and tools. The primary microstructure of this commercial steel is α -Fe martensite phase [24]. In order to perform repair, a 15-mm diameter ball end mill generated defects were created on the top surface of the substrate to a depth of 3 mm as shown in Figure 2. Three indexing points were marked on the surface of each substrate to define the position of the substrate with tool path in repair experiment.

It can be found in Figure 2 that the repair volume of the damaged substrate was enveloped by the fracture surface and a missing top surface. Therefore, the repair volume can be obtained by scanning the fracture surface and then processed to generate a tool path. The process from scanning to tool path generation is illustrated in Figure 3.

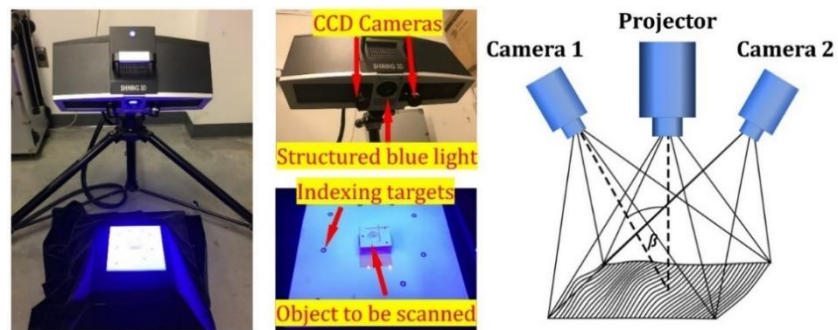
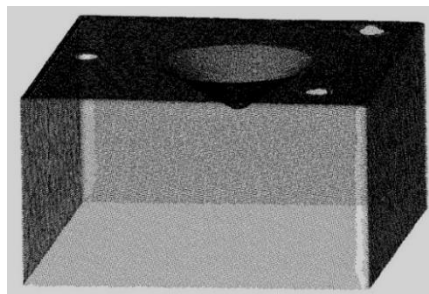
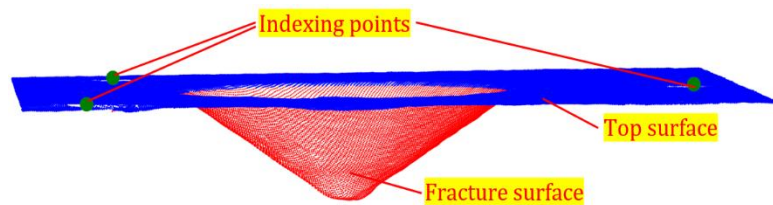
Figure 4. (a) 3D scanning setup; (b) Scanned point cloud; (c) Damage extraction

The scanning setup was shown in Figure 4a. The damaged substrate was scanned using a high accuracy structured light metrology 3D scanner (OptimScan 5M from Shining 3D Tech. Co. Ltd.). Structured light scanners project a narrow pattern of parallel stripes onto a three-dimensional object and convert the distortions into 3D coordinates of a point cloud. After calibration, a 6.5 mm ceramic gage block was at first scanned for six repetitions to test scanning accuracy, which was found to be 30 μm . The point cloud of the

substrate was obtained as shown in Figure 4b. A Python program was developed to detect point cloud on the fracture surface and indexing dots on the upper surface based on distance to the top surface. Points on the damaged surface and indexing dots were extracted as shown in Figure 4c.

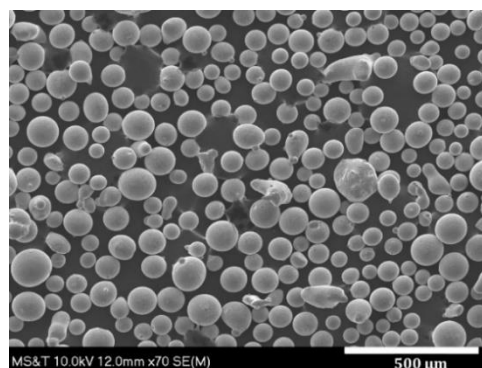
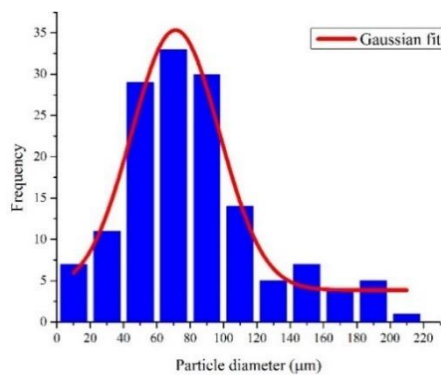
Figure 6. SEM micrograph (a) and particle size distribution (b) of Wallex 40 powder

particles exhibit spherical morphology although some irregular shaped powders were observed. Particle size distribution analyzed using ImageJ was depicted in Figure 6b and the average particle diameter was 71 μm .

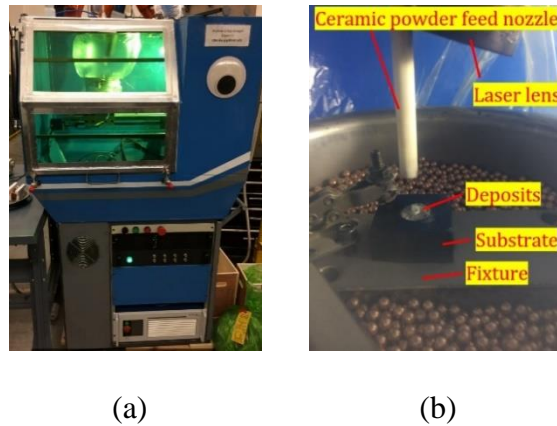
Figure 7. DMD equipment to perform repair experiment

The DMD system (Figure 7) consists of a laser, powder feeder, 3-axis work table, and a gas feeding unit. A continuous wave (CW) fiber laser with a peak power of 1000 W from IPG Photonics Corporation was adopted as the laser generator to emit a tilted laser beam with 1.8 mm diameter. A blown powder feeder (Model 1200 from Bay State Surface Technologies, Inc.) was utilized to convey metal particles to melt pool through a vertical ceramic powder feed nozzle with the aid of Argon gas. The process was performed in the Argon gas atmosphere for preventing materials from oxidization. The damaged area was cleaned with acetone prior to repair. One complete laser preheating process with a constant power of 300 W was performed without delivering powder. This preheating process can melt a tiny thickness of material on the substrate to smooth the surface and remove surface impurities. This process also helps to prevent cracking on deposits during rapid heating and cooling cycles when depositing cobalt-based alloys as the cracking resistance of such alloys is low [26, 27].

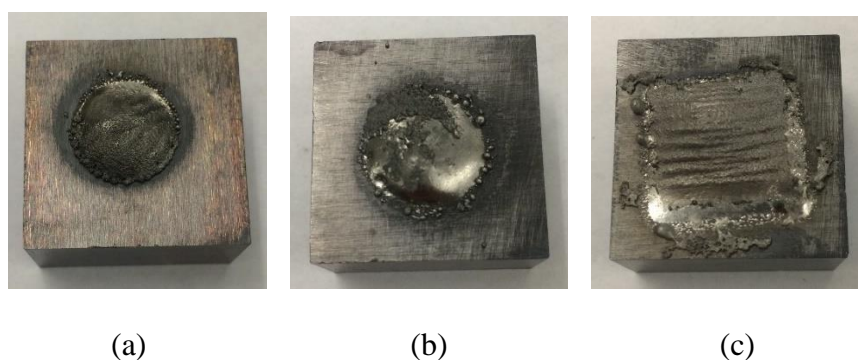
Figure 9. Repaired substrates from (a) repair 1, (b) repair 2, and (c) repair 3

Overview of the repaired substrates was shown in Figure 9. The figures show mountain-shaped deposits where the center of deposits was extruded. This can be attributed to the entrapped over-delivered powder in the damaged area during deposition. Power delivered to the damaged region cannot be melted entirely. Therefore, some particles were left in the damaged area and because of the V-shape of the damage, those powders cannot

be blown away completely by Argon delivery gas. Therefore, those particles were accumulated, re-melted and solidified, resulting in the mountain-shaped deposits.

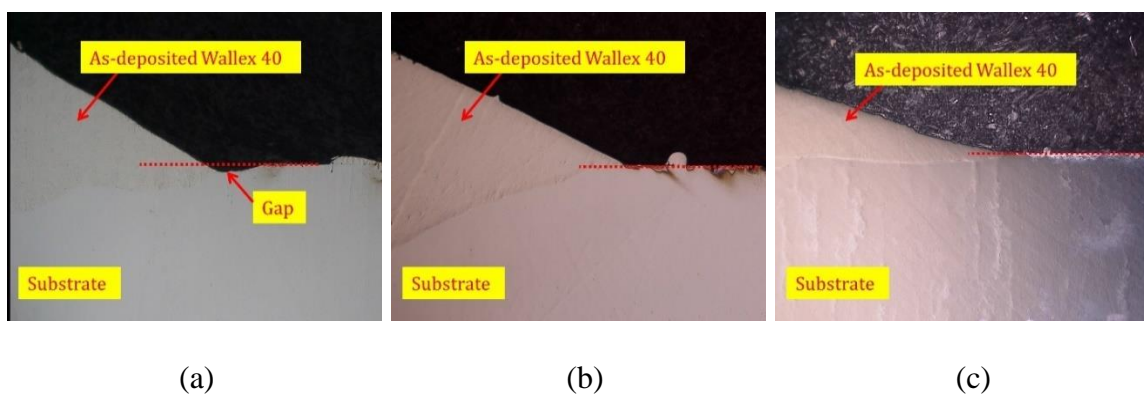
Figure 10. Optical images of cross-sections of repaired substrates from (a) repair 1, (b) repair 2, and (c) repair 3

Optical micrographs of the cross-section of samples were presented in Figure 10. One can see from Figure 10a is that, although adequate materials were deposited, a gap

between deposits and substrate along the boundary was found. The gap was produced because the laser beam cannot completely envelop the boundary, thus unable to melt material in such area. The gap can be effectively removed by depositing an extra layer along the boundary (Figure 10b) or by depositing an additional layer that completely covers the damage (Figure 10c). This overhang eliminates the gap successfully.

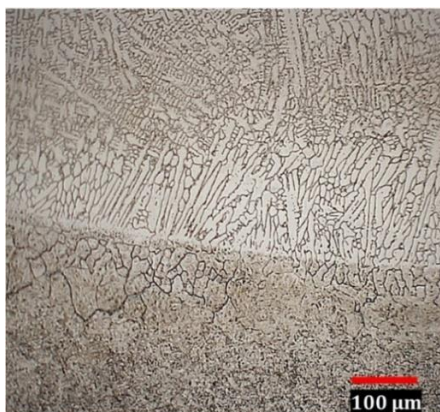
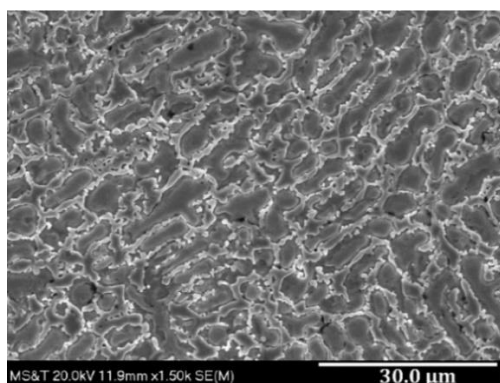
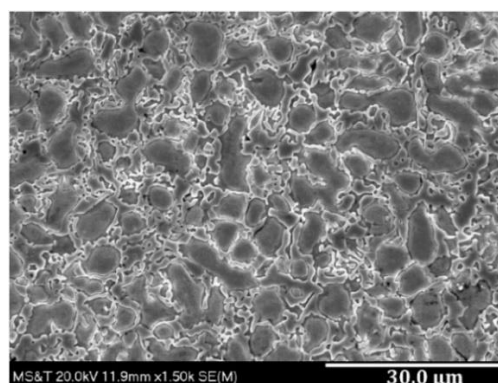
Figure 11. (a) Optical micrographs of materials on the bonding area; SEM micrograph of as-deposited Wallex 40 in the middle layers (b) and on the top (c)

Micrographs were taken at three locations of the cross-section of the repaired samples: near the bonding area (Figure 11a), in the middle layers (Figure 11b) and on the top (Figure 11c). The microstructure of deposits near the interface exhibits mostly columnar structure growing parallel to the heat flow direction towards the top of deposits. Very few dendritic structures were observed in such regions. In the DMD process, the solidification rate at first few layers was very high. The substrate plays a role of the heat sink, leading to the growing direction of grains opposing the heat flux direction. The columnar grains were severely elongated due to the rapid cooling rate during the DMD process. Such high cooling rate leaves not enough time for forming secondary dendrites. As materials building up layer by layer, the cooling rate drops, and the microstructure gradually changed from columnar structure to dendrite with interdendritic eutectics as shown in Figure 11b. Most grains are fine due to rapid cooling that leaving insufficient time to grow. Some equiaxed grains were elongated against heat flux direction due to the rapid solidification during deposition. The microstructure at top regions consists of a mostly cellular structure (Figure 11c). That is because, after several layers of deposition, the cooling rate decreased and subsequently, fewer grains were elongated.

Relatively large equiaxed microstructure was discovered right below the interface and in the heat-affected zone (HAZ) (Figure 11a). This structure was fabricated because the material of the substrate near the interface was melted by the laser beam and then mixed with the delivered Wallex 40 and subsequently re-solidified. The rapid cooling rate during the process results in this coarse equiaxed-like morphology.

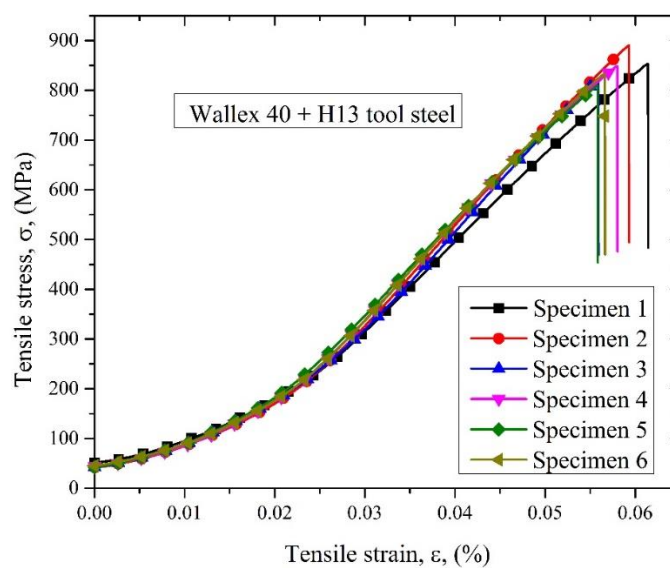
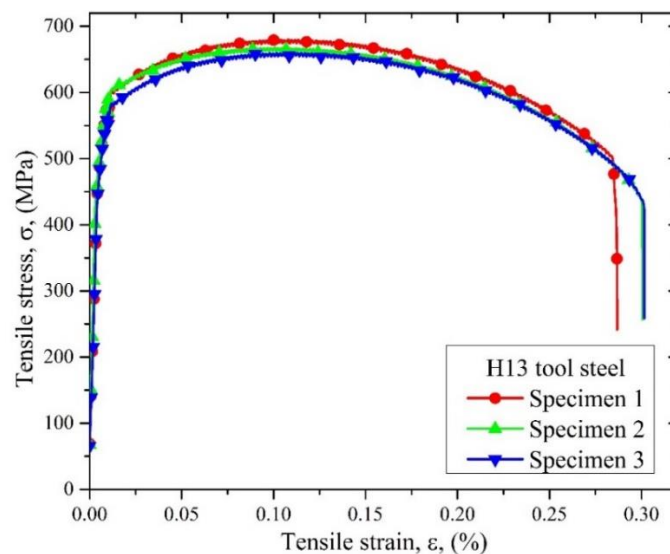
Figure 12. Tensile stress-strain curves obtained from the tensile test for (a) Wallex 40 + H13 tool steel samples, and (b) H13 tool steel samples

4.3.1. Tensile Behavior. The stress-strain curves obtained from tensile testing were shown in Figure 12 and the results were summarized in Table 3. Two groups of samples were tested, including combined samples which is made of Wallex 40 deposits and H13 tool steel substrate, and pure H13 tool steel samples. The tensile testing of the combined samples is shown in Figure 12a and of the pure H13 tool steel samples is shown in Figure 12b. The combined samples revealed largely consistent tensile properties. The tensile stress increased with the increase of tensile strain to a peak of around 850 MPa. Then the tensile samples fractured suddenly, and the stress decreased rapidly. No yielding regions were found from the stress-strain curves, showing that the samples repaired using DMD process reveal brittle fracture failure. The ductility of the tensile samples was very low (approximately 6%). A further investigation of fractured samples reveals that the combined

samples broke at the as-deposited Wallex 40 section. Thus, the deposits show brittle failure during the tensile testing.

Tensile testing of samples consisting of pure H13 tool steel shows that the tensile stress increased with the increase of strain to yield stress (YS) of approximately 600 MPa. Then an extensive plastic deformation and energy absorption were followed to reach a UTS of around 660 MPa, and the samples finally fractured. The samples were very ductile with an elongation of up to 30%.

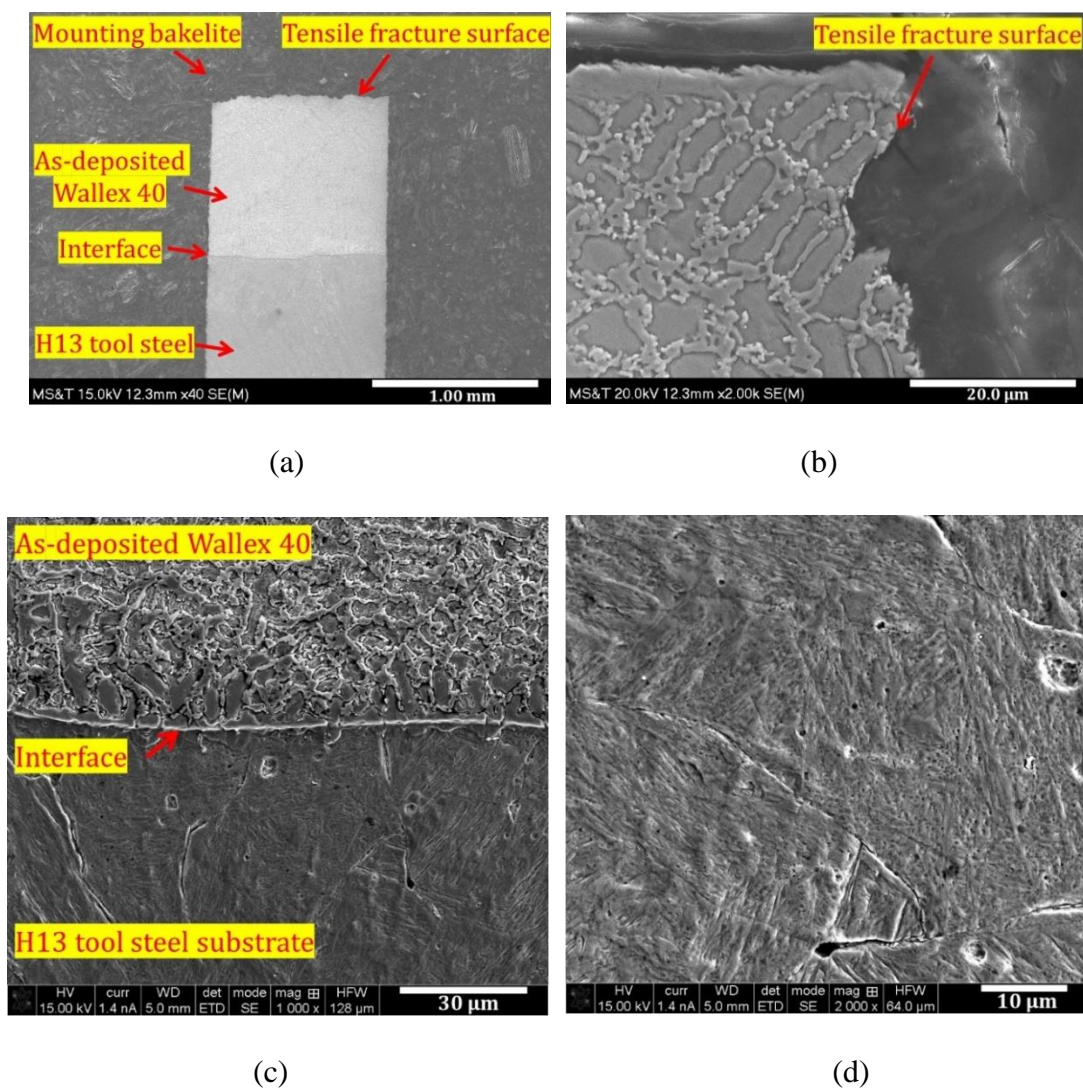
Figure 13. Fracture morphologies in longitudinal section of a Wallex 40 + H13 tool steel sample. (a) Overview of the fracture surface; (b) Magnified view of the fracture surface; (c) Magnified view of the bonding area; (d) Magnified view of the substrate near the interface

4.3.2. Tensile Fracture Surface Morphology. The micrograph of the longitudinal section of the tensile fractured sample shown in Figure 13a reveals that samples broke at the as-deposited Wallex 40 section. There is barely necking region near the fracture surface, confirming the brittle fracture of deposits. The interface between deposits and substrate shown in Figure 13c was intact and defect free, which assures that good metallurgical bond was formed along the interface. Good bi-metallic bonding is essential to inhibit materials from delaminating during service. Since the interface is intact, one can conclude that the interface is stronger than the weaker material which is as-deposited Wallex 40.

The magnified view of the longitudinal fracture surface was shown in Figure 13b. One can see that the cracking during tensile testing was propagating along the grain boundaries. EDS mapping revealed that the boundary area was rich in Cr, W, Si, Mn and C. The high composition of Cr, W and Si form very hard phases, resulting in the brittle

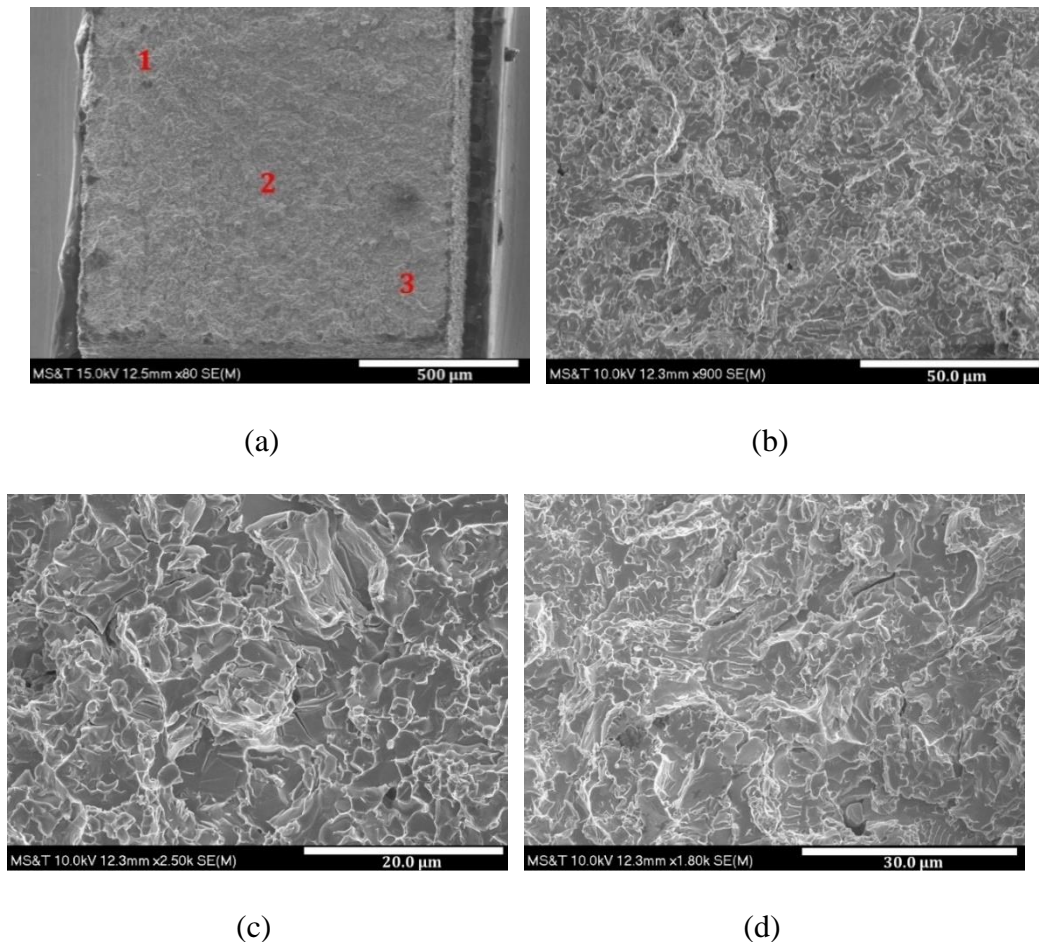
Figure 14. Fracture morphologies in cross-section of a Wallex 40 + H13 tool steel sample. (a) Overview of the fracture surface; (b) Magnified view of position 1; (c) Magnified view of position 2; (d) Magnified view of position 3

SEM micrographs of a transverse section of the tensile fracture surface were depicted in Figure 14. The overall view shown in Figure 14a reveals a relatively flat surface that is perpendicular to the tensile stress axis. There is no significant necking in the gauge length of the tensile specimens. Magnified view of morphology in various locations of fracture surface exhibits microscopically unsmooth fracture regions (Figures 14b-d). Microcracks were found on the fracture surface as shown in Figures 14c-d due to the overload during the tensile test. There is very limited population of voids and dimples observed in the fracture surface. This reveals a brittle fracture mechanism of the as-deposited Wallex 40.

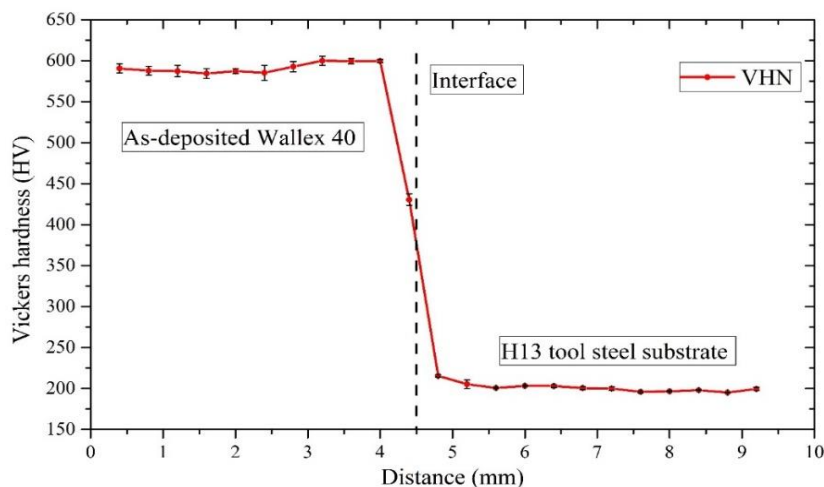
Figure 15. Vickers hardness distribution

4.3.3. Vickers Hardness Analysis. Vickers hardness was measured on the cross-section of the repaired sample from deposits to substrate and the result was plotted in Figure 15. A constant distance of 0.4 mm was applied between two indentations.

It was shown that the as-deposited material has a relatively constant hardness of around 580 HV. The hardness of deposits is much higher than that of the as-received H13 tool steel substrate in annealed condition (220 HV). The hardness increased rapidly from

220 HV on the substrate to approximately 600 HV on the deposits. The sharply increased hardness on deposits is because of the rapid cooling rate and fine microstructure obtained on deposits. Cobalt-rich matrix with carbides also contributes to the elevated hardness. The hardness measured approximately near the interface reveals transitional values between 220 HV and 600 HV, indicating the existence of a narrow region of dilution in the heat-affected zone. The dilution distance between deposit and substrate from the hardness analysis was approximately 1 mm. Another feature that can be seen is that the hardness of deposits decreases slightly during multi-layer deposition. This was due to the higher cooling rate during the first layer of deposition. In a multi-layer deposition, the pre-deposited material was re-melted and heated, causing coarse microstructure and slightly drop of hardness. The hardness at the substrate near the interface is slightly higher than the area away from the interface. Heating history in HAZ acts as a normalization process that increases the hardness in such area.

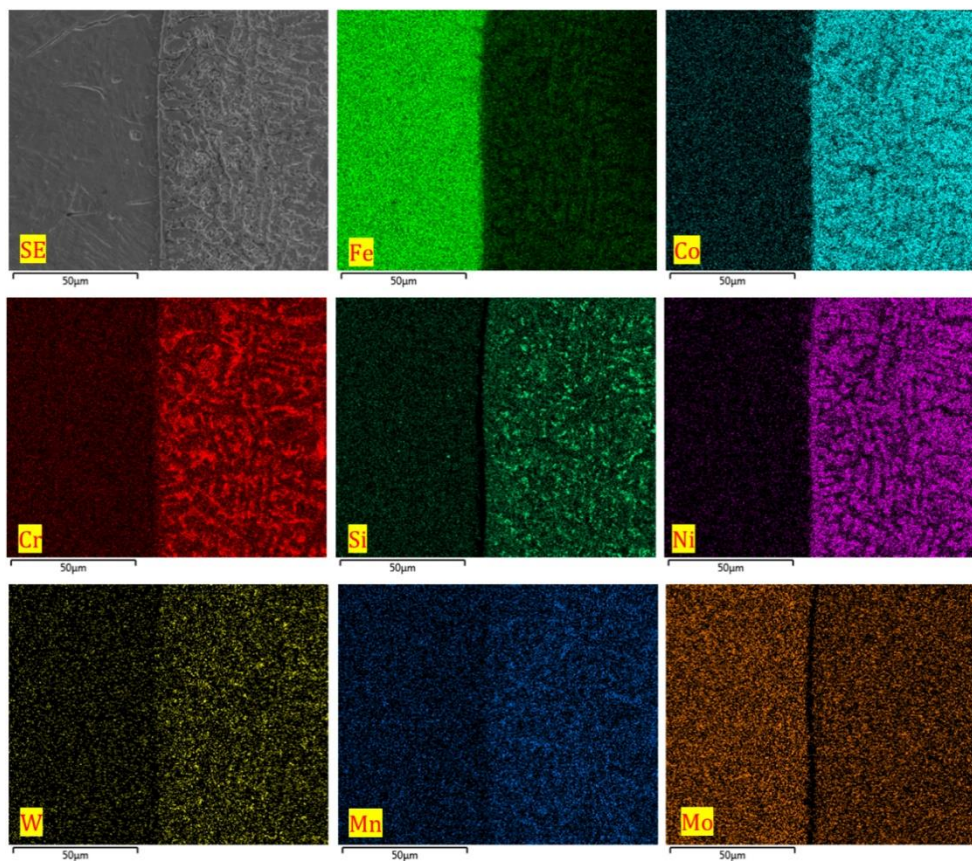
Figure 16. EDS mapping at the interface

4.4.1. Interface EDS Analysis. EDS mapping and line scan analysis were performed to analyze elemental composition and distribution from the substrate to deposits passing through the interface. For the line scan analysis, major elements were quantified through the route. Totally 806 points were selected at a distance of 251 μm . Dwell time for each point was 200 ms. The EDS mapping and line scan were depicted in Figure 16 and Figure 17 respectively.

EDS mapping reveals that some elements such as Ni and Co were diluted from the deposits into the substrate since the H13 tool steel has no composition of Ni and Co. Another point is that Si and Mo were not detected along the interface while all other elements were found in the interface region.

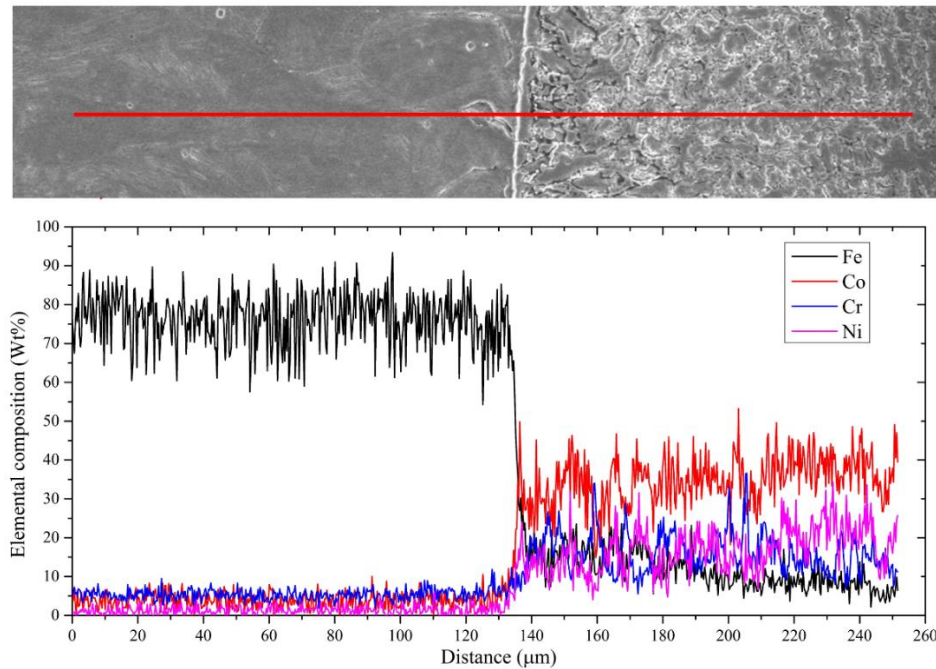
Figure 17. EDS line scan analysis from the substrate to deposits

The EDS line scan analysis in Figure 17 exhibits that the transition of major elements from the substrate to deposits is rapid. Fe is slightly higher in the deposits near the interface compared to the area away from the interface, showing the dilution of Fe into deposits. Fe contributes a lot to phase transformation over the interface. The result confirms that excellent metallurgical bond was formed along the interface after deposition.

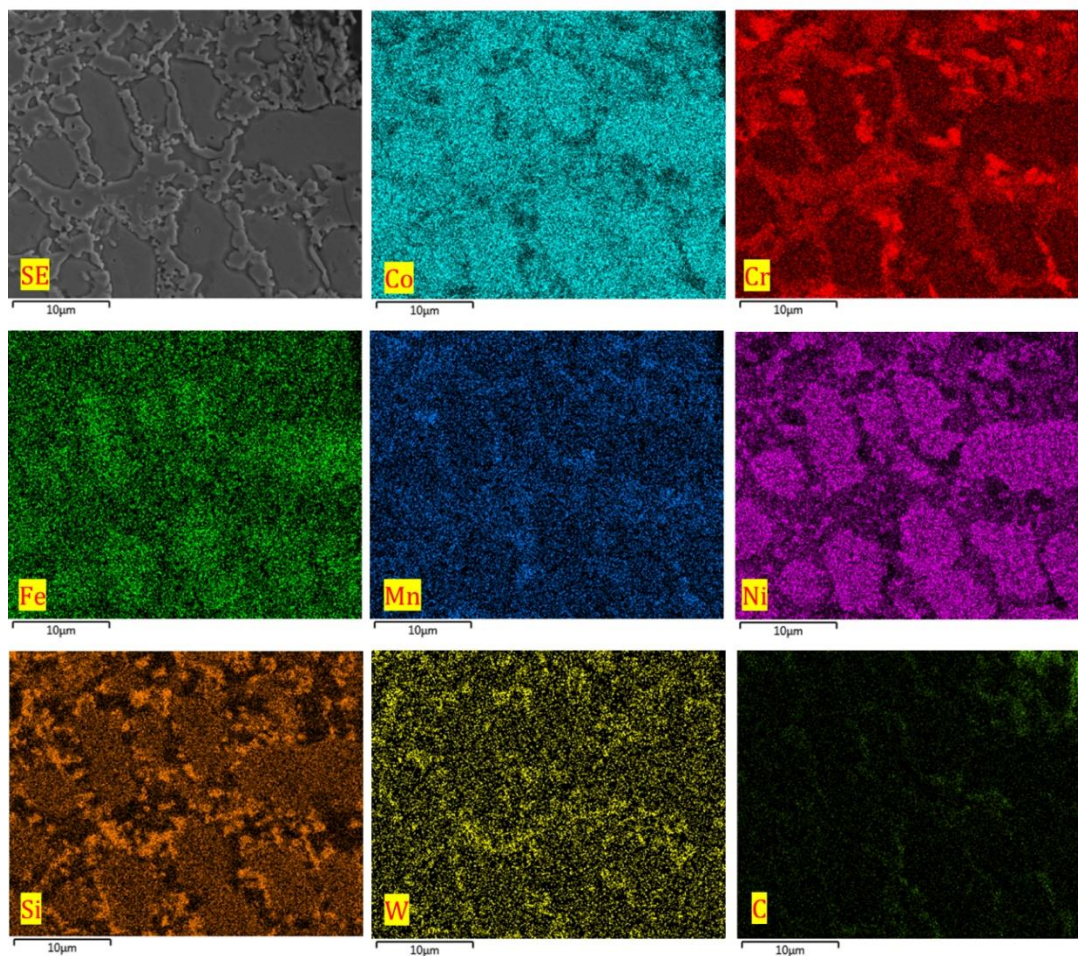
Figure 18. EDS mapping at the deposits

4.4.2. Deposits EDS Analysis. The secondary electron image of deposits was depicted in Figure 18, and EDS mapping was performed in this area to analyze the elemental distribution. Two phases were revealed by the EDS mapping, one is mostly along the grain boundary and another one is inside the boundary. The mapping shows that the grain boundaries were rich in Cr, W, Si, Mn and C while less in Co and Ni. The inner phase was dominated by Co and Ni and also has higher concentrations of Fe and Si.
