A Method for Determining the Strength of Z- and C-purlin Supported Standing Seam Roof Systems

**A METHOD FOR DETERMINING THE STRENGTH
OF Z- AND C-PURLIN SUPPORTED
STANDING SEAM ROOF SYSTEMS**

*Steven D. Brooks*¹
*Thomas M. Murray*²

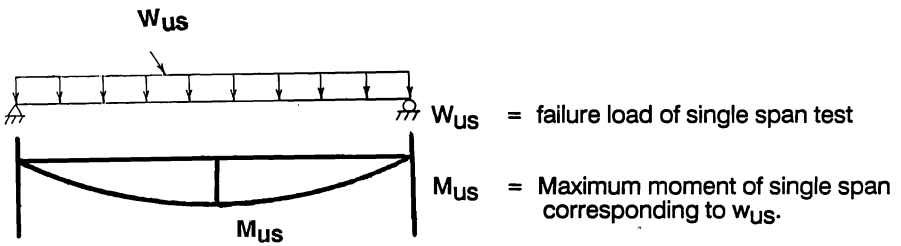
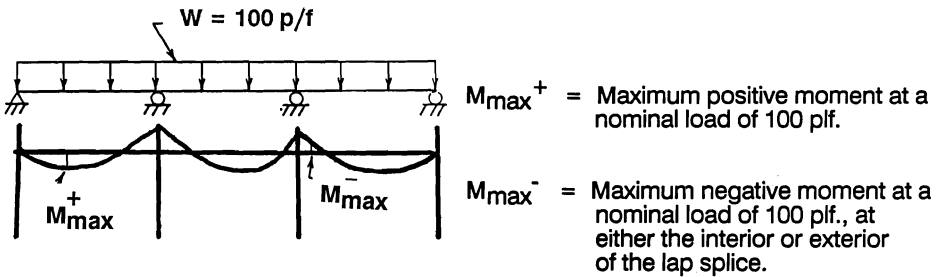
FIGURE 1 BASE TEST METHOD

The basic concept of the base test method is to predict the flexural failure load of a multi-span, multi-purlin line standing seam roof system from the experimental failure load of a single span. The basic component of the method is the failure load of the single span test called the "base test". From this failure load, the corresponding moment capacity of the standing seam roof system braced purlin is calculated for the single span. This phase of the method must be completed in the laboratory by loading a full scale single span system to failure.

A stiffness analysis with a nominal uniform load (say 100 plf) on a multi-span system is then performed. The stiffness analysis results in maximum positive and maximum negative moments. For gravity loading, a positive moment is defined as a moment which causes compression in the purlin flange which is attached to the roof panel. A negative moment is a moment which causes tension in the same purlin flange.

Two failure loads are then calculated using the data thus obtained and two assumptions: (1) the positive moment capacity of standing seam roof system braced purlins is limited to that determined from the base test, and (2) the negative moment capacity is limited to that of a fully-braced purlin. The first failure load is the nominal uniform load used in the stiffness analysis multiplied by the ratio of the single span failure moment to the maximum positive moment from the stiffness analysis. The second failure load is the nominal uniform load multiplied by the ratio of the fully-braced theoretical flexural capacity of the cross section-to the maximum negative moment from the stiffness analysis. The predicted failure load of the multi-span system is the minimum of the two calculated loads. Figure 1 summarizes the procedure.

a) Single Span Base Test

b) Multi-Span Stiffness Analysis

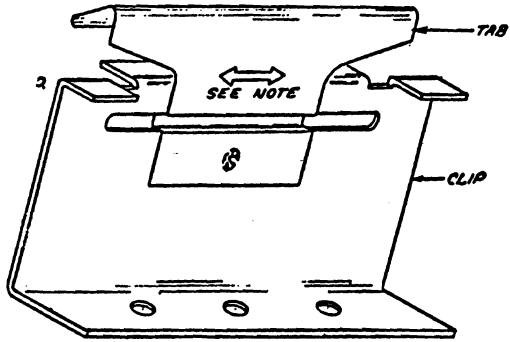
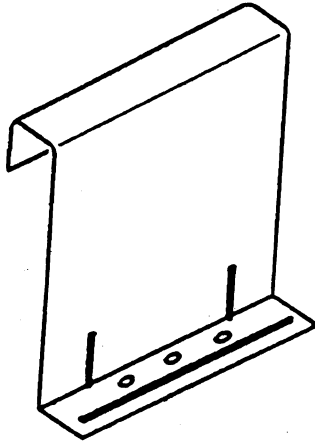
FIGURE 4 REPRESENTATIVE CLIP CONFIGURATIONS

Clips. The "standing seam clips" used in the tests were of two types; one piece fixed clips and two piece sliding clips. The exact clip detail varied among the sets of tests; representative configurations are shown in Figure 4.

a) Two Piece Sliding Clip

b) One Piece Fixed Clip

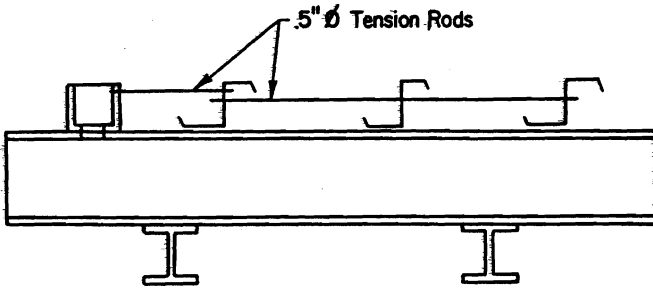
FIGURE 5 RAFTER BRACING DETAILS

Bracing. The bracing at the rafters consisted of 1/2 in. diameter tension rods connected to the purlin webs near the top flange and anchored to a rigid stand attached to the rafter. Figure 5 shows details of the rafter bracing system.

The rafter braced sequence of tests consisted of six sets of tests with each set of tests including a single span base test and a three span confirming test. The bracing of the system was as shown in Figures 5 and 7. Four of the six sets of tests were conducted using Z-purlins facing the same direction. One set of tests was conducted using C-purlins facing the same direction in each bay, but opposite in adjoining bays. For these five test sets, three lines of purlins were used in the three span tests and two lines in the single span tests. The sixth set of tests used opposed Z-purlins. Two lines were used in the single span test and four lines of purlins were used in the three span test. Table 2 shows the failure load and failure mode for each test.

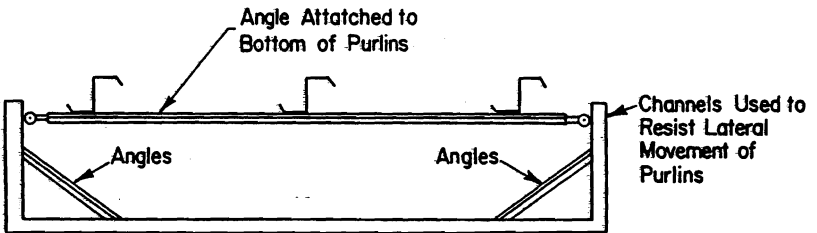
FIGURE 6 THIRD POINT BRACING DETAILS

Bracing used in the interior of the spans consisted of a continuous angle bolted to the bottom flanges of the purlins. A set of rollers was attached to each end of the angles. The rollers were restricted to vertical movement by channels anchored to the laboratory floor. This system allowed the purlins to deflect in a vertical direction while providing lateral bracing at the third points of the spans. Figure 6 is a schematic of the bracing system.

The third point braced sequence of tests consisted of three sets of tests with each set containing a single span base test and a three span confirming test. The bracing of the systems was as shown in Figures 6 and 8. The three sets of tests used Z-purlins facing the same direction. Two lines of purlins were used in the single span tests and three lines of purlins were used in the three span confirming test. Table 3 is a summary of the test results, showing failure loads and failure modes.

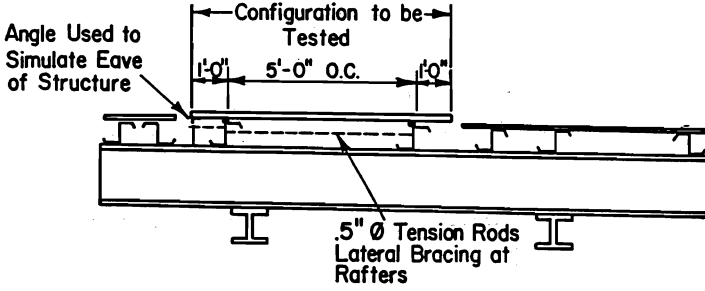
FIGURE 7 CROSS-SECTION OF SINGLE SPAN BASE TEST SETUP

The single span base tests consisted of two lines of purlins 5 ft. 0 in. on center with a span of 25 ft. 0 in. The purlins were bolted through the bottom flanges to the rafter. The panels used were 7 ft. 0 in. in length. This permitted a 1 ft. 0 in. overhang beyond the webs of the purlins. In some tests, the panel-to-purlin clips were bolted to the purlins with 1/4" bolts to simplify removal of the panels after testing, otherwise, self-drilling fasteners were used. A cold-formed angle was attached continuously to one edge of the panels to simulate the stiffness provided by an eave strut. Figure 7 is a cross section of the single span test.

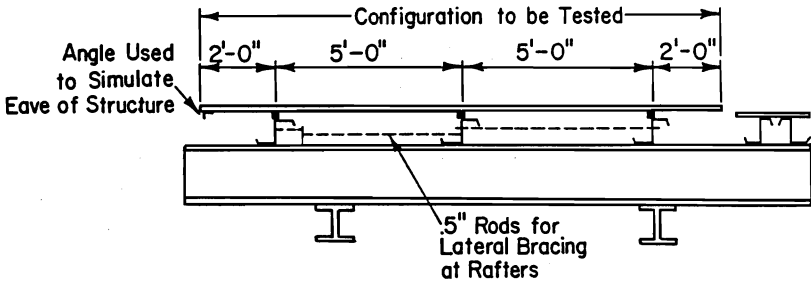
FIGURE 8 CROSS-SECTION OF THREE-SPAN TEST SETUP

The three span tests consisted of three or four lines of purlins depending on whether the purlin flanges were facing the same direction or opposing each other, respectively. Each of the three spans were 23 ft. 6 in. between rafters. The lap splices over the interior rafters varied between tests and were set by the manufacturer of the purlins. Lap lengths are listed in Table 1. The purlins were connected through their bottom flanges to the rafter. The panels were 14 ft. 4 3/4 in. in length. When three lines of purlins were used, the purlins were spaced 5 ft. 0 in. on center with a 2 ft. 2 3/8 in. overhang of the panels. When four purlin lines were used, the purlins were on a 3 ft. 7 in. spacing with an overhang of 1 ft 9 3/4 in. The clips were bolted to the purlins with 1/4 in. bolts to simplify removal of the panels after testing. A cold-formed angle was attached continuously to one edge of the panels to act as an eave. Figure 8 is a cross section of the three span test setup.

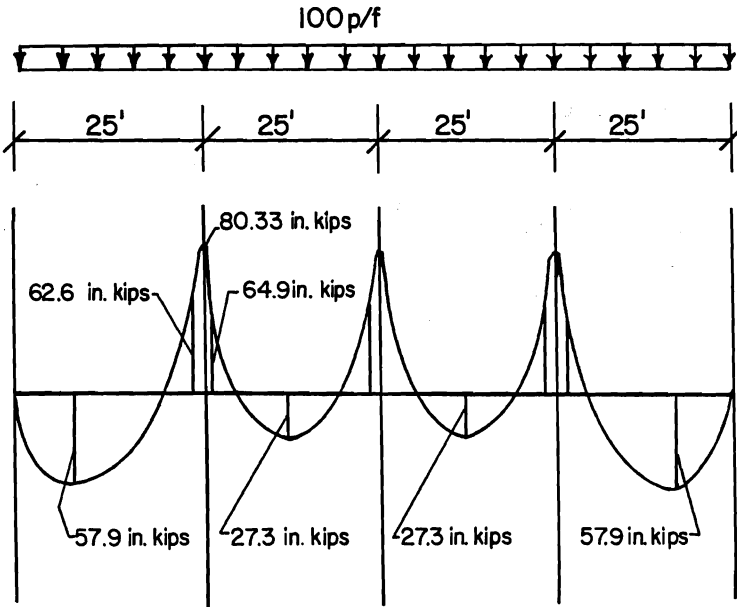
FIGURE 9 MOMENT DIAGRAM FOR EXAMPLE CALCULATIONS

Next, a stiffness analysis of a four span purlin line was conducted. The resulting moment diagram for a 100 plf nominal load is shown in Figure 9. The controlling positive moment is 57.9 in-kips and the controlling negative moment is 64.9 in-kips both per purlin.

$$w = \min \left\{ \begin{array}{l} \text{Positive moment region:} \\ 61.7/57.9 \times 100 = 106.6 \text{ plf} \\ \text{Negative moment region:} \\ 82.1/64.9 \times 100 = 126.5 \text{ plf} \end{array} \right.$$

Assuming the positive moment region controls (106.6 plf), the negative moment region capacity is recalculated considering shear plus bending effects and found to be 119.7 plf. Thus, the capacity of the proposed standing seam roof system per purlin line is 106.6 plf.
