SITE DEVELOPMENT IN DEEP KARST TERRAIN

Thomas P. Hart, P.E., R.G.
Black & Veatch Corporation
Overland Park, Kansas

The development of a site for a power plant was complicated by the presence of pinnacled karst bedrock located beneath more than 24 meters (80 feet) of intermediate geo-materials (IGM). Shallow mat foundations had been planned in the conceptual design. Detailed subsurface investigations included an extensive supplemental drilling phase that identified a complex layer of pinnacled karst lying beneath a hard, nearly inelastic layer of residual IGM. In an effort to keep the site on shallow foundations, the design team attempted a preload approach to pretest the load-bearing capacity of the potentially karst prone site. Project schedule constraints required the preload be removed and abandoned in lieu of more positive, fast-track solutions after detection of collapse-like movements. With schedule milestones fast approaching, the project moved to conventional H-piles to expedite foundation construction. The pile design effort included an indicator pile program with confirmation borings, a static load test and PDA testing. Pile installations were installed up to a depth of

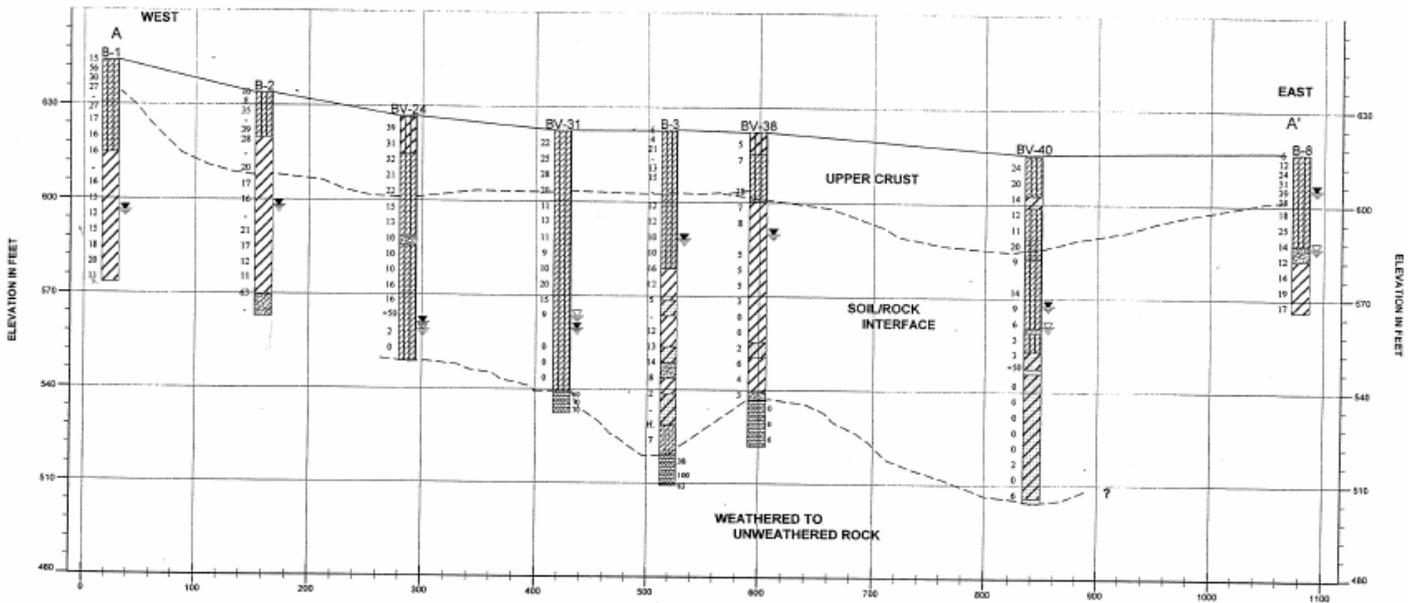
Figure 2 East-West Cross Section

The investigation started off in dramatic fashion with the first boring encountering much softer clay from the ground surface through the entire IGM zone, beneath one of the heaviest, most critical pieces of equipment. The rest of the borings were a mixed bag of strong IGM overlying either bedrock or soft clay. The top of bedrock was defined at depths ranging from 10 meters (33 feet) to 40 meters (132 feet). Borings extending beyond 21 meters found the signature soft, normally consolidated clay typically found in slots between pinnacles of limestone. The thickness of the slot material varied from very thin to thicknesses of 15 meters (50 feet) or more.

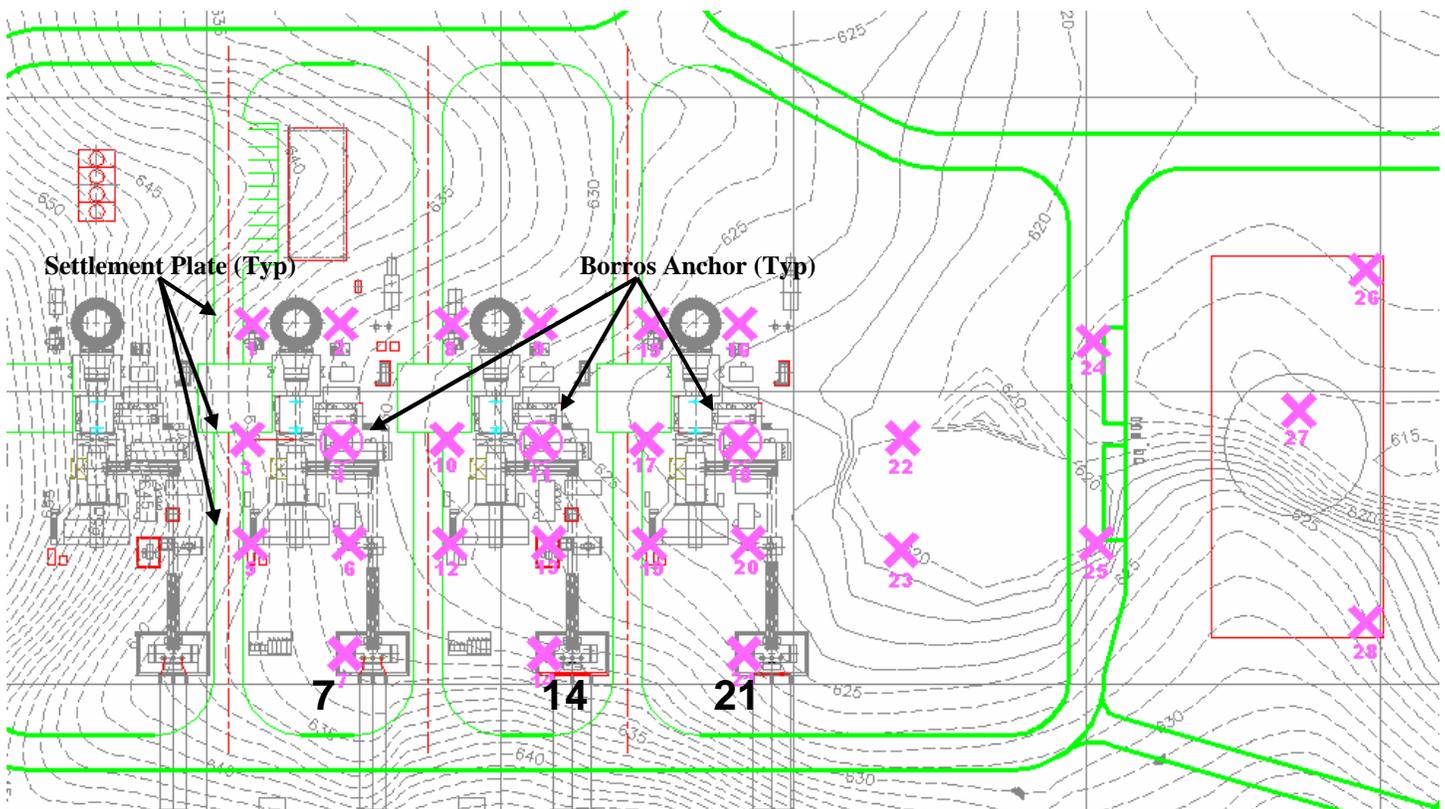
Figure 3: Settlement Plate Plan

The pre-load was scheduled for three months. The monitoring plan incorporated both conventional settlement plates installed immediately beneath the preload, and borros anchors, drilled in and installed 25 meters below the plant grade. The shallow plates would reflect an overall picture of settlements across the site. The deep plates would identify how much settlement was occurring in soft clay between the limestone pinnacles.

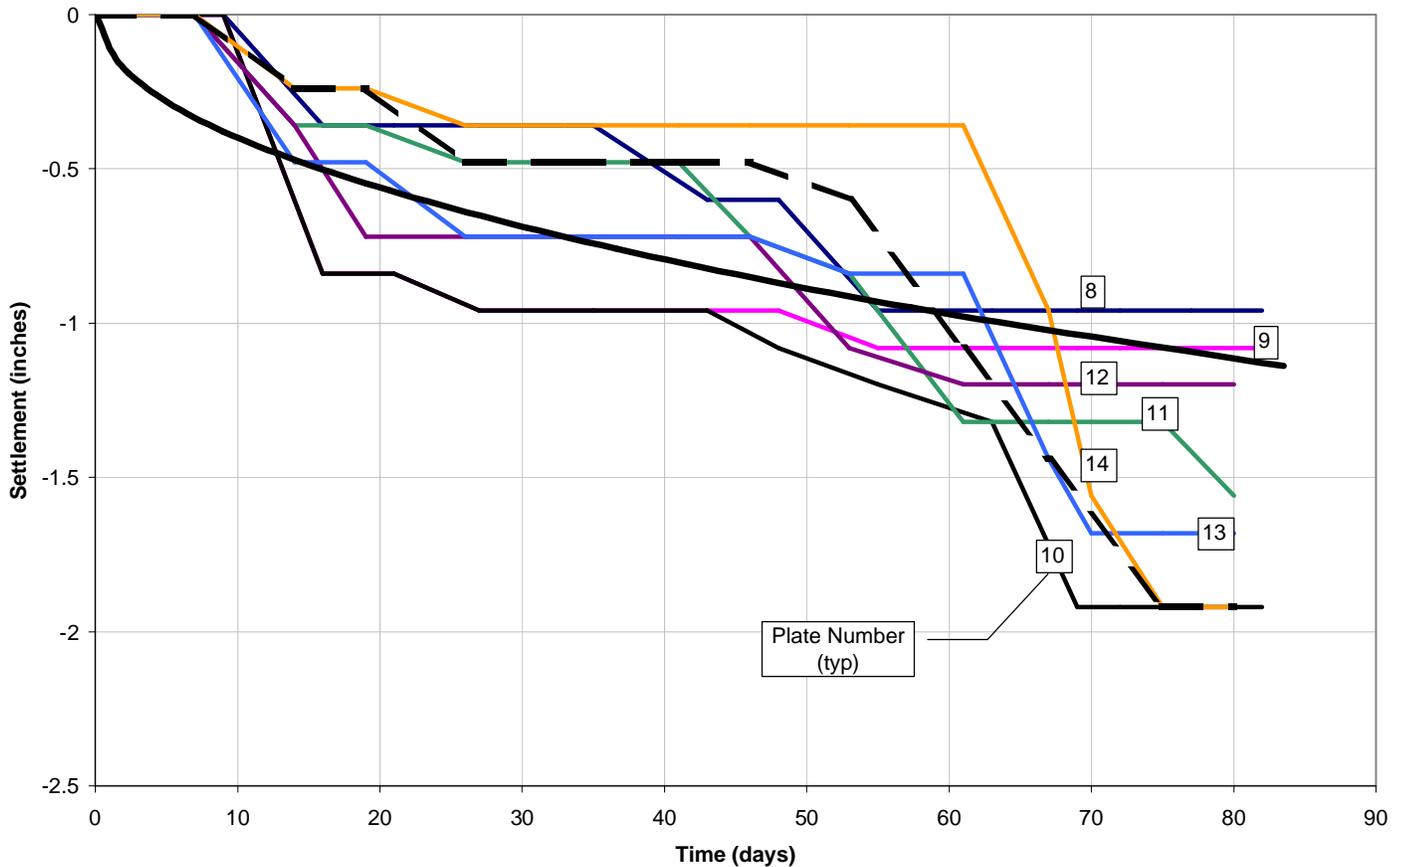
Unit 3 Settlement Monitoring

Figure 4. Illustrates data from 8 settlement plates beneath a CT/transformer foundation. Settlement data reflects characteristic recurring movement and stabilization reflecting the crushing behavior of the overburden. The dashed deep plate, anchored just above bedrock reflected compression of the soft soil between pinnacles. Stability was reflected in 23 of 28 plates at 70 days. At 75 days, 3 of the 7 plates at Unit 2 (Not shown, westernmost foundation on fill) resumed movement, as well as plate 11 seen here.

The settlement data (Figure 4) for the foundation near the center of the pre-load illustrates the chaotic behavior of the karst regime. The predicted consolidation is shown as the smooth, hyperbolic solid line. The deep borros anchor is the dashed line. Both shallow plate and deep anchor data illustrates the stop-start settlement behavior.

At 75 days, the data appeared to be stabilizing. Plans were underway to begin stripping preload at the west end of the pre-load. At 80 days, preload removal had begun when the final set of readings were collected. However, unexpected news soon

followed: several plates beneath the west and center foundations had begun moving again. The stripping of pre-load was stopped. Predicting the remaining duration of the settlement and stabilization proved impossible. Difficult decisions had to be made quickly to maintain the construction schedule.

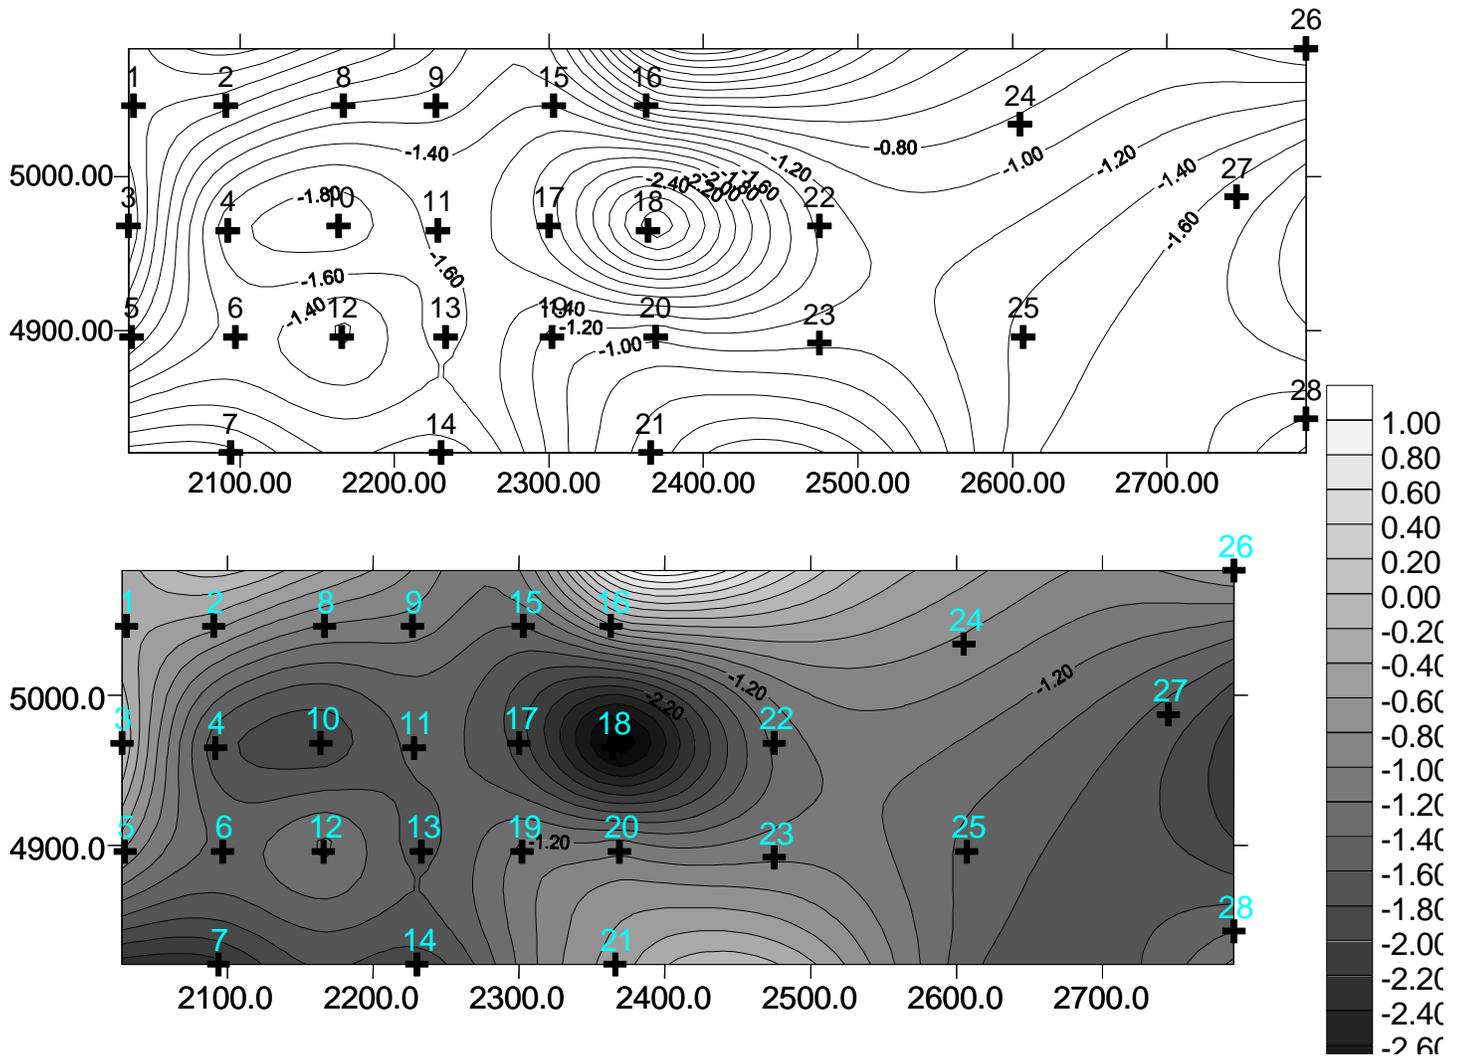
Figure 5. Final (total) settlement contours (distance in feet, settlement in inches). Areas of the greatest settlement magnitude at the surface grade are shaded dark (bottom). The circular nature of the concentrated settlement may reflect karst movement with maximum settlements over six cm. Pile driving records reflect very deep cavities in the bedrock near settlement point 18 with piles reaching depths of over 60 to 90 meters (200 to 300 feet). Conversely, the relatively stable area near settlement 21 reflected very little movement, but piles reached the greatest depths on the project, with one rejected at a length of 124 meters (407 feet) and some meeting solid refusal at 93 to 101 meters (305 to 332 feet).

The results of confirmatory drilling were mixed. Piles were driven to refusal far deeper and shallower than borings offset only a few feet, confirming the extremely jagged nature of the pinnacled limestone surface (Figure 5). Using the average lengths of the indicator pile, Black & Veatch estimated the quantity of pile for the project at nearly 12,200 lineal meters (40,000 linear feet) with an average length of 100 feet.

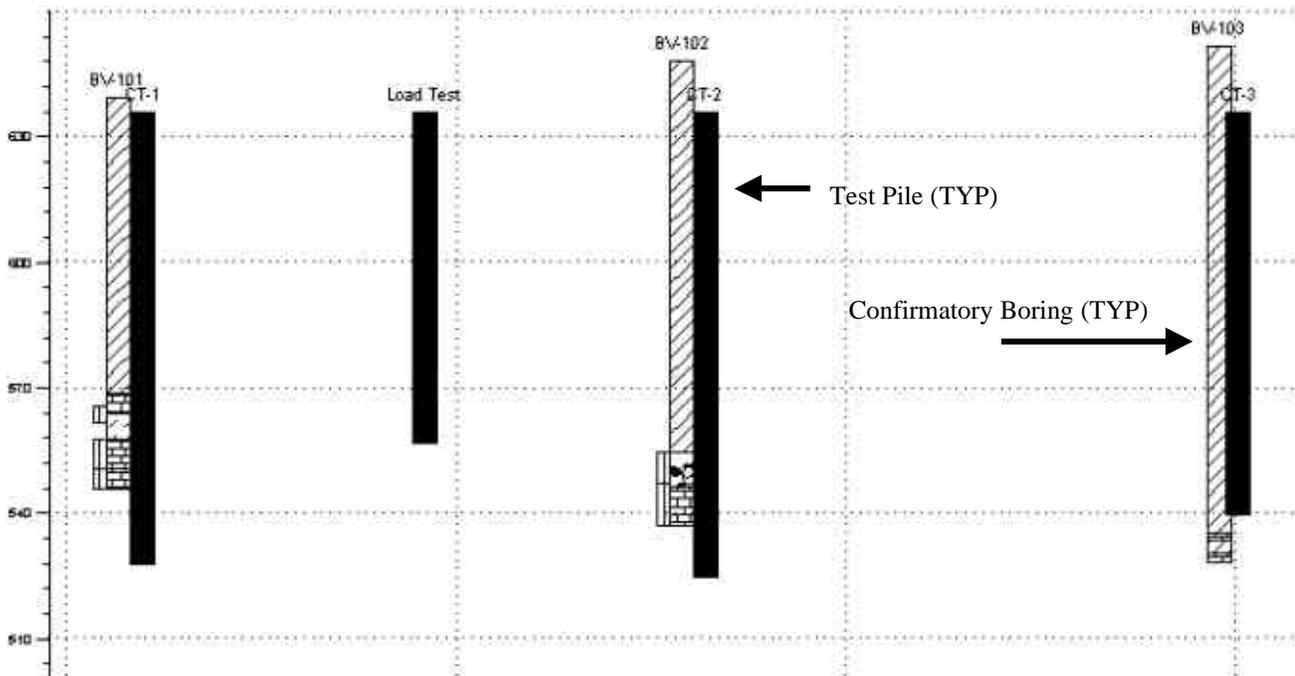
Figure 6. Indicator piles shown as solid black lines in elevation, over confirmatory offset boring, representing the variability in the top of rock over very short horizontal distances. HP 12X63 piles refused both above and below where confirmatory borings would indicate.

indicator test program was underway. The indicator piles were driven under each of the four major foundations. First, four more borings were drilled at the indicator piles locations to determine the depth to competent rock. Refusal criteria and ultimate capacity were developed while driving the piles using a pile driving analyzer (PDA). A full-scale static load test confirmed the results.

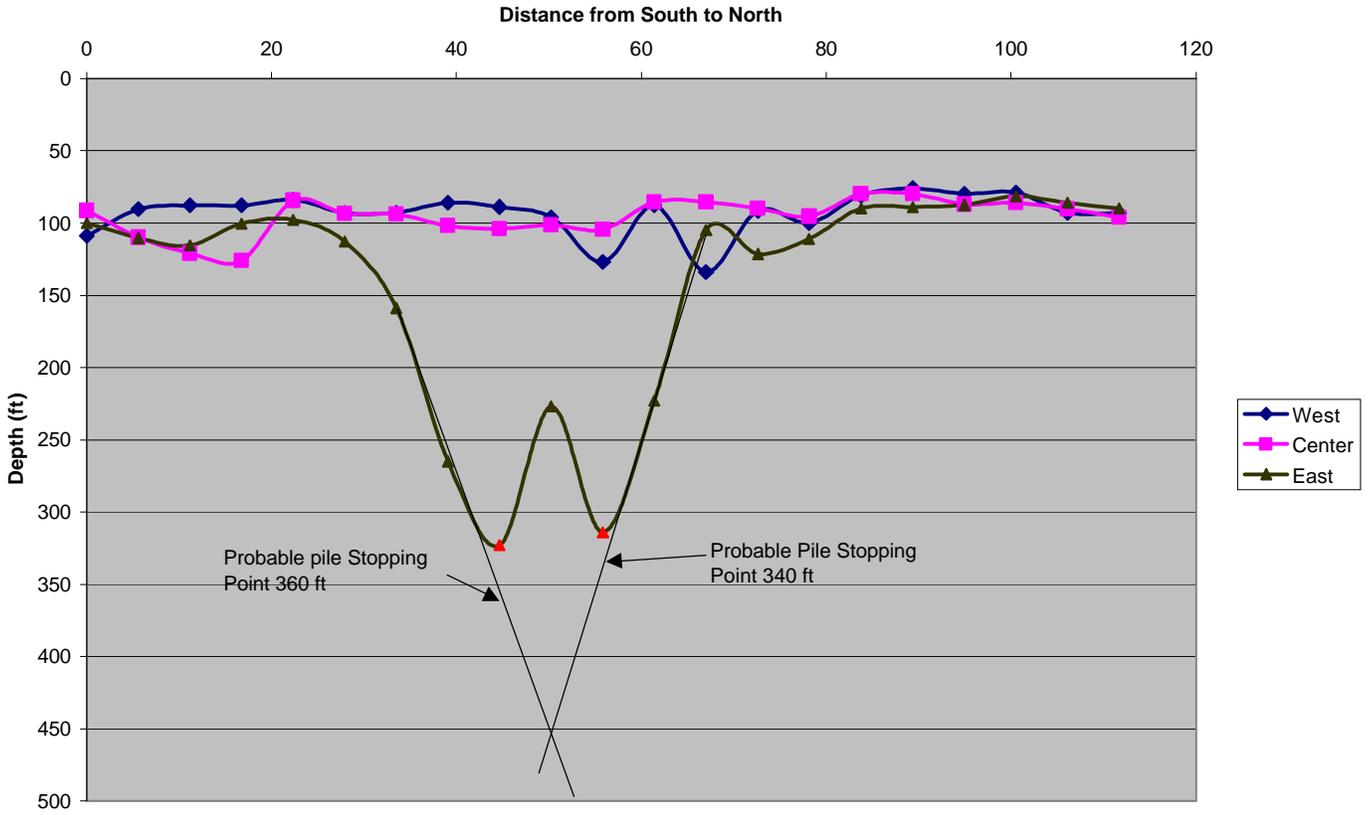
CT - 4

Figure 7. Pile tip refusals for three rows of piles. Each row is two to three meters apart. Illustrates the large settlement feature reflected in Figure 5. The deepest two piles were abandoned for excessive length.

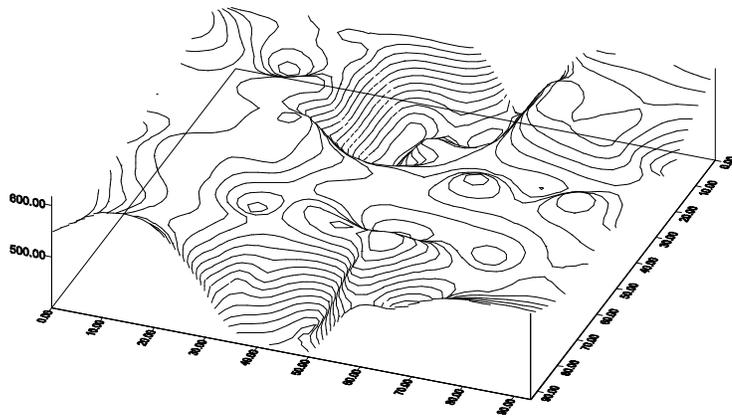
Figure 8. Surface of limestone bedrock, generated from fuel tan area at the east end of the site.

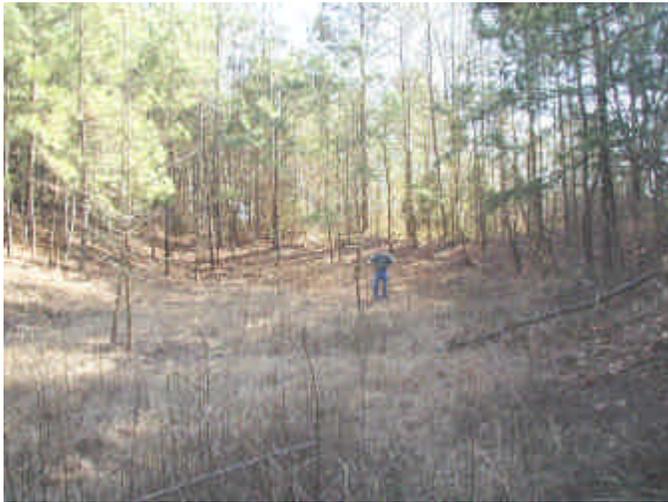
Figure 8. "Dry Pond" located on adjacent property, about 30 meters north of the site.

During the pre-load period, the owner's project manager walked along a potential fuel pipeline corridor, north of the site with the adjacent property owner. When coming across dry pond, the property owner expounded on how he could not seem to plug the large holes in the bottom of his "pond." Upon further reconnaissance and inspection, we discovered no tell-tail signs of an excavation. No dam or spoils pile were evident, very unusual characteristics for an old pond. The dry pond appears to be a very large, 30 meter by 60 meter sinkhole, three to five meters deep, with several one half meter to three meter diameter throats daylighting along the base. The probable sinkhole is more than double the size of the largest foundation planned on site, and was located in dense woods, approximately 30 meters north of the property line.

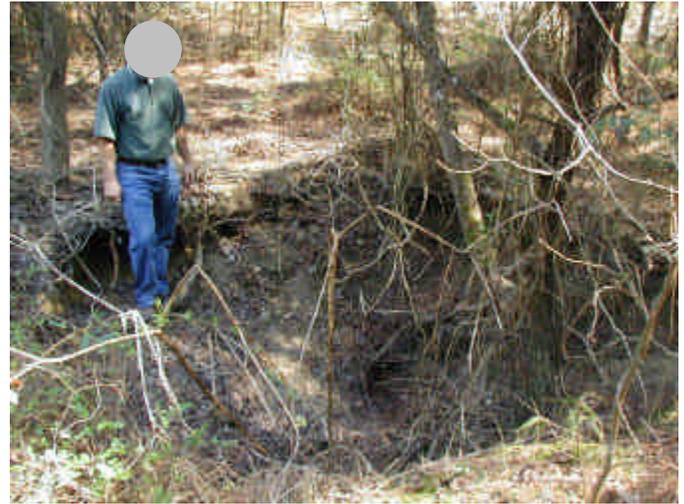
Figure 9. Karst throat inside the dry pond.
