Errors in Design Leading to Pile Failures During Seismic Liquefaction

ERRORS IN DESIGN LEADING TO PILE FAILURES DURING SEISMIC LIQUEFACTION

ABSTRACT

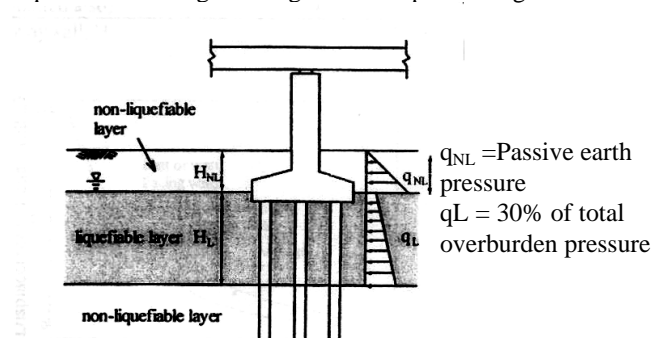
Fig 1. JRA (1996) code of practice showing the idealization for seismic design of bridge foundation.

The Japanese Code of Practice (JRA 1996) has incorporated this understanding of pile failure and is shown in Figure 1. The code advises practising engineers to design piles against bending failure assuming that the non-liquefied crust offers passive earth pressure to the pile and the liquefied soil offers 30% of the total overburden pressure. Other codes such as the USA code (NEHRP 2000) and Eurocode 8, part 5 (1998) also focus on the bending strength of the pile.

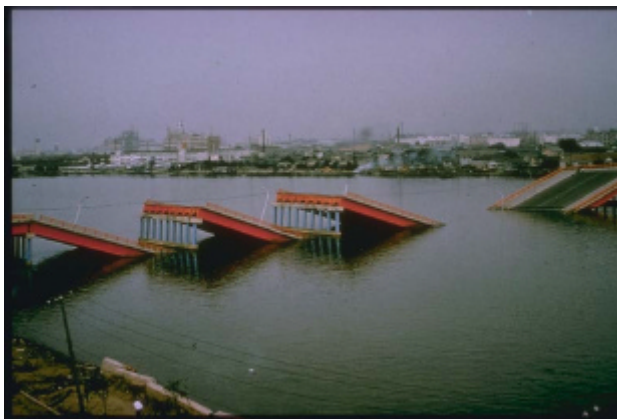
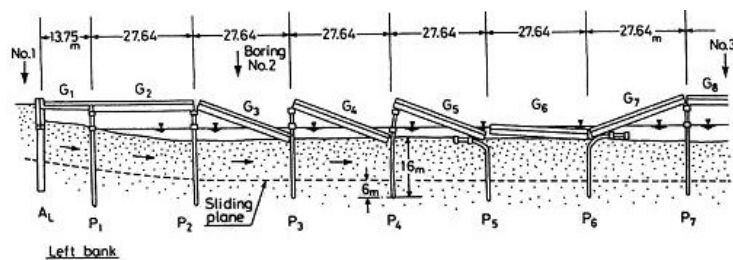
Figure 5: Failure of Showa Bridge; (a): Photograph of the failure after NISEE; (b): Schematic of the falling of the decks after Takata et al (1965)

due to lateral spreading the piers should have deformed identically in the direction of the slope. Furthermore, the piers close to the riverbanks did not fail, whereas the lateral spread is seen to be most severe at these places.

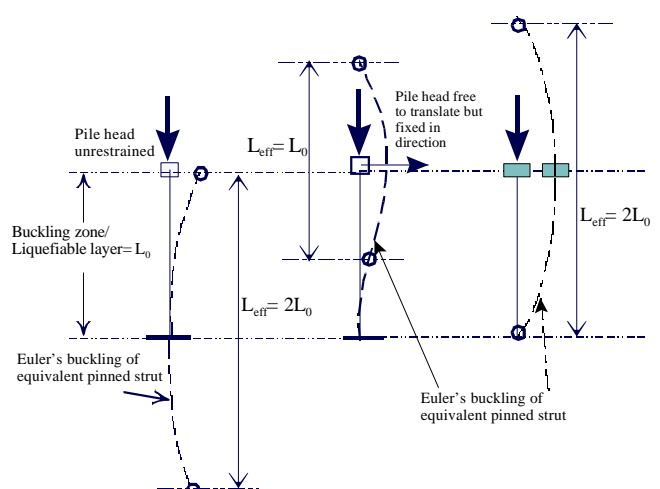
Figure 6: Concept of effective length of pile in liquefiable soil

At time interval 1, slender piles will be prone to axial instability, and buckling failure may occur, enhanced by the actions of the lateral disturbing forces. A simple model is shown in Figure 11. For practical purposes, it may be assumed that the pile is virtually fixed at some depth in the non-liquefiable hard layer, shown by (D_F) in Figure 11. D_F can be estimated using Fleming et al (1992). Thus, the unsupported zone can be taken as $(D_L + D_F)$ where D_L is the depth of liquefiable layer. $(D_L + D_F)$ corresponds to L_0 in Figure 6 and denotes the buckling zone.

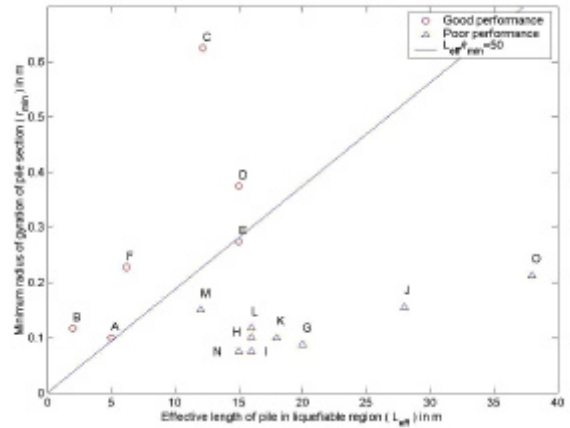
Figure 7: Effective length (L_{eff}) and r_{min} of the piles studied.

Figure 7 plots L_{eff} against the r_{min} of the piles listed in Table 1 with identification of their performance during earthquakes. A line representing a slenderness ratio (L_{eff}/r_{min}) of 50 is drawn and it distinguishes poor pile performance from good performance. This line is of some significance in structural engineering, as it is often used to distinguish between “long” and “short” columns. Columns having slenderness ratios below 50 are expected to fail in crushing whereas those above 50 are expected to fail by bending due to buckling instability. Thus, the analysis suggests that pile failure in liquefied soils is similar in some ways to the failure of long columns in air. The lateral support offered to the pile by the soil prior to the earthquake is removed during liquefaction.

This is consistent with the fact that piles in laterally spreading soil (Marked A through F in Figure 7) having slenderness ratio below 50 did not collapse. It is proposed in this paper that piles in liquefiable soil should be maintained below a slenderness ratio of 50 to avoid buckling instability.

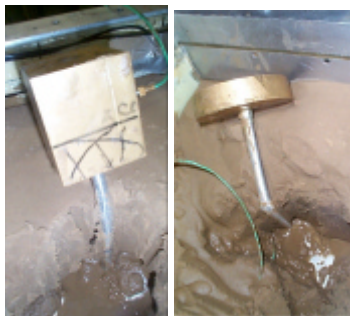
Figure 8: Some failed piles in the centrifuge tests. The tests were carried out in level grounds to avoid lateral spreading.

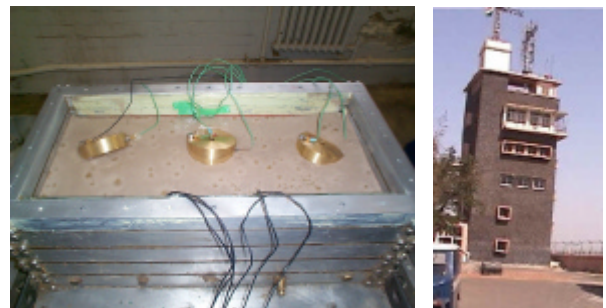
Figure 9: Replication of the failure; (a): Failed piles in the centrifuge test carried out in level ground; (b): Collapsed piled Kandla Tower after 2001 Bhuj earthquake in laterally spreading soil, after Madabhushi et al (2001).

Figure 9 shows the surface observations of the piles after test SB-02. It may be noted that the head of the piles rotated. This is quite similar to the visual observations of the collapsed piled building in laterally spreading soil after the 2001 Bhuj earthquake.

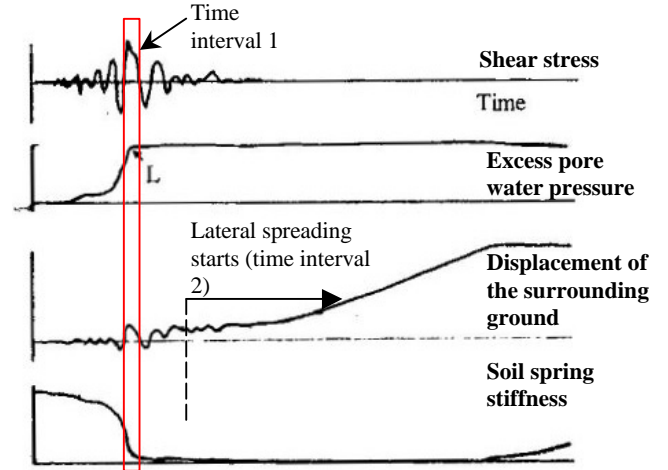
Figure 10: Typical time history of events after Yasuda and Berrill (2001).

Figure 10 shows a typical time history of shear stress, excess pore pressure, displacement of ground and soil stiffness during an earthquake after Yasuda and Berrill (2001). In the figure, two time intervals are identified:

Interval 1 is the time interval between the soil being fully liquefied and lateral spreading yet to start, whereas interval 2 relates to the time interval when lateral spreading starts.

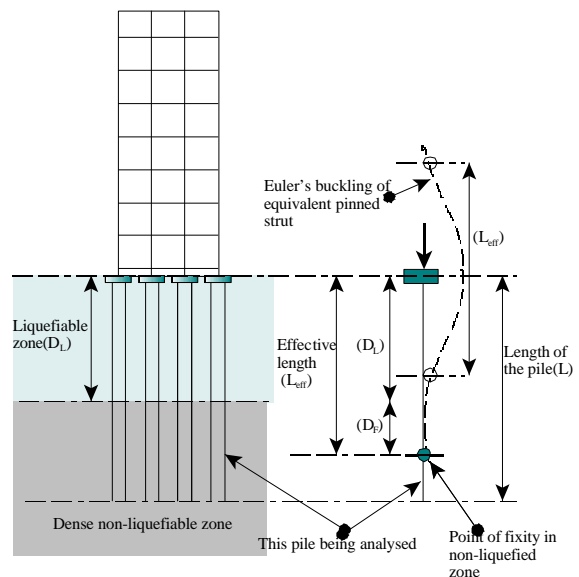
Figure 11: Idealisation of buckling instability of piled foundation.

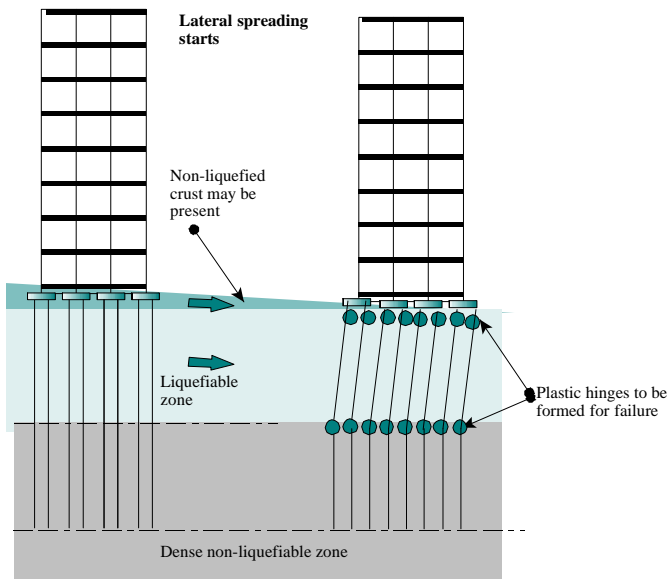
Figure 12: Collapse mechanism of piled foundation due to lateral spread.

During time interval 2, the piled foundation experiences additional drag due to lateral spreading of the soil (transient forces and residual forces). Haigh (2002) showed that the transient forces can be quite high compared to the residual forces. His centrifuge results showed that the transient forces are 3 times the forces predicted by JRA (1996). These drags (transient or residual) will induce bending moment in the pile as shown in Figure 12.
