# Deterioration of Bored Cast in Situ Piles Due to Aggressive Water

V. T. Ganpule

S. Y. Mhaiskar

## **DETERIORATION OF BORED CAST IN SITU PILES DUE TO AGGRESSIVE WATER**

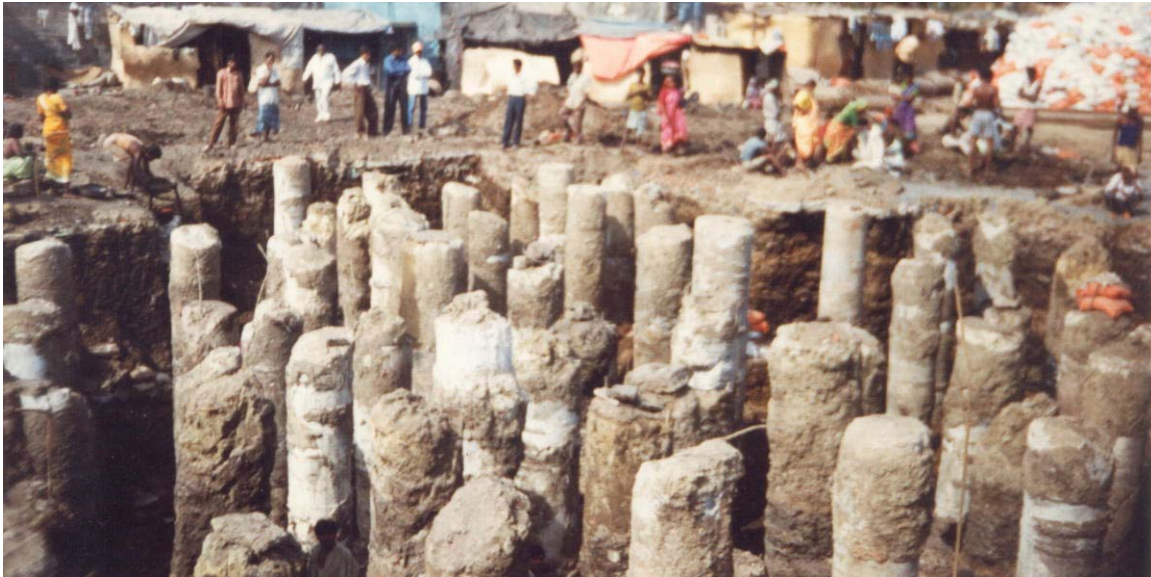
Piling on dumping ground at Worli, Mumbai.

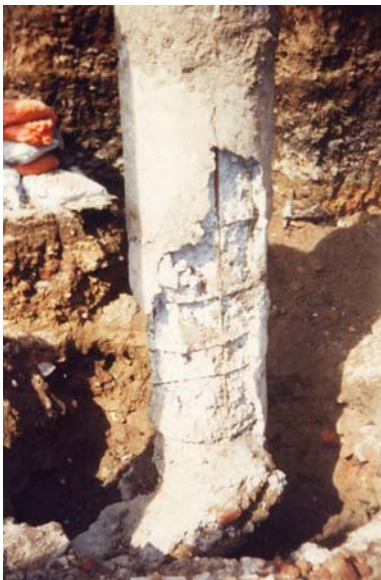
Site 2 Bund Garden, Pune  
Diesel spillage site

C) Similar experience was noticed at site in Pune located in the Bund Garden area. The bored-cast-in-situ piles casted using OPC on exposing for pile caps were found to be in an extremely deteriorated condition. Casing of cubes and curing them in the ground water clearly showed non-setting cubes and very white layer on the surface of cubes. The Ryzner Index test was carried out which confirmed the behavior of cubes and piles were exactly similar to the site of petrochemical industry an unexpected phenomenon in a posh area like Bund garden, Pune. On enquiry it was found that few years back a goods train carrying Wagon containing diesel met with an accident spreading the diesel which seeped through the ground water through 'runoff (1994, August).

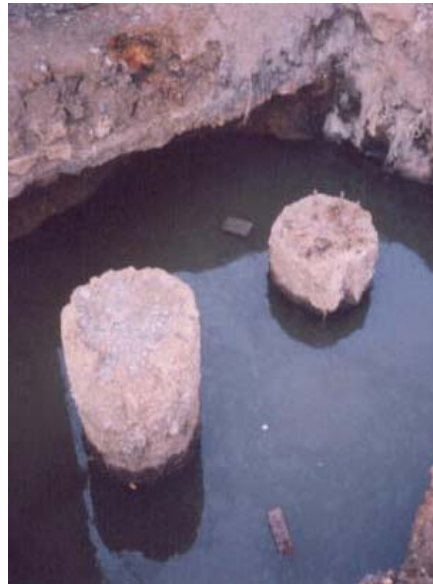
Site 3 Bund Garden, Pune  
Diesel spillage site

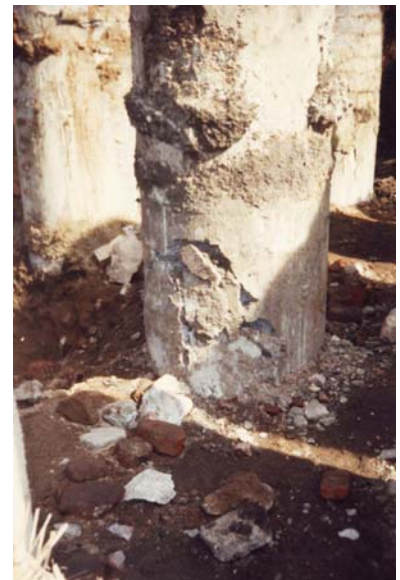
Site -Worli, Mumbai  
Piling on dumping ground

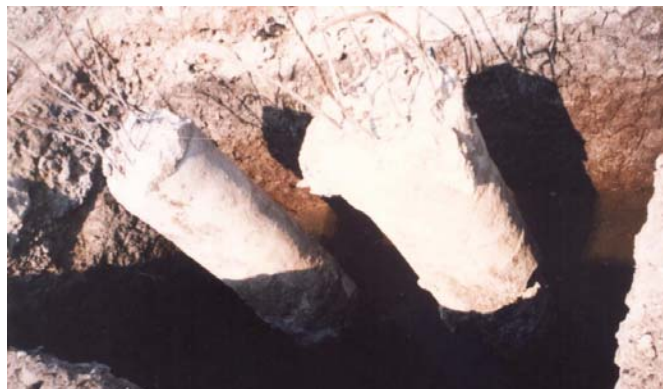
Site 1 Patalganga Petrochemical Industry

About 600 piles were installed. The cement used for the work was OPC. Couple of routine static tests by conventional methods were conducted to confirm the design capacity of piles. The results were satisfactory and hence pile capping was undertaken for the pipe rack supports. The excavated pits for the pile caps were extended up to the cut-off level of piles which was about 60 cm below the ground water level. The number of white floats were observed on surface of the water. The field engineer did not pay serious attention to the particular phenomenon and continued the capping activity being confident about the pile capacity because of satisfactory results of the pile load test. After completing pile capping work of pipe rack supports the pit for the ring beam of storage tank was excavated up to the pile cap bottom level, here not only floats whitish in colour but after dewatering the pit, the pile shafts below the ground water table were exhibiting snow white colour. The eroded shafts were looking like fruit bitten by the bird. Some of the shafts were extremely hot suggesting some chemical action was continuing even after 28 days after casting. The situation was very serious and three samples of pit water were sent to three different testing houses. All of them confirmed that water is non-aggressive. In fact one of them, very leading one added in the report that water is potable.

All sorts of doubts about quality of material and workmanship were expressed. The quality of materials used was confirmed and found to be very satisfactory. To remove or confirm the workmanship doubt fresh piles were casted under the supervision of the consultants. These piles were exposed and observed to be equally bad. The concrete cubes on deshuttering the mould after one day and concrete balls in pan a were kept for curing in the same ground water. The results confirmed that there concrete was not setting fully, the colour of the cubes and balls on the surface was whitish. It meant that the neither the workmanship nor the materials are responsible for the mishap.

Simultaneously the tests, on water sample on water sample were carried out in the petro-chemical laboratory. The procedure of test in this particular laboratory was according to test procedure for flow of fluid through pipes in the chemical industry. Test reports along with the conventional testing included a test called 'Ryzner Index' with a comment that water is corrosive as RI is 7.8 and is unsaturated in calcium carbonate ( $\text{CaCO}_3$ ). This helped in finding out the cause of damage. The details are discussed later. All the piles were rejected and new foundations system was provided (Dec.1989). (chloride 150 ppm, sulphate 400 ppm, pH 7.8, RI 7.8 ).

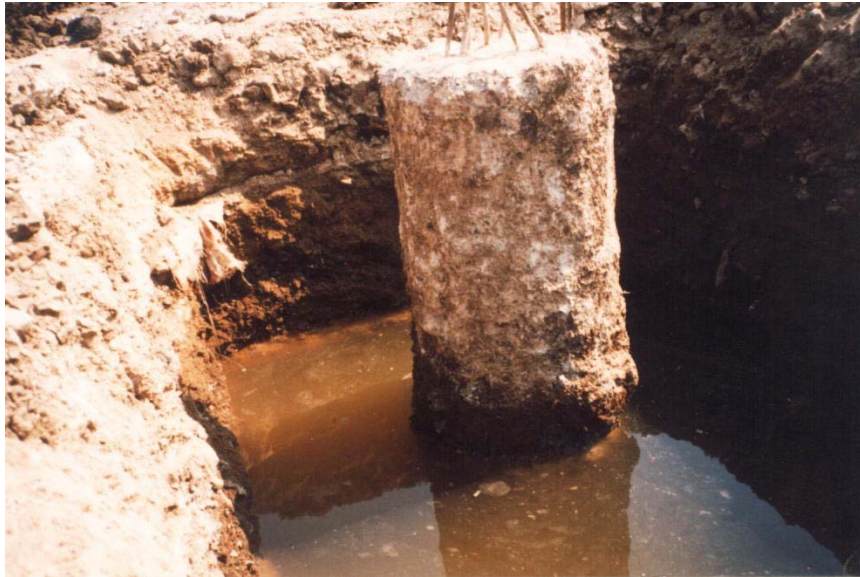
Site 1 Patalganga Petrochemical Industry

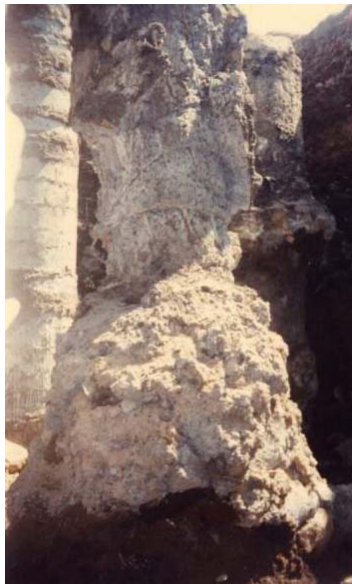
Site –Worli, Mumbai - Piling on dumping ground

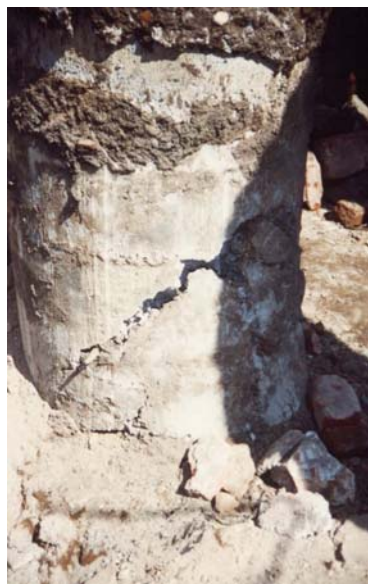
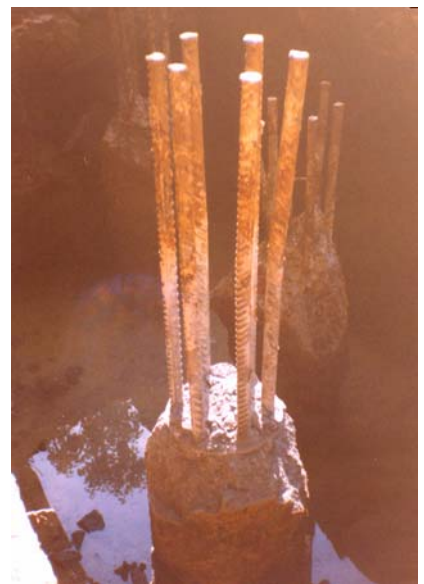
Site 1 Patalganga Petrochemical Ind.

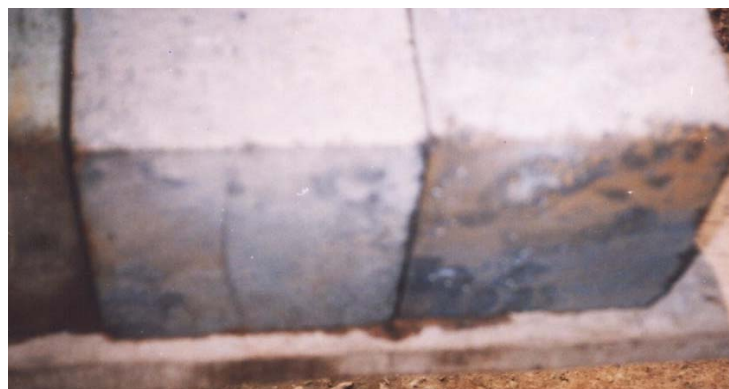
Concrete cubes – Experimental work

- I. The experimental set up comprises of pouring concrete in the cube molds with the help of funnel to stimulate tremie concrete activity. The empty cubes were kept in the ground water and then concreted so as to ensure similar conditions to bored cast in situ piles.
- II. The set of 18 cubes were cased as above and marked with identification mark. On completing 24 hours curing the cube molds were removed and curing in the ground water for scheduled period was continued. The 18 no. of cubes were also cast and cured in the normal water as per the procedure outlined. The cubes were tested for compression and results are presented in the table no. 2
