DESIGN AND PERFORMANCE OF SHALLOW FOUNDATIONS OVER DIAGENETIC LIMESTONE ALONG THE ARAB GULF COAST: REALITIES AND CHALLENGES

Waddah Akili

Professor of Civil Engineering (Retired)
Principal, Geotechnical Engineering
3222 Evergreen Rd., Ames, IA-USA 50014

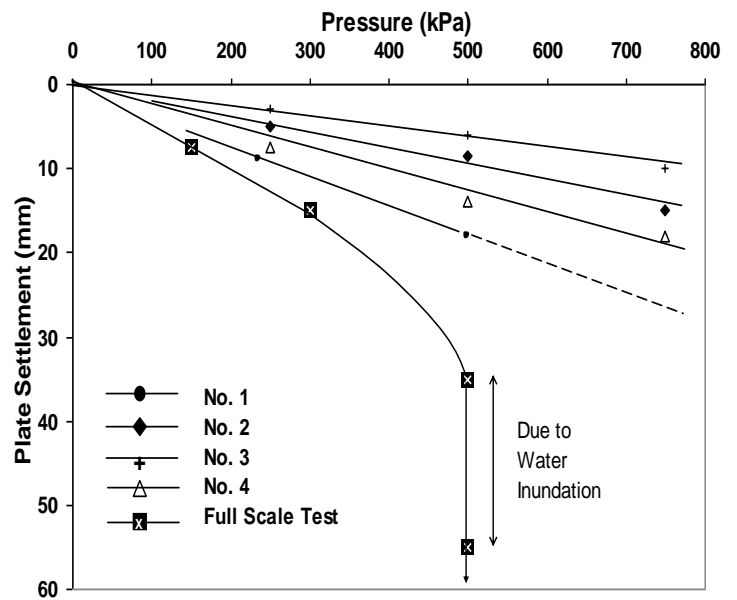
Fig. 4b. Plate load test results at site III (four plate load + one full scale).

A full-size concrete footing block 2.0 m x 1.5 m, located on an even surface 3.0 m below ground, was tested using a piling load test reaction frame. The loaded footing block (the prototype) overlaid an estimated 6.3 m thick partially saturated “diagenetic limestone” which in turn, overlaid harder and more competent limestone. This arrangement, thought to depict actual conditions of the proposed structure, was loaded up to 500 kPa. Also, in the same excavation, four *plate load* tests were carried out. Results of the four *plate load* tests, along with the load-settlement results of the prototype footing (test footing) are shown in Fig.4b.

The full-scale load test carried out at site III, and reported in Fig. 4b – comprising a 1.5 m x 2.0 m footing placed 3.0 m

below ground — was loaded only to 500 kPa, due to non-availability of reaction support beyond this limiting pressure value at the time of the test. Good correlation appears to exist between measured settlement of the load test (see Fig.4b) and calculated settlement at the same site, deploying elastic moduli from *plate load* tests. This is to say that applied pressure to induce 20.0 mm settlement of the test footing, estimated from Fig.4b as 350 kPa, falls within the calculated range of 363.4 to 224.8 kPa (see Table 2). This observation supports the notion that *plate load* tests do provide settlements, and thus moduli values, appear consistent with full-scale load tests.

Towards the end of the test, and at 500 kPa pressure, footing perimeter and the area below, were subjected to wetting. A 30 cm head of water above footing base was maintained for a duration of 48 hrs. During the time of wetting, settlements were monitored. As anticipated, a dramatic increase in settlement (additional due to wetting) began to occur simultaneously as water percolated down below. The final estimate of this increase was 63 % of value reached before wetting under the maximum pressure of 500 kPa (see Fig. 4b). This sudden increase in settlement, as water percolated down, is a form of ‘collapse upon wetting’ known to occur in cemented soils, and has been reported on (Alonso and Gens 1994; Wheeler 1994). The implications here is that matrix materials are ‘water susceptible’, and the extent of “the susceptibility” is a function of matrix composition; i.e., *attapulgitic*.
