A Case History of Deep Excavation in Doha

L. Tony Chen

Hyder Consulting Limited, Hong Kong, China

A CASE HISTROY OF DEEP EXCAVATION IN DOHA

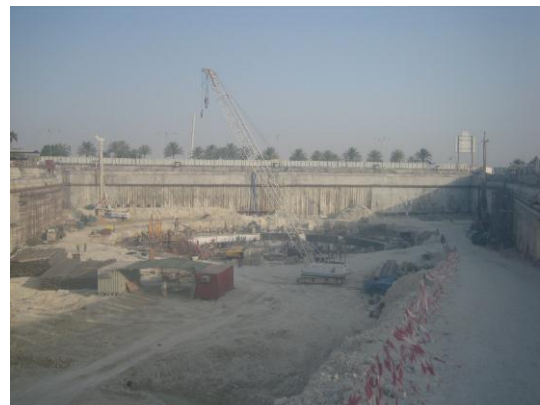
Plate 1. Excavation to Level of -12m

Lateral and vertical ground/wall movements were monitored by inclinometers and settlement markers, respectively. Plate 1 shows the site condition when the excavation reached the level of about -12m.

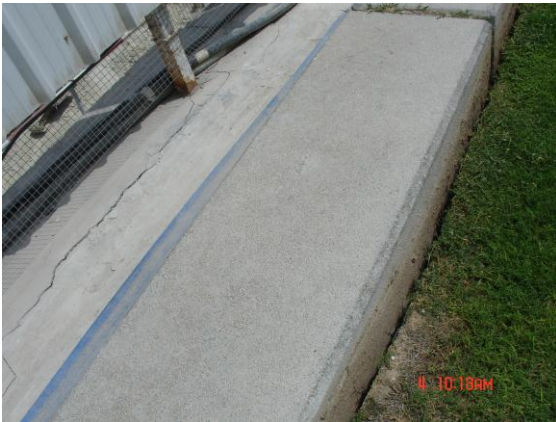
Plate 2. Ground Depression behind Secant Pile Wall

When the excavation reached the level of about -13.5m, excessive lateral wall movement was detected on part of the southern wall. Within a couple of days, the measured wall deflection had reached about 80mm which was significantly greater than the design limit of 25mm. Plate 2 shows the ground depression behind the wall.

A subsequent investigation found that the excessive wall movement had been caused by some loosened ground anchors.

The excavation was immediately stopped and the concerned wall section backfilled to the level of about -10m as an emergency measure to prevent wall collapse.

The loosened ground anchors were subsequently re-stressed to their design load level. Furthermore, it was considered necessary to strengthen the concerned wall section by additional lateral support prior to resumption of excavation works, in order to prevent further wall movement.

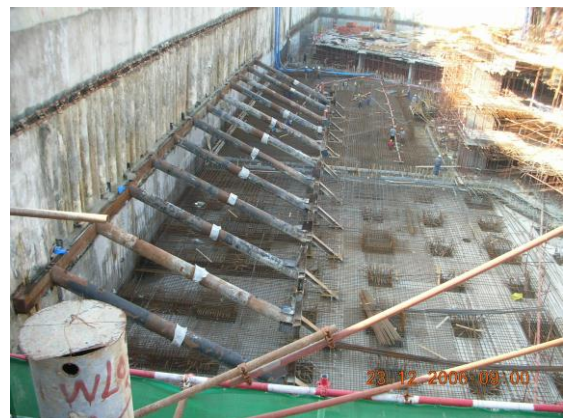
Plate 3. Installed Strutting System

After option evaluation, it was decided to adopt a strutting system consisting of inclined steel tubular pipes having an external diameter of 600mm and a wall thickness of 10mm, installed at an inclination angle of 30° to the horizontal and at a spacing of 4.3m, see Plate 3. The top of these bracing pipes were connected by a steel wailer beam fixed to the wall at the level of -10m. The bottom of the bracing pipes was supported by a foundation consisting of inclined steel sections and the 750mm diameter bored piles which had been installed as tension piles to support the basement.

Although this strutting system had caused inconvenience to the subsequent excavation and construction of the basement slab, it played a critical role in safeguarding the retaining system.
