Bridge Foundation Pile Driving Vibration Monitoring

Zand-Parsa, Kumars and Zand-Parsa, Kamran, "Bridge Foundation Pile Driving Vibration Monitoring" (2013). *International Conference on Case Histories in Geotechnical Engineering*. 4.
<https://scholarsmine.mst.edu/icchge/7icchge/session04/4>

BRIDGE FOUNDATION PILE DRIVING VIBRATION MONITORING

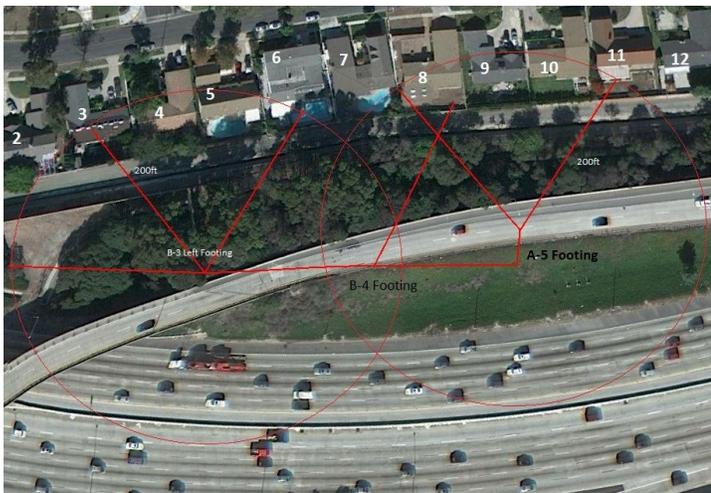
A four-span, cast-in-place, post-tensioned concrete box girder bridge approximately 9.0-feet deep with a 6-foot deep haunch at Bent 2, and 42-feet wide and supported by concrete and steel pipe piles all constructed in one stage. According to project specifications, monitoring equipment were stationed within 3 ft of the exterior of the buildings that were within 200 ft from the footing pile driving. Number of buildings that were within the 200ft from the footing pile driving area is shown in Fig. 1.

Fig. 1. Buildings within the 200ft of the pile driving

Just three footing of this bridge was in the limit of 200 ft from the residential buildings. The project for which this study was performed included driving 35 ft long, 14 inches rectangular concrete piles, and 57 ft long 16 inches diameter steel pipe piles. An APE D36 open ended single acting diesel hammer was used for driving the piles. Total of 37 fourteen inches concrete piles and 91 sixteen inches steel pipe piles were driven within 200ft limit from the residential buildings. There was a continuous V-ditch along the backyards between the pile driving locations and the buildings. The site cross section is shown in Fig.2.

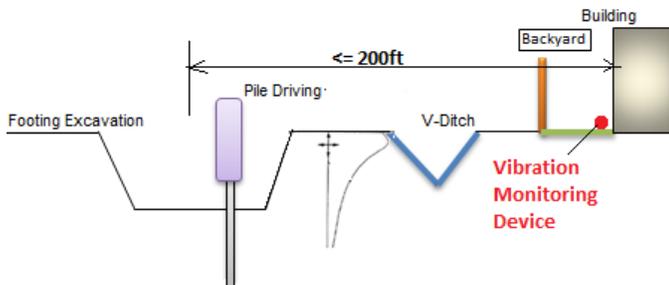
Fig. 2. Typical site cross section through the 200ft

Effect of the V-ditch close to the backyard wall was reduced the soil movement by surface separation, and rays traveled longer distances to get to the sensors. So, V-ditch existence had a reduction effect on the ground motion.

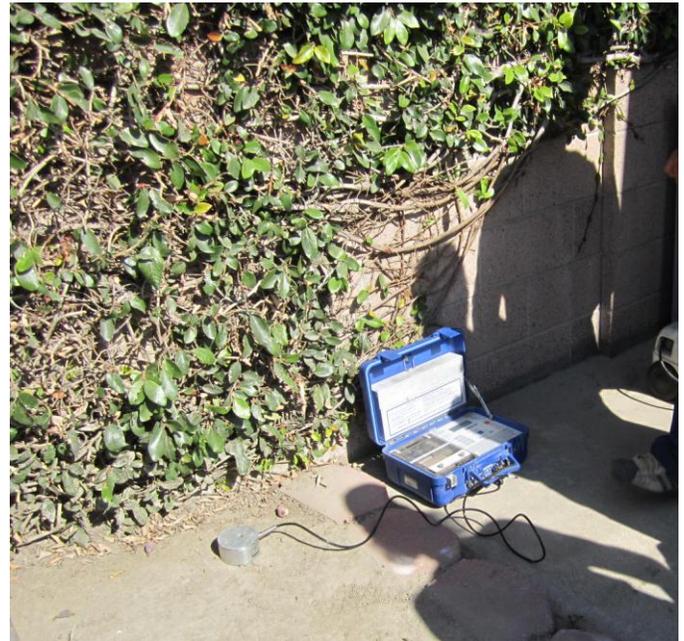
Monitors were installed within 3 ft of the building if the homeowners allowed entry to their backyards. Otherwise they were installed within 3 ft of the southern fence of the property facing the pile driving location.

Fig. 3. Monitor installations in the backyard of a building

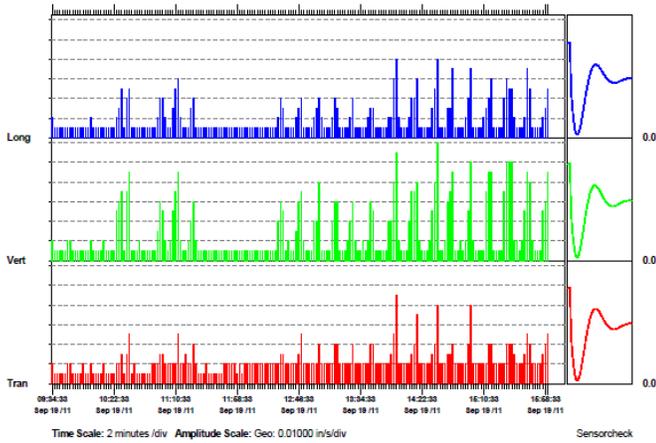
Raw data showing the PPVs recorded in Longitudinal, Transverse, and Vertical direction and their corresponding frequencies for each two minute interval are provided for each footing and Fig. 4 is showing one of them.

Tran	Vert	Long	
PPV	0.0450	0.0900	0.0400	in/s
ZC Freq	23	20	23	Hz
Date	Sep 19 /11	Sep 19 /11	Sep 19 /11	
Time	14:02:33	14:33:33	14:02:33	
Sensorcheck	Passed	Passed	Passed	
Frequency	7.5	7.7	7.4	Hz
Overswing Ratio	3.5	3.4	3.9

Fig. 4. Longitudinal, vertical, and transverse velocity histogram

Surface ground movements were measured in three directions (longitudinal, transverse, and vertical), and the vertical velocity was the maximum.
