***Visual SHM for Concrete Infrastructure Using a Wall-climbing Robot***

**Abstract**

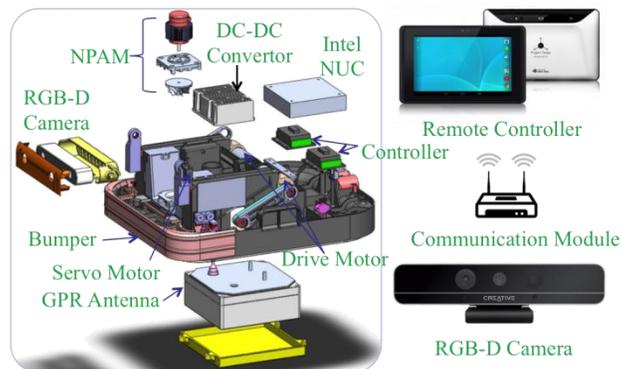
*Fig. 1 The electrical components and sensors in wall-climbing robot.*

We produce a wall-climbing robot prototype as shown in Fig.1. It consists of a negative pressure adhesive module (NPAM), a pressure sensor, two drive wheels and the associated motors and controllers, one servo motor to adjust the camera tilt angle, a bumper, a DC-DC converter, an Intel NUC computer for on-board image/signal processing. It maintains a constant negative pressure inside a suction chamber by adjusting the propeller speed of the NPAM to achieve a desirable balance of strong adhesion and high mobility. Since it doesn't require perfect sealing as vacuum suction techniques would, it can thus move on both smooth and rough surfaces, and cross over shallow grooves. It carries a RGB-D camera on a tilt mechanism in the front to adjust the viewing angle. The RGB-D camera not only produces regular Red-Green-Blue (RGB) video images but also provides distance measurements. The remote control graphic user interface (GUI) on a tablet computer commands the robot motion, adjusts the suction power, controls camera view angle and LED lighting, and displays the first-person-view of the scene transmitted from the video camera through WiFi communication. The robot has a dimension of  $16.5 \times 13 \times 8$  inches with self-weight 12 lbs. It can carry a payload up to 20lbs.

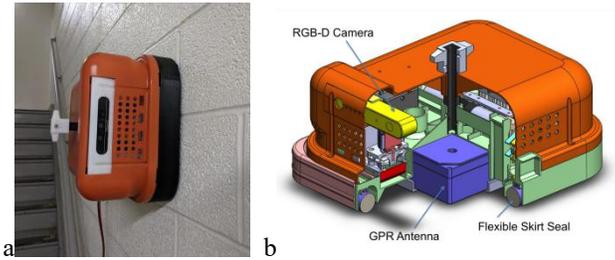
Fig. 2 The Wall-climbing robot prototype, a) Wall-climbing adhere to vertical wall, b) It carries an RGB-D sensor in front, and a GPR antenna at the bottom, inside a chamber enclosed by the flexible skirt seal.

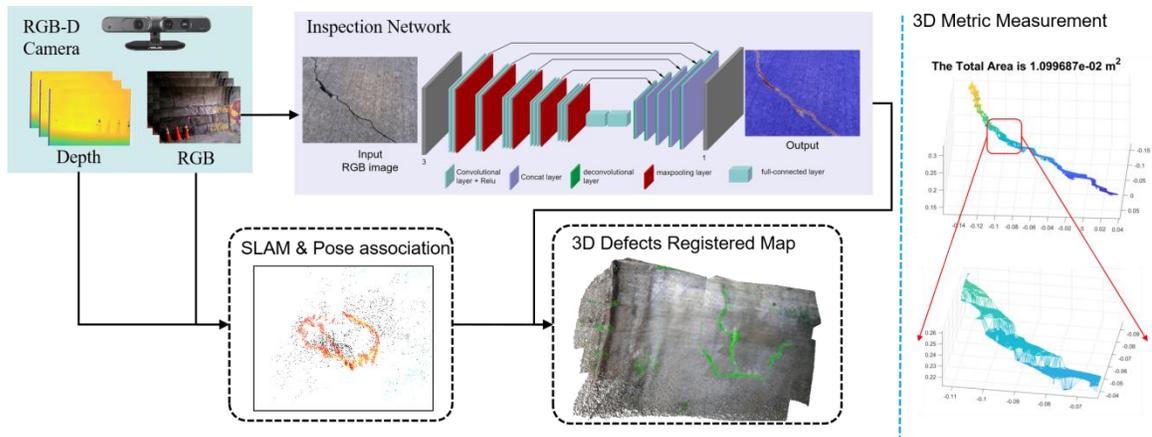
Fig. 3 The semantic 3D inspection system pipeline. The input from RGB-D sensor consists of RGB image and depth image. Then, our deep inspection network performs semantic detection of crack and spalling. Meanwhile, the visual SLAM system perform pose estimation and fuse the detection result to form a semantic 3D map as well as metric measurement.

To perform metric 3D inspection of the concrete structure, we propose to use an RGB-D camera based semantic reconstruction system as illustrated in Fig.3. For an RGB-D camera, it outputs both RGB image  $I = \{(u_i, v_j, c) \in R^3 \mid 0 \leq i \leq n, 0 \leq j \leq m, c = 0,1,2\}$ , and the corresponding depth image  $D = \{d\}$ . Then, we can obtain the point cloud at the each pose  $T = (R, t)$  using pinhole model as,

Since we have the pose  $[R, t]$  and the inspection result over the images, we propose to use a 3D conditional random filter based fusion to obtain the semantic 3D map. The registration is performed using Equation (1) and Equation (2), meanwhile, we keep updating the color information coming from the inspection network. Thus, we can keep continuously updating the map when we move the RGB-D camera.

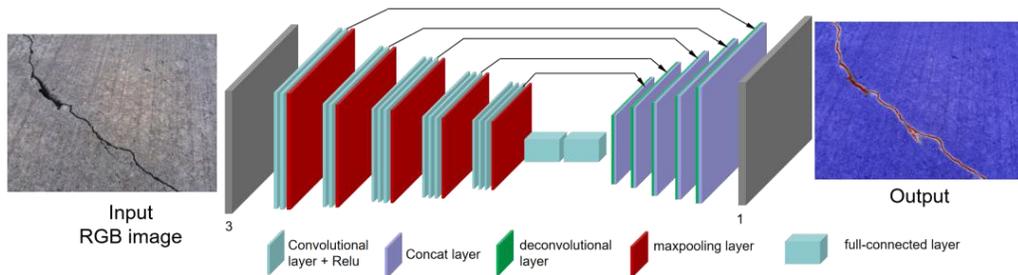
*Fig. 4. Illustration of InspectionNet architecture for spalling/crack segmentation with pixel level accuracy.*

Second, we adopt the U-net style deep neural network to perform end-to-end full pixel level segmentation as shown in Fig. 4. The InspectionNet consists of 25 layers, with the first 15 layers on the left are initialized based on VGG-16 as the pre-feature-extraction layers, and on the right side 10 convolutional layers (5 groups of deconvolution and convolution operations) to do upsampling. The defects are classified as either spallings or cracks with pixel level accuracy, enabling the quantitative measurement (e.g., the crack width, the area and depth of spallings) with the help of depth scale information obtained from the RGB-D camera.

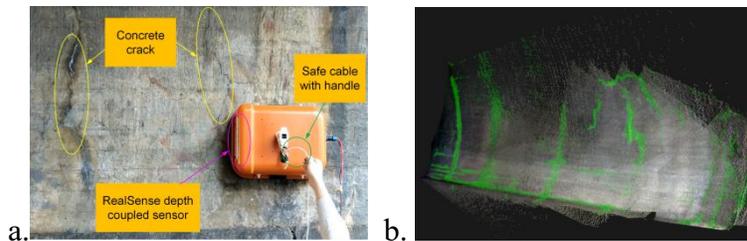
Fig. 5 Field testing results, a) deploy the robot on a vertical wall of a bridge tunnel, b) register the defects (green) in 3D point cloud map of the bridge tunnel.

We perform a field test to inspect the bridge tunnel at Riverside Drive and West 155<sup>th</sup> Street, New York City, NY 10032, whose results are illustrated in Figure 5. The inspection results (cracks in green) are registered in the concrete structure 3D model for better visualization and also provide a metric measurement for condition assessment and monitoring.
