INTRODUCTION

METHODS

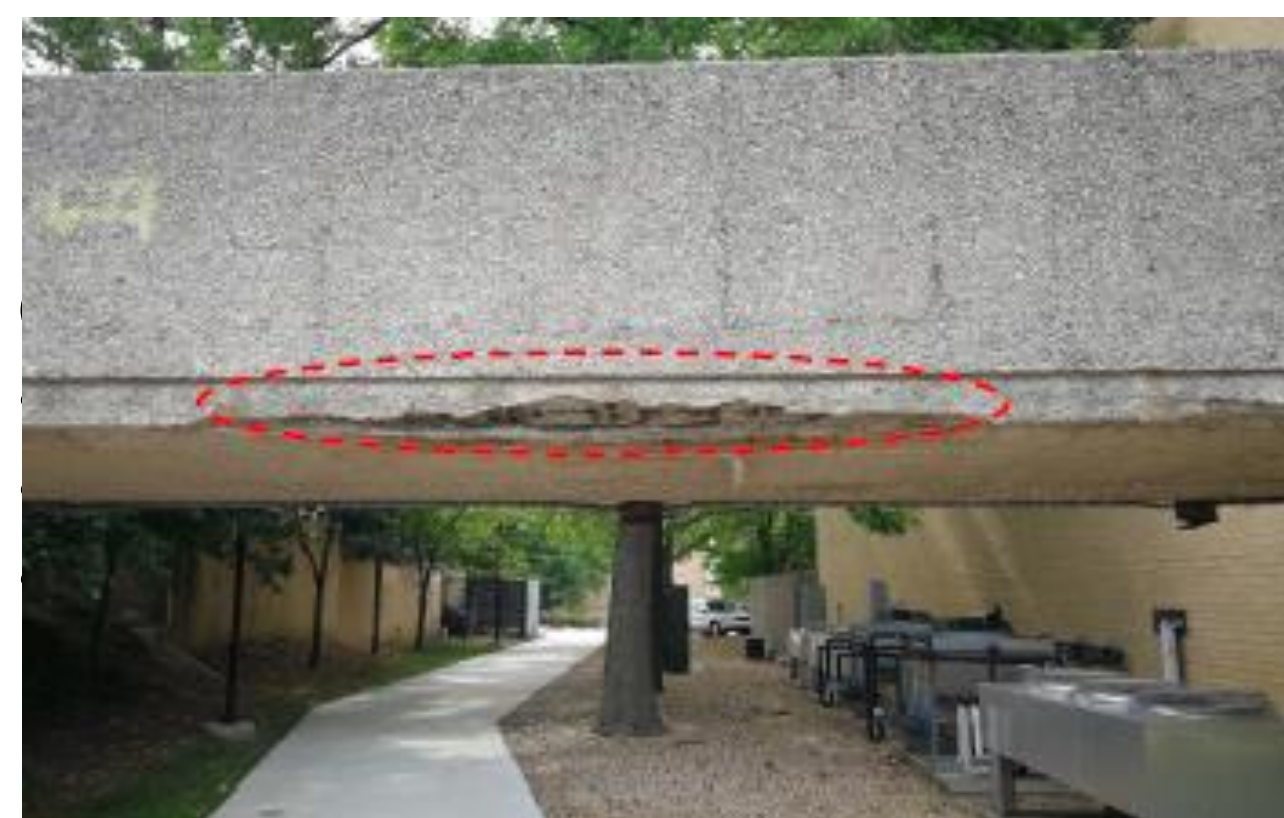
Bridge deterioration

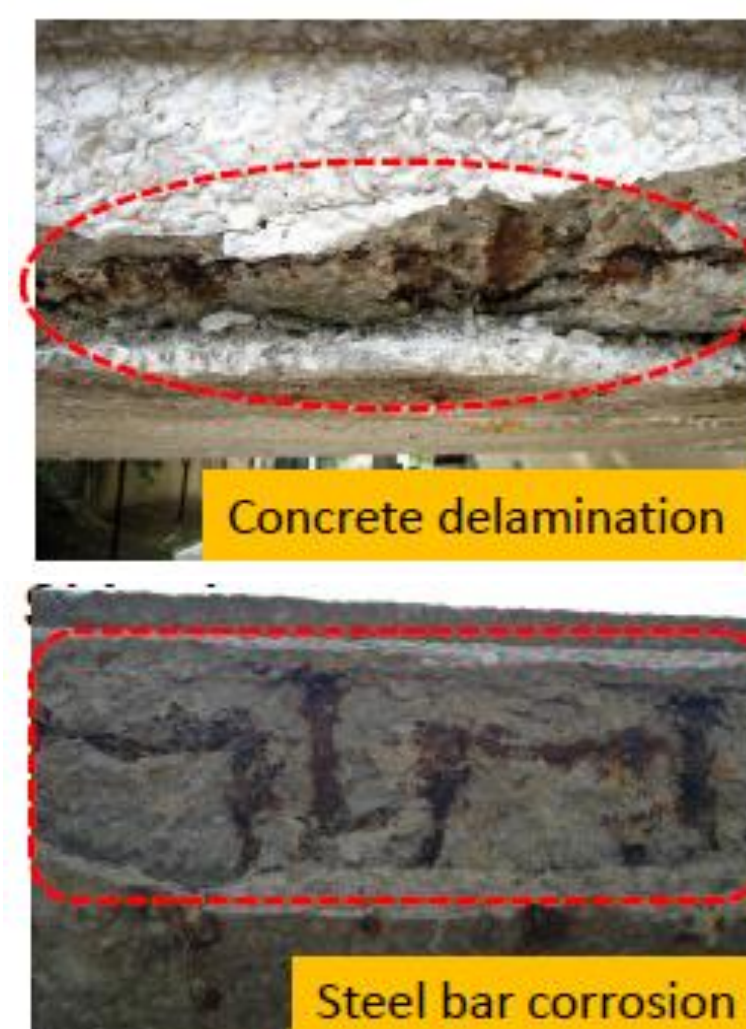
Concrete delamination

Steel bar corrosion

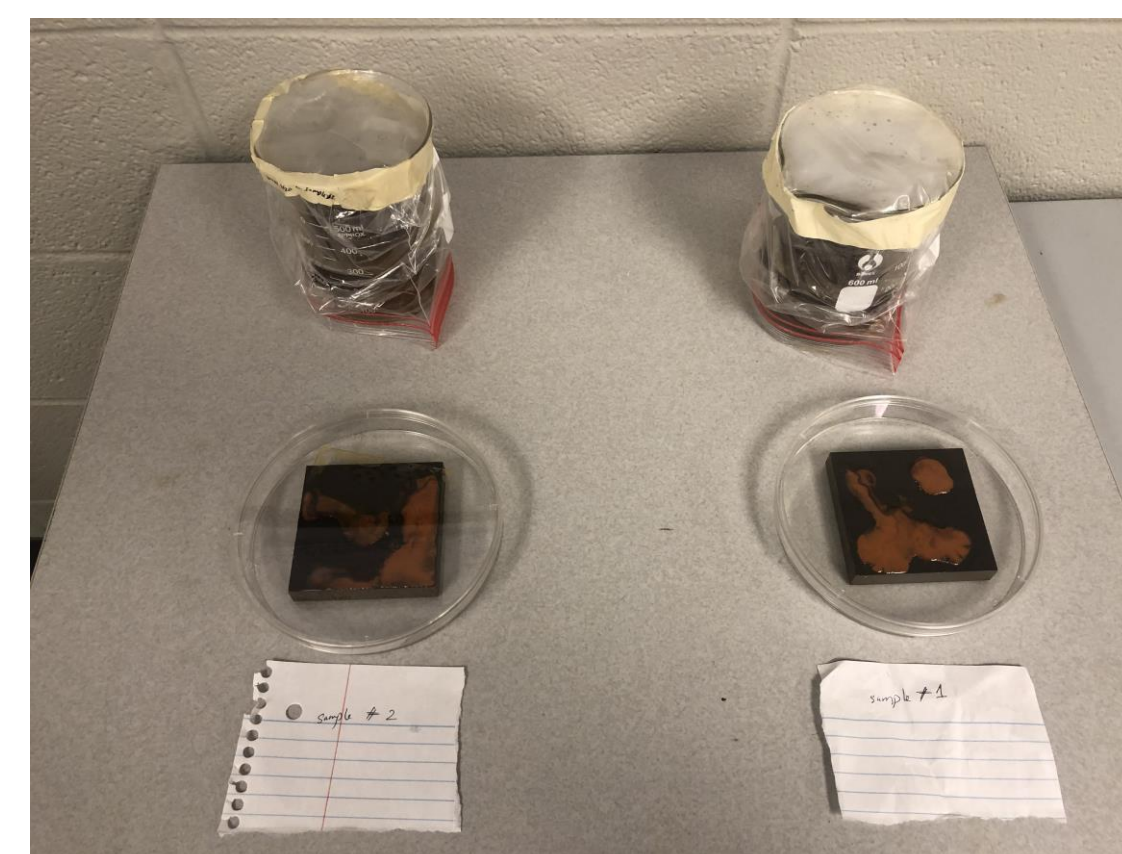
Samples preparation

Steel samples were corroded using two mechanisms of half immersion of some samples and applied droplets on other samples' surfaces. NaCl solution concentrations of 18 g of NaCl in 500 ml of tap water and 36 g of NaCl in 500 ml of tap water were used during corrosion process.

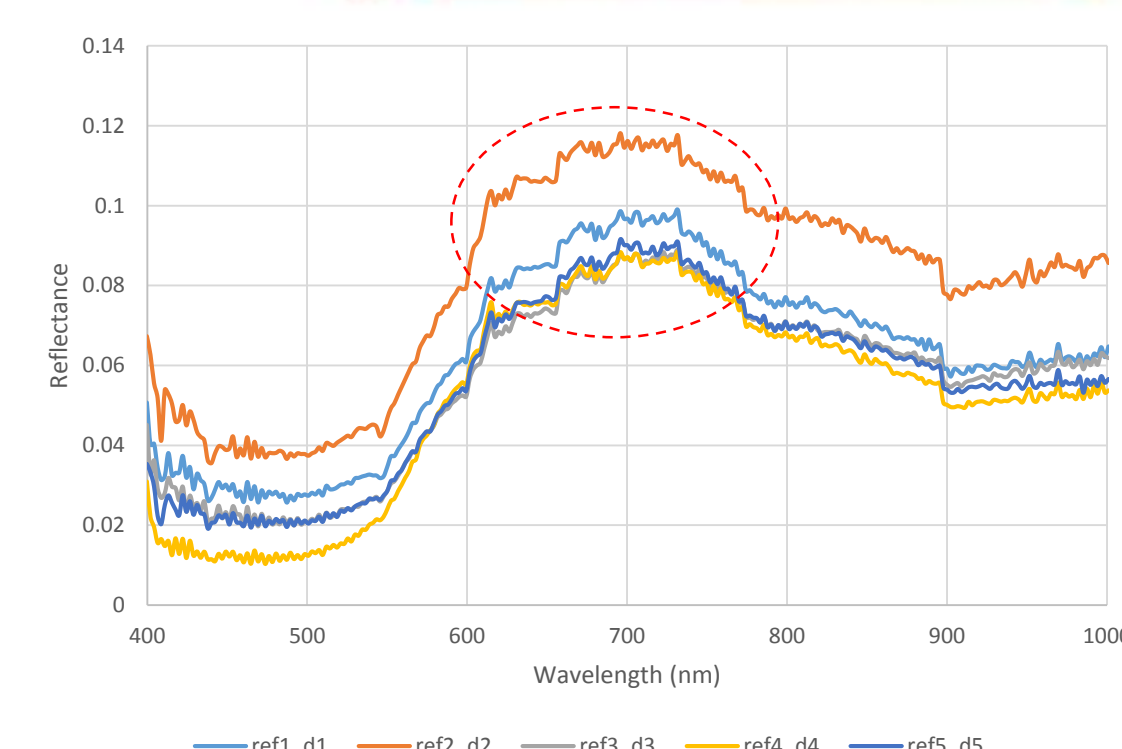
Average reflectance of pitting corrosion locations on a steel sample surface after 71 days (1704hr) of applied drops of 36g of NaCl solution

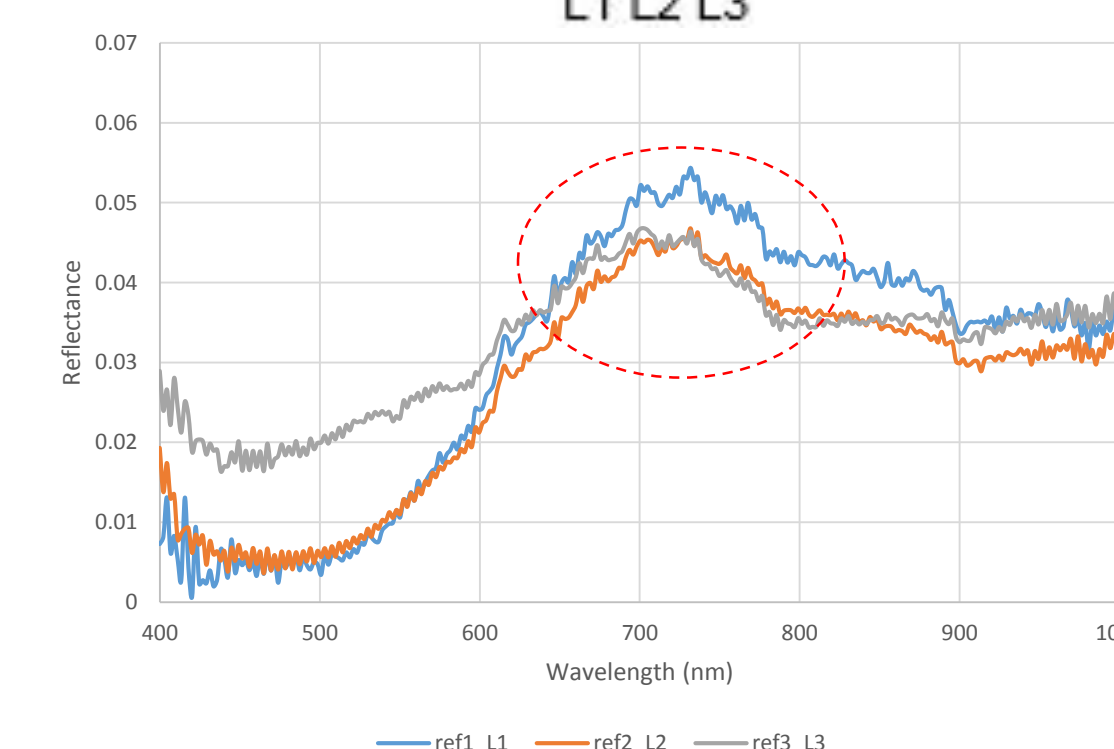
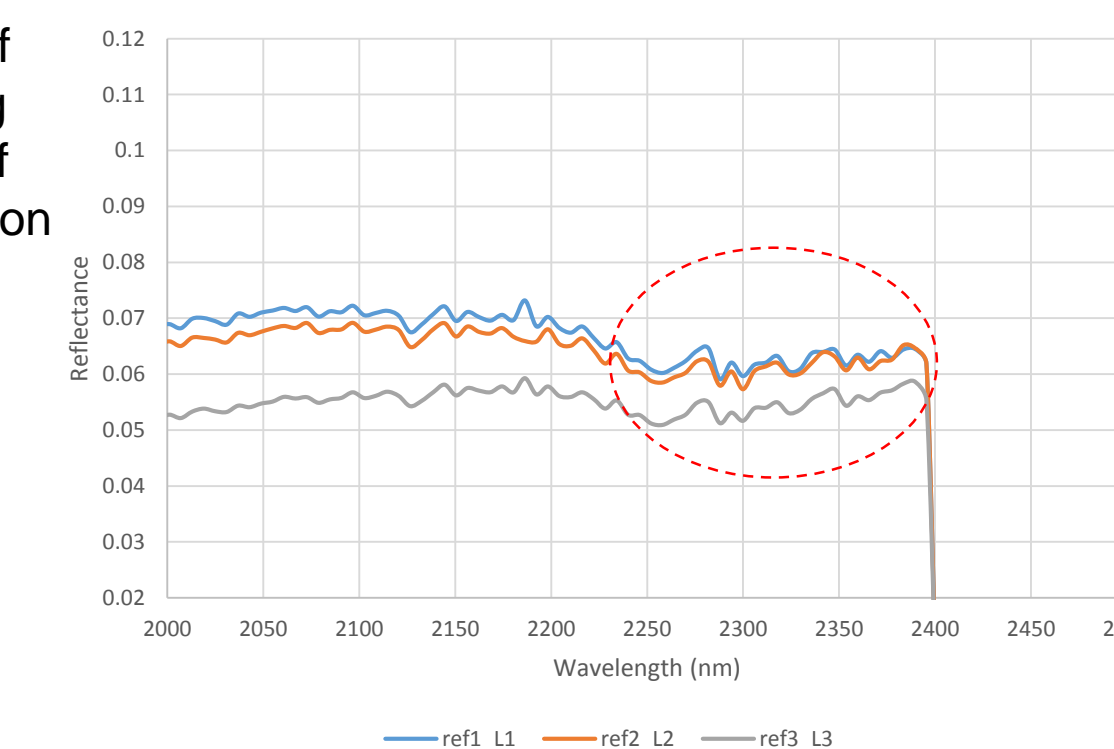
Average reflectance of transitional zone between the corroded and non-corroded half of a steel sample after 71 days (1704hr) of immersion in 18g of NaCl solution
