Evaluation of Rock Fall Hazards using LiDAR Technology

Evaluation of Rock Fall Hazards Using Lidar Technology

Norbert Maerz¹, Travis Kassebaum², Ken Boyko¹ and James Otoo³

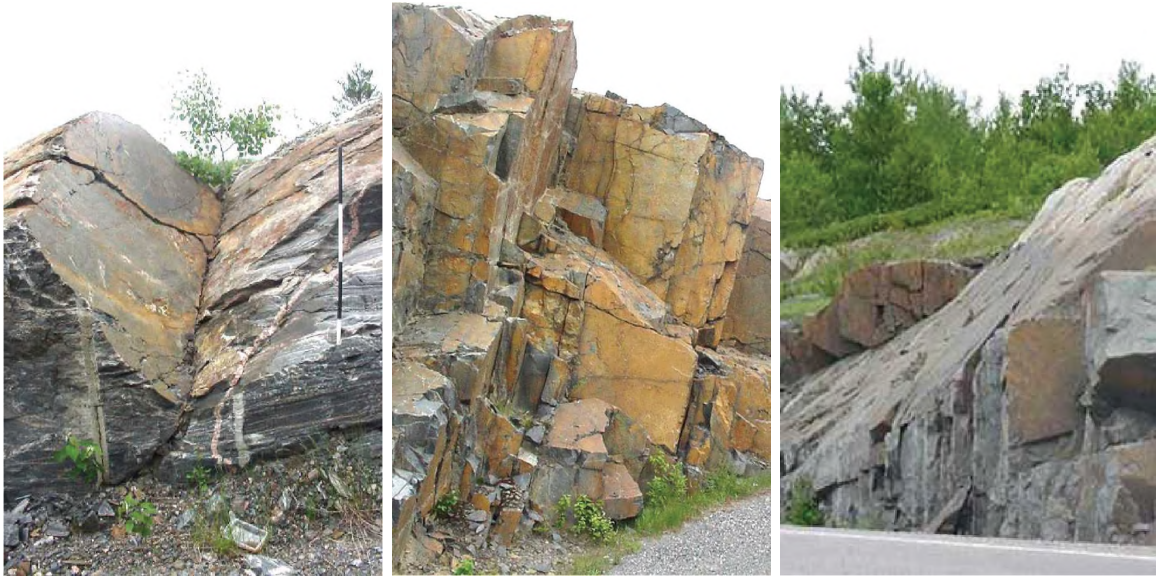
Fig. 1 Example of (a) wedge; (b) toppling; (c) planar failures along road cuts.

Many of these failures result because of release along planar cracks or discontinuities in rock mass. Whether or not failure occurs will depend on the orientation of the cracks, individually or in combinations (Fig. 1). The cracks or discontinuities tend to cluster in terms of their orientations into typically three or more sets, which tend to be mutually orthogonal, or roughly at 90° to each other (Fig. 2). Knowing the orientations of the discontinuities, it can lead to stability prediction based on well-established analytical tools [1].

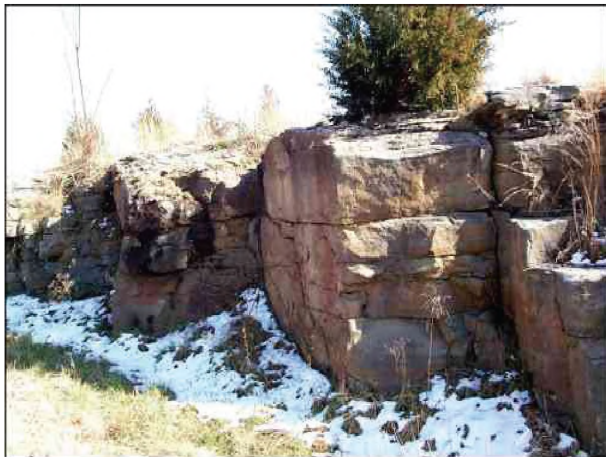
Fig. 2 Orthogonal nature of joint sets. Measurements of the “cracks” or discontinuities are displayed in Fig. 3.

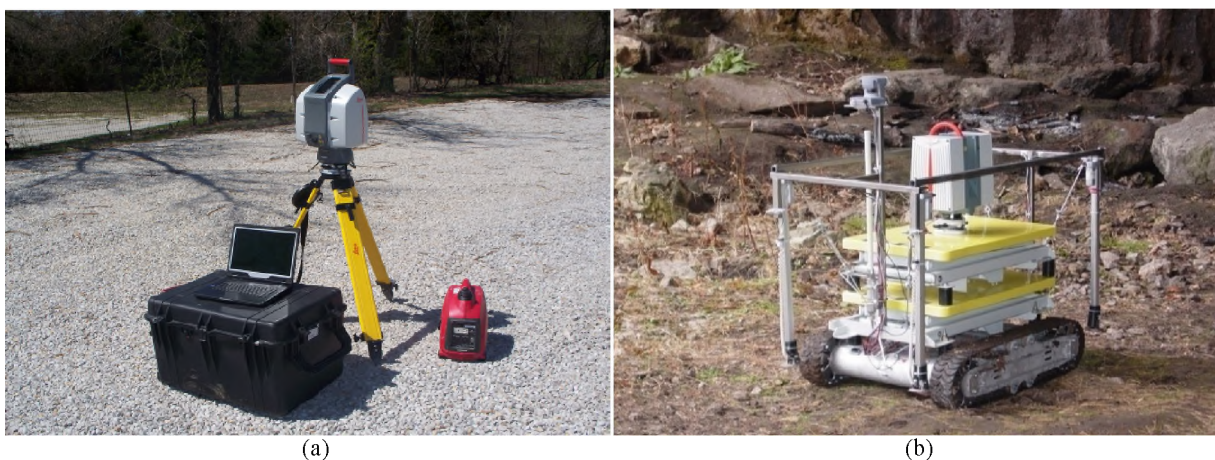
Fig. 7 (a) Leica ScanStation II time of flight scanner with integrated optical camera; (b) Leica HDS 6000 phase shift scanner on remote controlled robotic buggy.

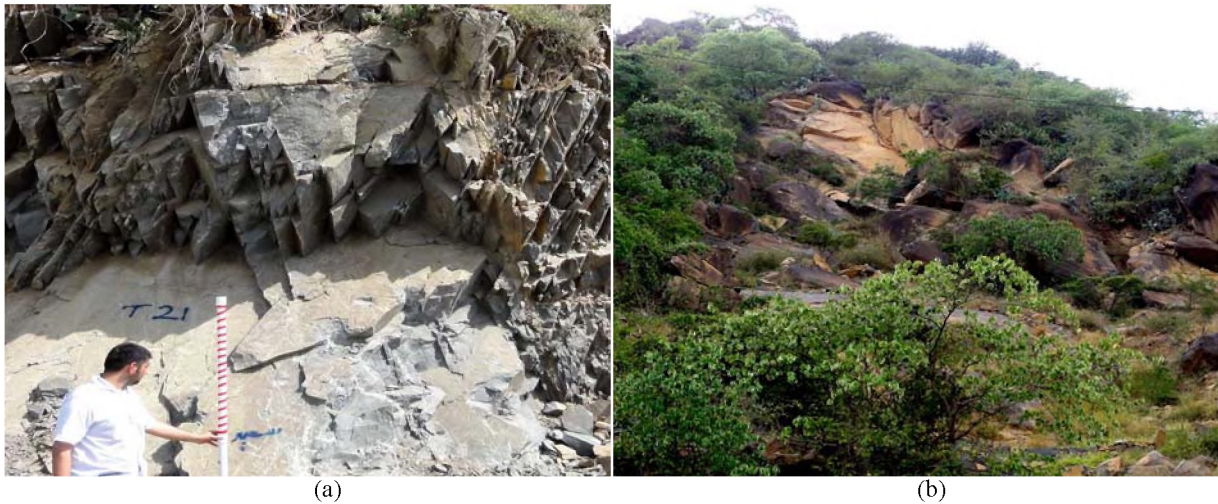
Fig. 8 (a) Rock faces with 100% coverage of natural joint surfaces; (b) rock faces with significant ambiguity as to the location of natural joint surfaces.

feature in the scan. In addition, since only a single lidar scan is sufficient, no image registration is required. It must be noted that in the case of the Leica ScanStation II, the optical image is automatically registered to the scanned point cloud. Two types of rock faces/cuts are possible (Fig. 8). In the first case, some rock faces are composed almost exclusively of natural discontinuity surfaces. The orientation of each of these surfaces can be and should be measured. These are conducive to automatic or semi-automated analysis as described in Refs. [32-39]. Fig. 9 shows an example of an automated analysis of such a rock face, in which the discontinuity measurements are clustered into sets and each resulting set is represented by a different color.

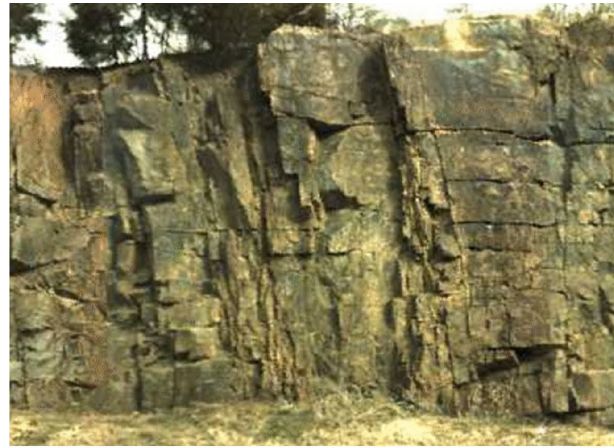
Fig. 11 Rock cut selected for verification study.

Figs. 11 and 12 show the results of a small verification study where lidar measurements are compared with manual measurements using a Brunton compass.

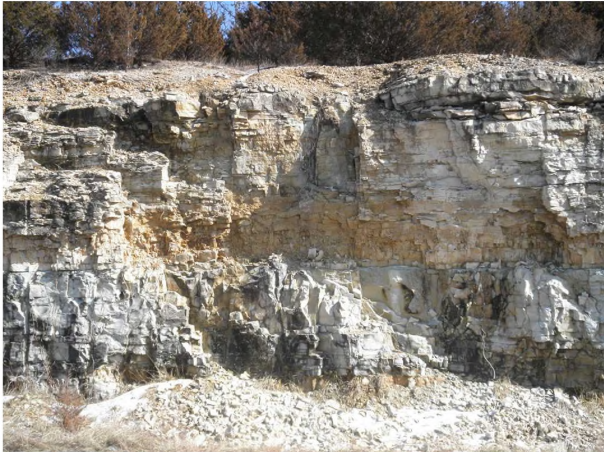
Fig. 13 Scan section of a rock face near a local quarry.

To quantify raveling of rock, scans of a raveling rock face are taken over a period of time. Again, to simplify and speed up the process, no survey control is needed, it is simply required to position the lidar unit in the approximately same place and scan approximately the same area. Algorithms for automated registration are used to superimpose the two scanned sets and then the volume differences between the two sets are measured and displayed. Fig. 13 shows an example of a raveling

rock cut in weathered dolomite. Fig. 14 shows the results of three sequential measurements with the missing pieces highlighted for a 6 month pilot study.
