Analysis of the Behavior of the Piled Foundations of a Group of Earthquake Damaged Buildings

ANALYSIS OF THE BEHAVIOR OF THE PILED FOUNDATIONS OF A GROUP OF EARTHQUAKE DAMAGED BUILDINGS

ABSTRACT

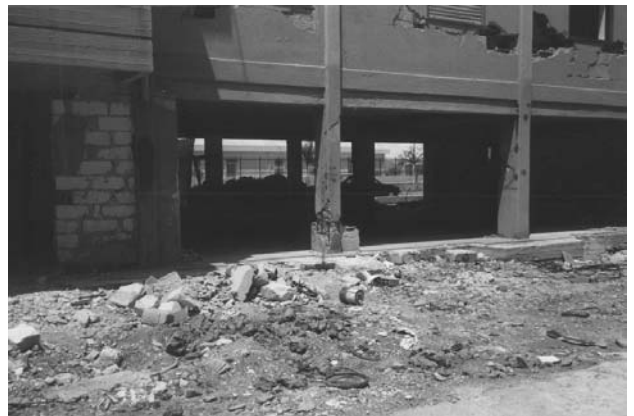
A group of reinforced concrete buildings with 228 flats, located in the Saline of Augusta site, were heavily damaged (Figure 2) by this earthquake of moderate magnitude ($M = 5.4$). To evaluate the possibility to repair these buildings, an investigation on soil, building foundations and structures was carried out.

Fig. 2. Damages occurred on buildings.

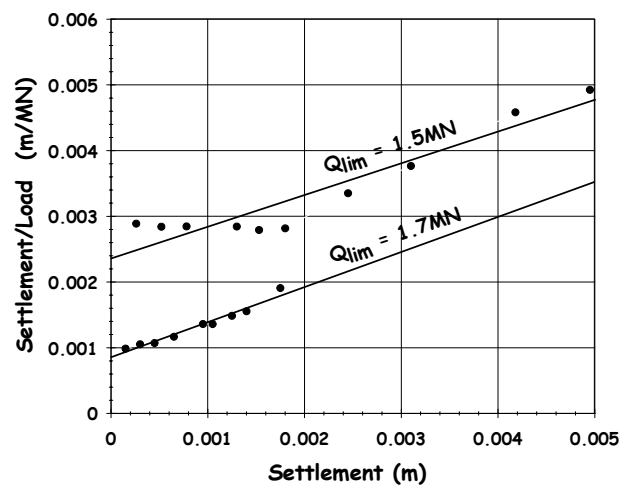
According to this procedure the ultimate failure load derived by the load tests is ranging between around 1.5 MN and 1.7 MN (Figure 15), in a very good agreement with the value of 1.53 MN computed in undrained conditions by the well-known Vesic's pile capacity relationships.

The safety factor of the soil-pile system derived by the back-analysis of the load tests is greater than 3, thus the effectiveness of the piled foundation was considered able to support axial loads, instead of the damages occurred on the structures due to the earthquake.

Fig. 15. Evaluation of the ultimate vertical failure load.
