Deep Foundation Construction in Bouldery Bed: An Overview

R. K. Dhiman

DEEP FOUNDATION CONSTRUCTION IN BOULDERY BED AN OVER VIEW

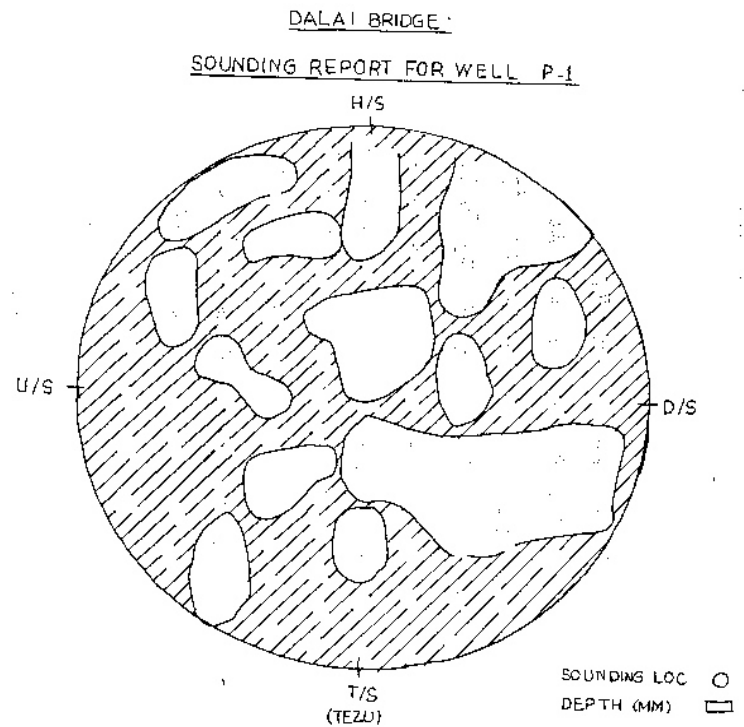
Figure : D3

(a) The soil strata plan at RL 7.50 is indicated in Fig.(D3).

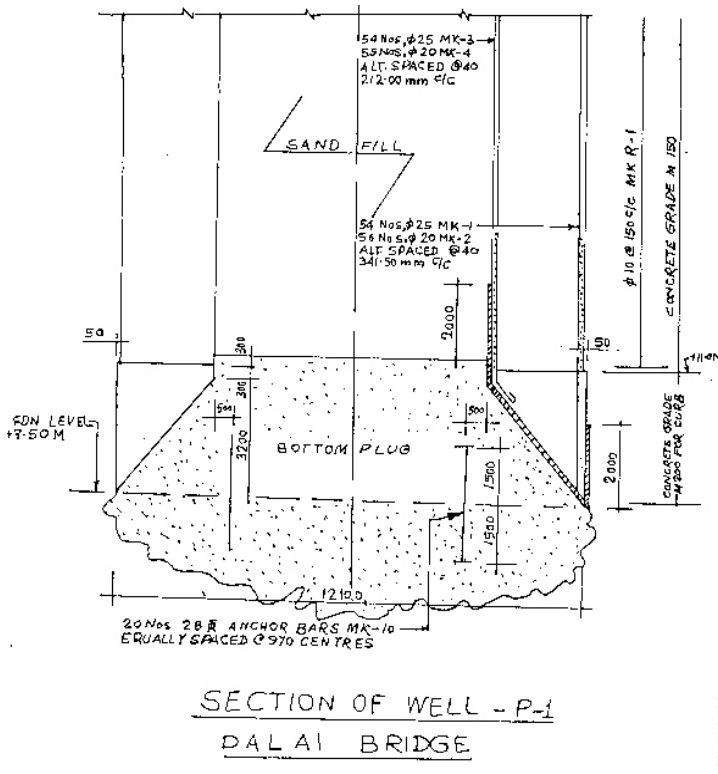
Figure : D4

(b) Well Curb was anchored with the ground with anchor bar as indicated in sketch. Fig (D4).
