## BEHAVIOR OF A FRICTION-PILED BOX FOUNDATION FOR AN URBAN BRIDGE IN MEXICO CITY CLAY

### ABSTRACT

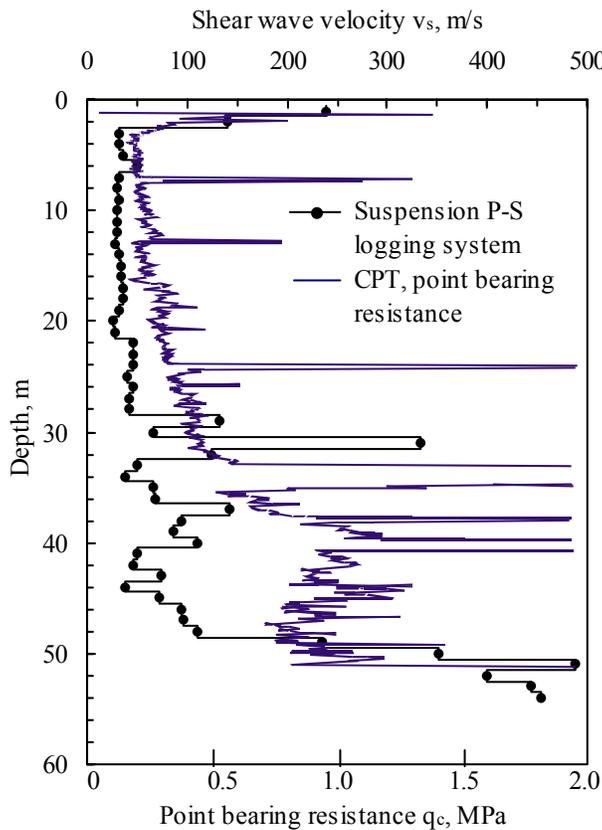
Fig. 1. CPT and shear wave velocity profiles.

The site of interest is located in the north-eastern virgin portion of the Lake Zone, characterized by thick deposits of very soft lacustrine clay, interbedded with silty-sand lenses. After a shallow superficial dry crust that was removed by the excavation, young and normally consolidated clays, with a mean value of 346% for the natural water content show up. The mean undrained shear strength of the upper clay formation (UCF), for the top 30 m, was only 12.6 kPa, determined by UU triaxial tests and CPT, Fig. 1. Its reduced stiffness was verified by field determinations of shear wave velocities by means of the P-S logging system; a mean value of 35.5 m/s was measured. Underlying the UCF lays a layer of lightly cemented silty sand, 2 m-thick, locally known as the first hard layer (FHL). It is followed by the lower clay formation (LCF) and then, from 52 m-depth, a harder formation of cemented silty sand with gravels, called the deep deposits, is found.

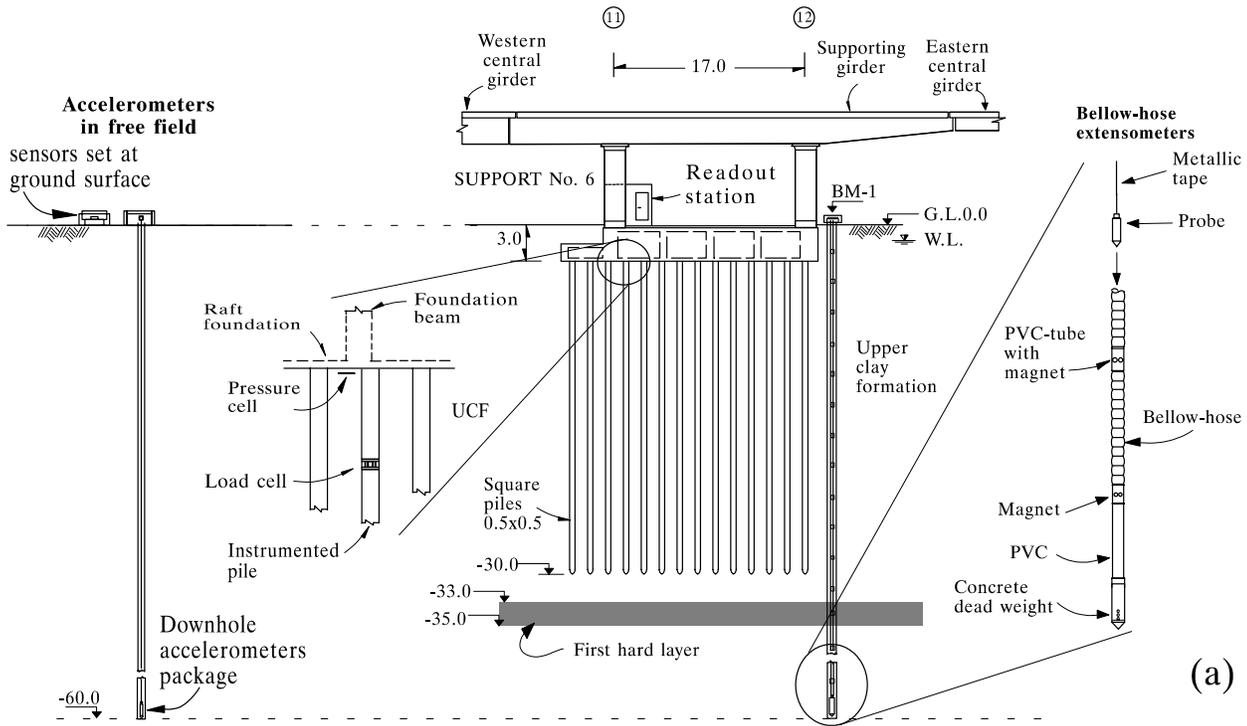
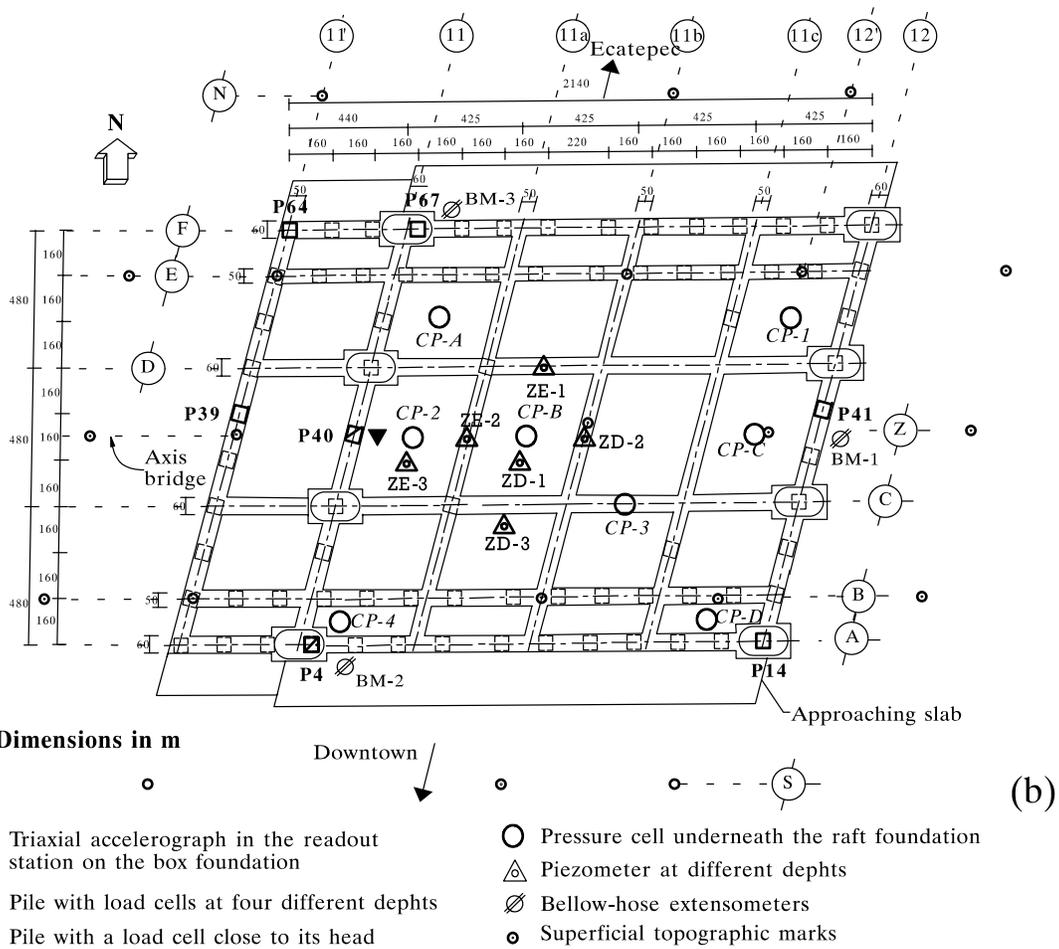
Fig. 2. Layout of the instrumented prototype foundation

The profile and the plant of the instrumented foundation are depicted in Fig. 2. It consists of a reinforced concrete hollow box, 15 m wide, 22 m long and 3 m deep. It has a rhomboidal shape in plan, according with the oblique-angled intersection of the merging avenues. 77 precast square piles (0.5 m of side) were driven (no prebored) before the excavation for the box foundation, and coinciding with the foundation beams. Their tip reaches a depth of 27 m and they work primarily by friction; about 3 m clay cushion was kept to guarantee enough space for future foundation settlements, mainly due to ground subsidence induced by aquifer water withdrawal. This box supports eight columns in two axes that carry the deck-supporting box girders of the bridge; these elements in turn, carry the central prestressed concrete box girders in both sides of this Support No. 6, under freely supported condition.

The instrumentation consists of eight pressure cells distributed in the raft-soil interface, six piezometers laid down to different depths below the foundation, and thirteen load cells integrated to seven piles. The location of the instrumented piles within the foundation is depicted in Fig. 2. Load cells in piles were integrated to them near (2.0 m) the union with the foundation beams. In two of them three more cells were included to other depths. The objective in this case was to measure the axial force transmitted to these piles, and to know how they transfer the load to the surrounding soil through the pile shaft and tip base. The loading element in load cells is a thick-walled, high-strength steel cylinder instrumented with strain-gauges. Each cell was integrated to segments of the pile by placing them between steel plates, Fig. 3, that were fixed to each other by high-strength steel bolts, providing some prestress. The supporting plates were then welded to the reinforcement steel of the pile segments, assuring their structural continuity.

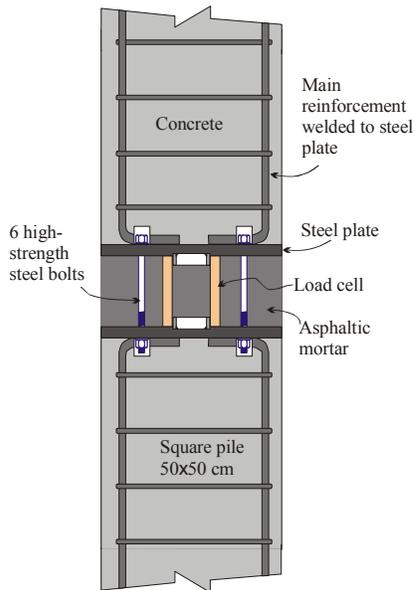
Fig. 3. Load cell in an instrumented pile

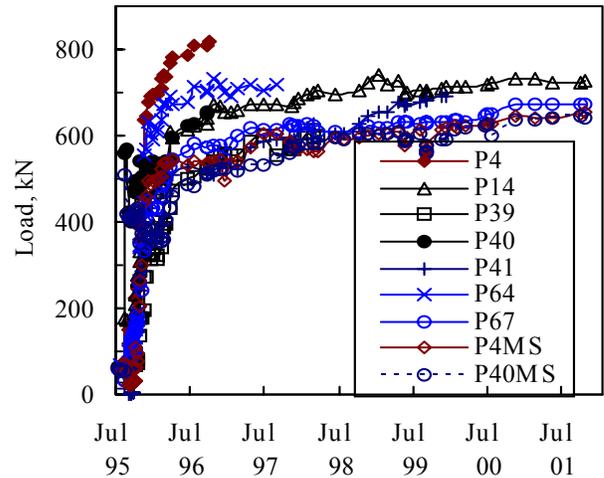
Fig. 5. Evolution of loads on piles.

It is worthwhile to notice that corner piles and one at the long-edge carry heavier loads than do interior and short-edge piles. This agrees with which has been measured by other researchers (Hansbo, 1984; Sommer, 1985; Jendebay, 1986). This fact is also in agreement with the theoretical solution given by Poulos (1968) for a rigidly capped pile group.

Loads have been measured near the head of seven piles, since the beginning of construction, as it is depicted in Fig. 5. Loads carried by the piles at the end of bridge construction were not evenly distributed. There was a maximum to minimum load ratio of 2.35 (Dec., 1995). However, six months later, when the bridge was opened to vehicle traffic, this ratio had decreased to 1.56. This non uniform distribution was mainly due to uneven or temporary eccentric loads on the foundation system, because construction operations like pile driving, ground excavation, and girders lifting.

Loads on piles kept on increasing, albeit at small rates, at apparently constant load after the end of bridge construction. This load gain was found to be caused by water flooding of the foundation-box-cells, as verified in the field. Also, the

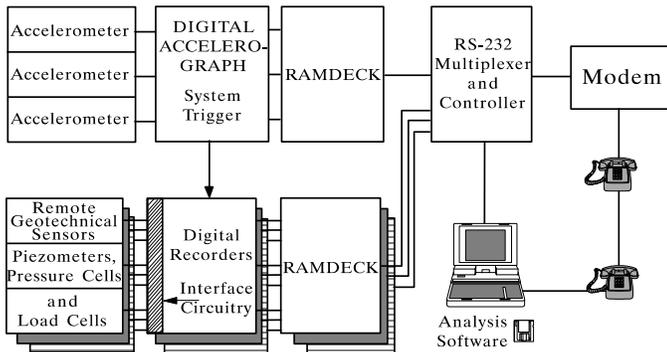
Fig. 4. Automatic data acquisition system for seismic events.

Portable readout apparatus were used during construction, and now under operation, to record the geotechnical variables under sustained loads. Vibrating wire and electric resistive-type strain gages sensors were involved. A digital triaxial accelerograph was attached to the box foundation. Additionally, two triaxial accelerographs were installed later. One is located on the ground surface in free field, 60 m far from the foundation. The other one lays down in a 60 m-deep well in the Deep Deposits, precisely in the vertical of the surface sensors. Fifteen of the resistive-type transducers, eight load cells, four pressure cells and three piezometers were continuously monitored, in order to record the effect of earthquakes. Five 16-bit digital recorders were implemented for this task, controlled by the accelerograph which triggers the system when an acceleration threshold is reached. The master-slaves array is shown in Fig. 4. A rate of 250 samples/second is used for recording each channel.

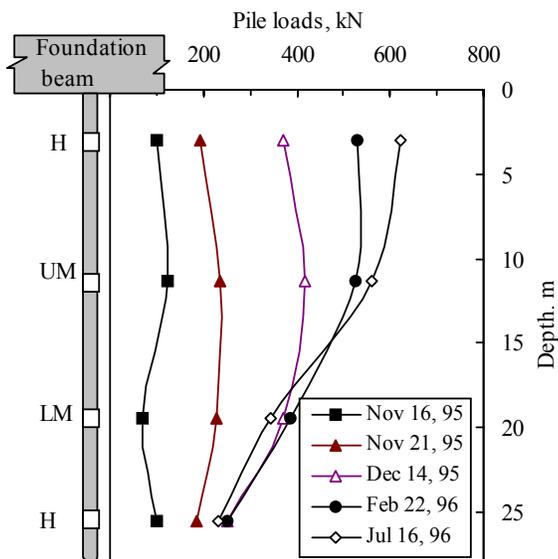
Fig. 6. Time-varying load-transfer curves for pile P4

Piles P4 and P40 were instrumented with four load cells along their length. The cells at pile P4 have responded consistently throughout the initial period of measurement, yielding valuable information regarding the load-transfer phenomenon at pile-soil interface. The load distribution-depth curves are included in Fig. 6. These results show that at all times positive skin friction developed along the full length of the pile, except for a short period, at the early construction stages, near the pile tip where small negative skin friction seemed to develop. It is interesting to observe that, for friction piles in a very soft clay deposit, the end-bearing load can be as high as 30% of the total reaction of the pile, and that the soil at the tip of the pile might be yielding.

Knowing the load-transfer mechanism (Fig. 6) the shear stresses along the soil-pile interface may be easily computed. At the end of the bridge construction the shear stress along the mid-third had reached the undrained shear strength of the adjacent soil; the upper and the lower thirds had developed smaller shear stresses than the soil strength.

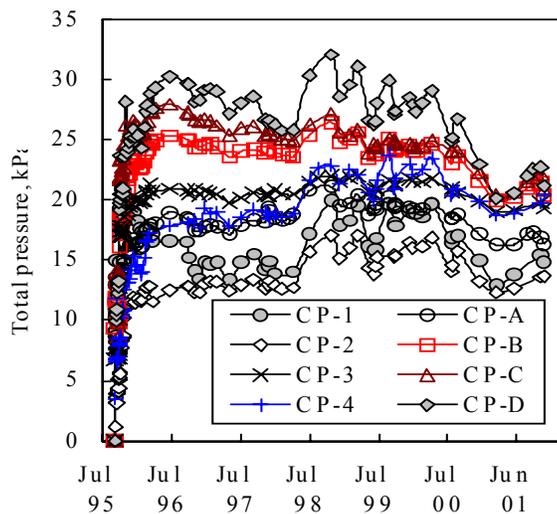
Fig. 7. Time-varying raft-soil contact pressures.

Observed time variations of soil-slab contact pressures follow a similar pattern to that of pile loads. Fig. 7 shows how the pressures increase with loading during the construction stage and remain more or less stable after the bridge was opened to vehicle transit. The soil-slab pressures measured across the foundation vary spatially. The maximum to minimum pressure ratio of 2.42 at the end of bridge construction reduces to 1.93 after three-year period of bridge operation. Tendency to contact pressure homogenization, as in the case of piles, appears indicative of larger soil deformations at the areas where higher pressures existed initially. Total pressure fluctuations seem to be related to seasonal changes of ground water level.

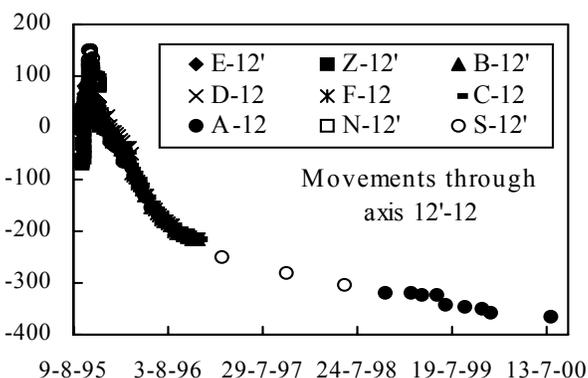
Fig. 8. Time-varying settlements curves

Continuous levelling surveys of the foundation have been carried out since its construction up to date. Initial heave due to piling and subsequent settlements of the box foundation are depicted in Fig. 8. Maximum settlements are 45.2 cm at the axis 11 (see Fig. 2), and 40.8 cm at axis 12, five years after the bridge began its construction.

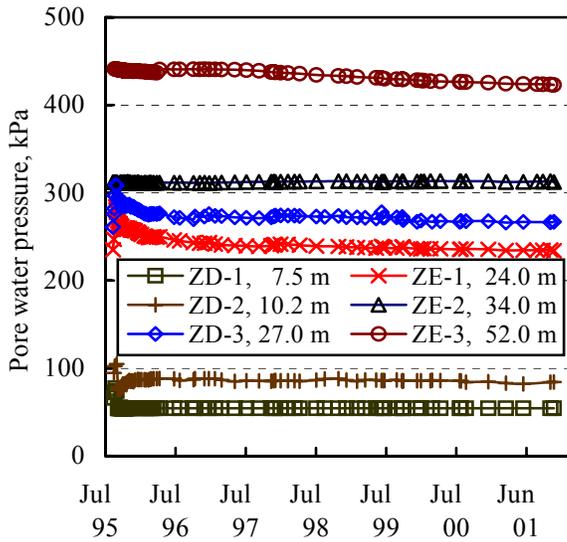
Fig. 9. Time-varying soil pore water pressures.

The piles were driven by hammer impacts without any preboring, except along the top dry crust. As a result, some 500 m<sup>3</sup> of soil were displaced causing compression and distortion of clayey soils. The highest pore water pressure induced by these effects was about 21% of the hydrostatic pressure near the pile tip elevation (piezometer ZD-3, at a depth of 27 m) as depicted in Fig. 9. Pore water pressure increments measured by the other piezometers were smaller. Time-pore pressure graphs show that the maximum pore water pressure was recorded by piezometer ZD-3. Afterwards it dissipated within a short period of time. This would seem rather surprising on account of the clay low permeability (10<sup>-8</sup> to 10<sup>-10</sup> m/sec). However, it has long been recognized that ground subsidence caused by aquifer water withdrawal has produced clay micro fissuring in many areas in Mexico City. Thus, it would be expected that pile driving operations, particularly when carried out with no preboring, activate them forming a net of fissures or cracks, allowing faster water

flow. It may be seen that the pore-pressure regime, established since the bridge was open to traffic, has not been modified within the clay layers. On the other hand, piezometer ZE-3, located at a depth of 52 m, shows a water level depletion of 4.5 m, which is attributed to aquifer water withdrawal. According to superficial surveys referred to a fixed point located at a relatively near rocky hill, this has already induced about 20 cm/year of ground subsidence at the foundation site.

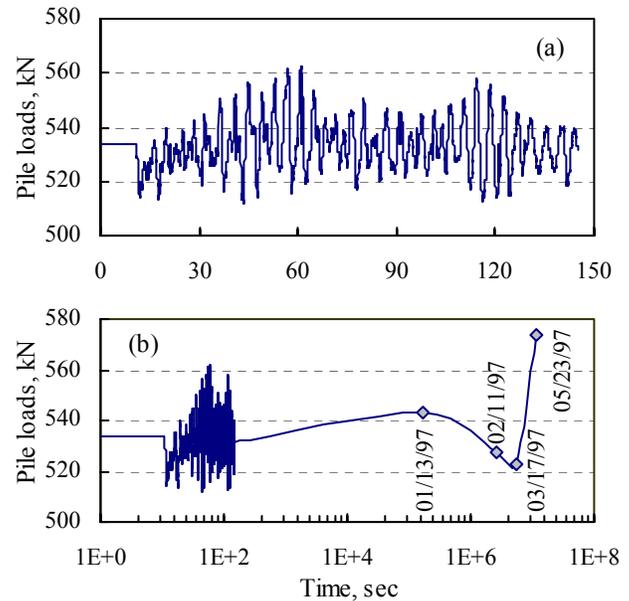
Fig. 10. History of loads on pile P41 during the January 11, 1997 earthquake

Loads on piles. The history of loads on the pile head P41 during this seismic event is shown in the Fig. 10a. It is distinguished that the maximum amplitude of the dynamic load was of approximately 25 kN, which represents 4.6% of the sustained load right before the earthquake. The recorded load-time history shows no degradation or decrease of the pile load capacity. The seismic event is completely transitory and after the shaking no change in the pre-earthquake loading is appreciated, Figs. 10a and 10b.

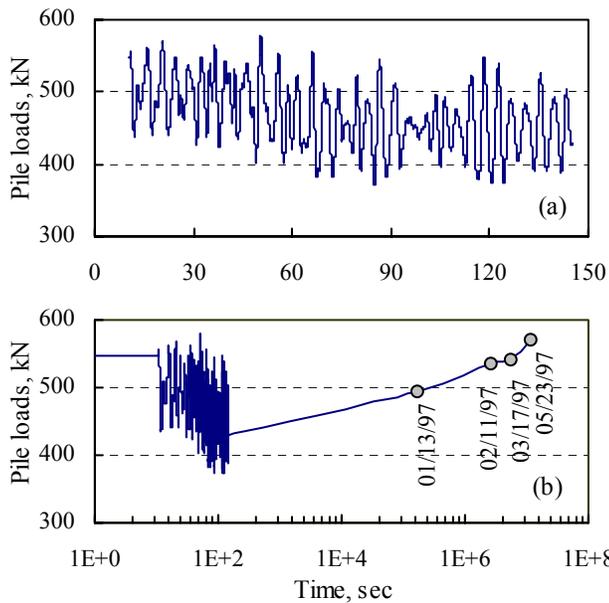
Fig 11. History of loads on pile P4 during the January 11, 1997 earthquake

The recorded signal at the pile P4 in its upper-medium cell, located 11.35 m below the foundation grade is depicted in the Fig. 11a. Larger changes are observed in the transient cyclic loads during the seismic event. Load amplitudes reach up to 88.3 kN. In this pile, some degradation on the load capacity is observed toward the end of the earthquake. This fact is related to the larger amplitudes of the cyclic loading regarding to the static capacity of the pile (Jaime et al., 1990). Observe that this pile is located in one of the long edges of the foundation plan, where maximum displacements caused by overturning moments occur; pile P41 in turn is in the longitudinal axis of the bridge, where lower rocking develops during the shaking.

Now, regarding the load increase after the earthquake halted (Fig. 11b), it may be explained on the grounds that shear stresses along pile-soil interface dropped from the dynamic to the static loading condition leading, by equilibrium conditions, to an increase on the load measured by the cell. This stress drop most likely did not occur instantaneously, as indicated by the load measured on Jan. 13, 1997. This load (495 kN) that is similar to the average load measured after the first load

pulse, keeps on increasing until the pre-earthquake load was reached on February 11, 1997. Afterwards, the load remains practically constant over a period of some 34 days, pointing out that seismic loading did not cause any appreciable fatigue damage to pile-soil interface materials. Then, the load increased again, perhaps due to water flooding of the box as contended previously and thixotropic effect.

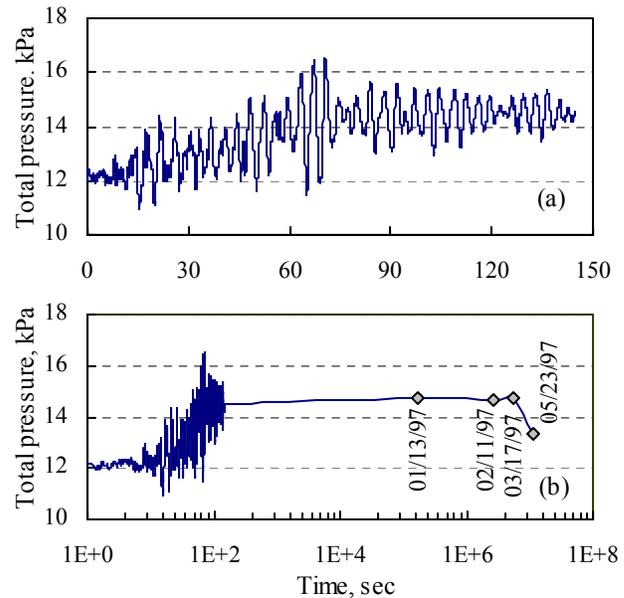
Fig. 12 History of vertical pressures at CP1 at the soil-slab contact during the January 11, 1997 earthquake.

Vertical pressure at the slab-soil interface. Pressure on the soil-slab contact exhibited transient cyclic low variations that attained larger amplitudes near to the long edges. Indeed, while the cell CP2 located in the axis of the bridge recorded an amplitude of 0.45 kPa, the cell CP1 placed near a corner reached a value of 2.5 kPa, as can be distinguished in Fig.12. The time-records in the four pressure cells reveal a gradual and cyclic increase in the total pressure as the earthquake proceeds, indicating that a phenomenon of transfer load from the piles to the soil-slab contact develops. This interpretation is consistent with the measured values with the portable digital readouts, under sustained loads. “Static” measurements of the geotechnical sensors were carried out on Dec. 19, 1996 (earlier to the 11 January, 1997 earthquake). Less than 48 hours after this seismic event, instrumental readings were repeated. While a decrease in the loads supported by the piles was measured, a small but clear increment on the foundation slab pressure was recorded. It is also convenient to highlight the recovery of the load supported by pile P4; from the load of 441 kN immediately after the earthquake, in less than two days the load increased to 494 kN. This could be explained by thixotropic effects of the clay around the shaft piles, and local consolidation near this same surface (Holmquist & Matlock, 1979). Afterwards, while load on piles increased, Fig. 11b,

contact pressures decreased, Fig. 12b. This is a clear manifestation of the pile-slab transfer mechanism

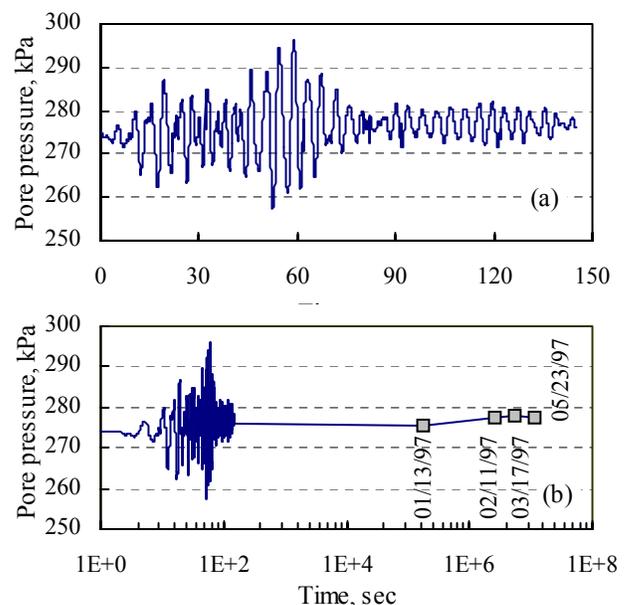
Fig. 13. History of pore water pressures in clayey strata to 27.0 m-deep during the January 11 earthquake, and later

Pore water pressure in the subsoil. This variable was recorded during the earthquake by means of the three quick-response piezometers, placed at different depths below the central portion of the foundation plan. The piezometer ZD1 laid down in a sandy stratum at the level  $-7.5$  m showed a cyclic and sustained very small increase of pressure, with double-amplitudes of not more than 3.5 cm of water column. The

piezometer ZD2 located ex professo in a clayey stratum to – 10.2 m reached dynamic double-amplitudes of 27 cm of column of water. However, the piezometer ZD3 located in a clayey stratum, but near the tip of the piles where some stress concentration develops, it exhibited pulses of larger amplitude (Fig. 13a). The maximum recorded amplitude was 1.88 m of water column, which is 6.7% of the hydraulic pressure before the earthquake. When shaking finishes, a very small residual pore pressure was observed. This denotes the transitory nature of the phenomenon. These results seem to point out that consolidation processes by earthquake-induced pore pressures are not relevant in Mexico City clay, at least at some distance from the piles. These measurements are in agreement with laboratory results of different research works. They indicate that the dynamic pore water pressure induced by cyclic loading is small, even near the failure (Romo, 1995). If significant pore pressures develop in the pile-soil interface, their effect seems to dissipate at relatively short distance from the pile.

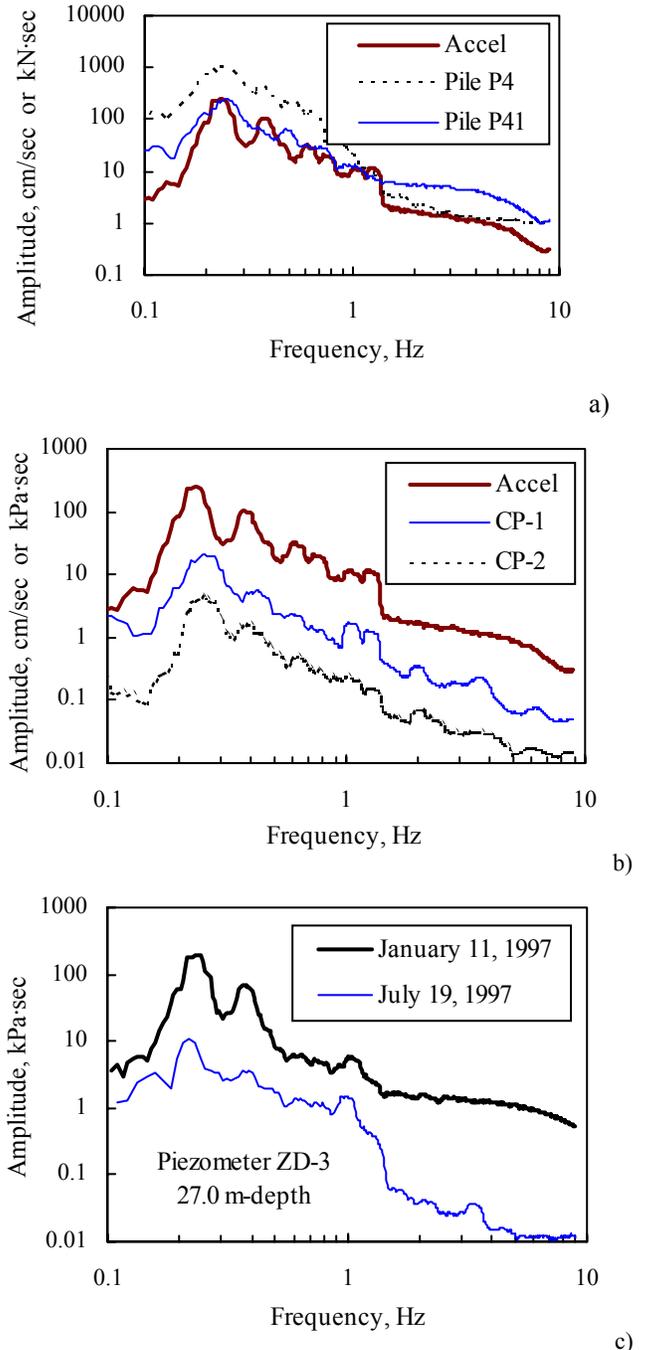
Fig. 14. Fourier spectra for longitudinal accelerations and a) loads on piles, b) pressures on foundation raft-soil interface and c) pore water pressures during two earthquakes

Fourier spectra of the loads recorded during the seismic event on piles P4 and P41, as well as the acceleration Fourier spectrum are shown in Fig. 14a. In a broad frequency range, pile loads and acceleration spectra have peaks and valleys practically at same frequencies. This fact is related to the large stiffness of the box-foundation system. The maximum amplitude in all three spectra occurs with a 0.24 Hz frequency, which corresponds to the dominant frequency of the free field. Pile P4 develops larger amplitudes than pile P41. This may be likely due to their location within the foundation. Since pile P41 is located at the edge of the foundation and almost on its longitudinal axis, it would be expected that the load be mostly caused by the rocking with respect to the transverse axis. Alternatively, this confirms that when the foundation is appreciably stiffer than the supporting soil, the loads induced by the structure-foundation rocking may be estimated by simple procedures.

Fourier spectra of the pressures recorded during the seismic event on cells CP1 and CP2 are compared in Fig. 14b with the acceleration spectra. It is remarkable the similitude of the three curves, although the maximum spectral amplitude of the pressure spectra shows a slight shift to higher frequencies with respect to that of the acceleration spectra. This could be caused by the coupled effects of foundation rocking and the higher-frequency vertical vibration of the box-foundation system. The larger pressure amplitudes on cell CP1 are explained on the basis of its location. While cell CP2 is near

Fourier spectra of the water pressures recorded by piezometer ZD3 for two seismic events are compared in Fig. 14c.

It is clear that all spectral curves are alike in their shape. The dominant frequencies of the system motions coincide with those of the geotechnical variables. This implies that these variables are in phase with the foundation movements.

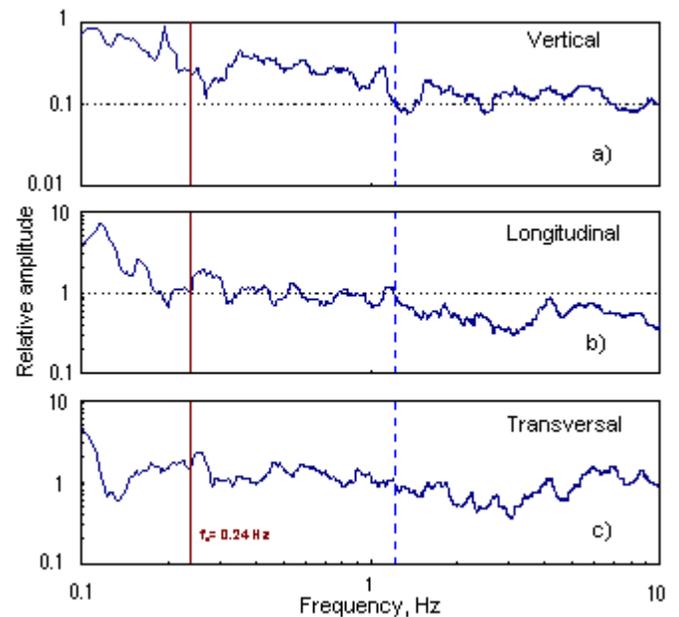
Fig.15. Transfer functions for the motions between the foundation and the surface free field. Tehuacan earthquake

A more detailed review of the dynamic interaction due to seismic events can be observed in terms of the transfer functions for all frequency domain. The transfer functions depicted in Fig. 15 were obtained as the ratio between the accelerations Fourier spectra of the foundation and the surface free field, for each component. A vertical reference line marks the fundamental frequency of the site (0.24 Hz). The transfer function for the vertical component shows an appreciable interaction effect in the entire frequencies interval, as indicated by the values of the relative amplitude always lower than one. On the contrary, lateral transfer functions make evident the low dynamic interaction; their values are around one throughout the frequency range.
