## Construction of Diaphragm Wall Support Underground Car Park in Historical Area of Bangkok

Narong Thasnanipan  
*SEAFCO Co., Ltd., Bangkok, Thailand*

## CONSTRUCTION OF DIAPHRAGM WALL SUPPORT UNDERGROUND CAR PARK IN HISTORICAL AREA OF BANGKOK

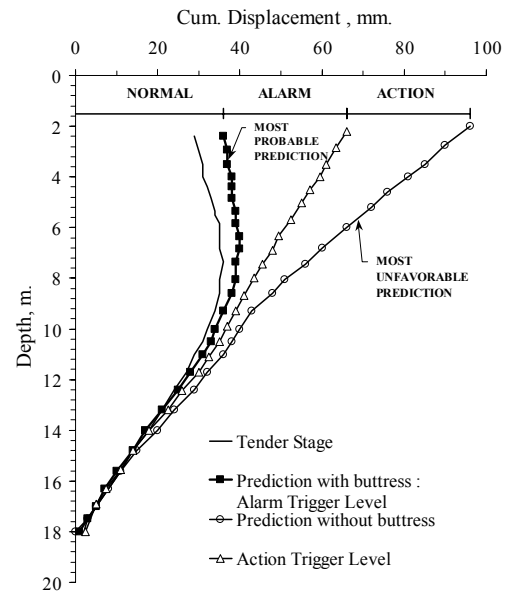
Fig. 6. Prediction of diaphragm wall performance in pre-construction stage with trigger criteria in comparison with tender stage prediction

Figure 6 shows the predicted diaphragm wall lateral displacement or deflection of Phase 1 (east, west and south diaphragm wall) at two conditions together with trigger levels and tender stage prediction. It should be noted that the diaphragm wall deflection was predicted to be maximum or most critical after removing the horizontal temporary strut.

Most probable condition was established for the predicted deflection of diaphragm wall with full influence of buttress support – assuming buttress effectively supports as permanent strut in diaphragm wall analysis model. Most unfavorable condition was set out for the predicted deflection of diaphragm wall without considering influence of buttress – buttress was excluded in the model. Diaphragm wall reinforcement was designed based on the most unfavorable condition.

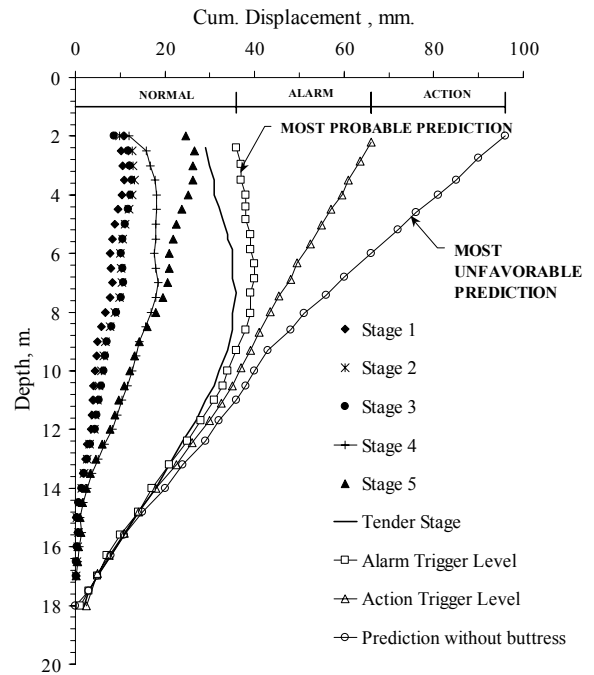
Fig. 7. Phase 1 East Wall - Monitored diaphragm wall deflection at different stages with trigger levels

After carrying out the comprehensive desk studies and establishment of systematic monitoring program presented above, Phase 1 excavation work was carefully commenced. Figure 7 shows the maximum accumulated diaphragm wall deflection at different stages of excavation monitored by inclinometer No.1 (I-1 at East wall of Phase 1) together with trigger levels and predicted maximum deflection profile of 3 different conditions - tender stage design (2 temporary struts), modified design with butress and modified design without butress. It can be observed from figure that measured lateral movement pattern of diaphragm wall agreed well with that of prediction for modified design with butress - meaning butress-support has significant influence on wall deflection.

Stage	Description
1	Excavate to -2.2m and installed temporary strut
2	Excavate to -4m
3	Excavate to -6.6m with berm
4	Removal of berm
5	Removal of temporary strut after completion of butress

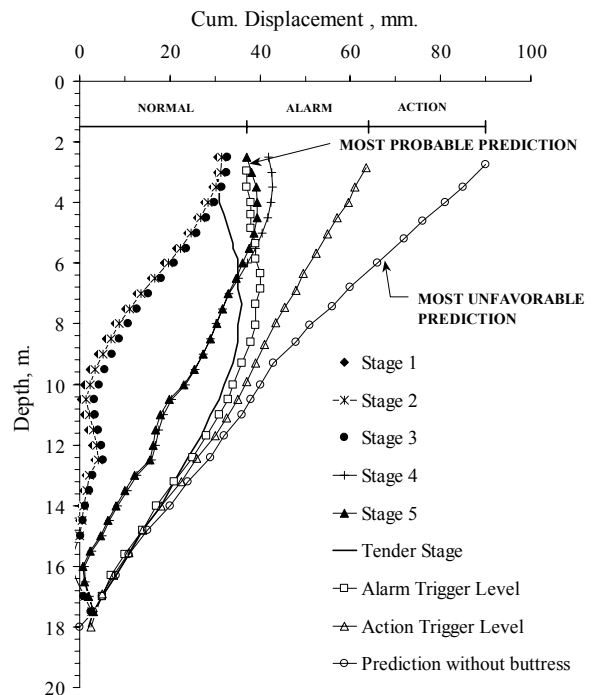
Fig. 8. Phase 1 South Wall - Monitored diaphragm wall deflection at different stages with trigger levels

Deflection profile of South diaphragm wall which braced against temporary sheet pile wall at Phase 1 and 2 boundaries is presented in Fig. 8. As can be seen in Fig. 8, South diaphragm wall deflection is significantly higher than that of east wall, which is likely to be caused by the fact that South diaphragm wall is braced with more flexible sheet pile wall. Description of stages shown in the legend of Fig. 7 and 8 is summarized in Table 2.

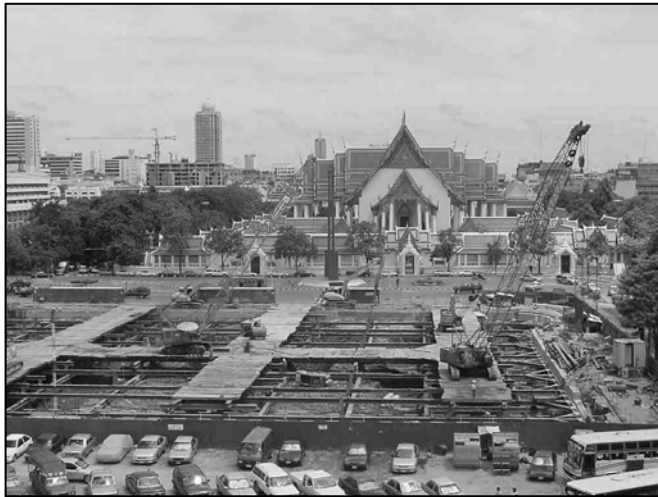
Fig. 9. Phase 1 excavation work in progress with historical Buddhist temple Wat Suthat in background (Phase 2 area was being used as car parking space)

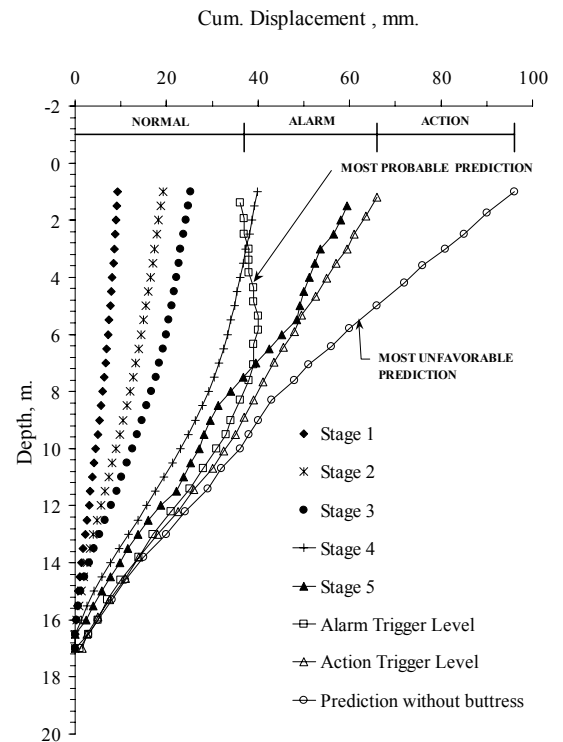
Fig. 11 Phase 2 East Wall - Monitored diaphragm wall deflection at different stages with trigger levels

Figure 11 depicts the measured deflection of east diaphragm wall. As can be observed in Fig. 11 in comparison with Fig. 7, the maximum deflection of east diaphragm wall in Phase 2 is larger than that of Phase 1. The likely reasons of this observation are;

- Un-strutted elapsed time for first temporary bracing in Phase 2 was longer than that of Phase 1.

- In Phase 1, horizontal struts were installed in north-south direction which temporary kingpost columns and strut were integrated in crisscross pattern with east-west struts - providing complete-support more rigid bracing system. Whereas in Phase 2, horizontal struts were installed only in east-west direction without having crisscross pattern with north wall – having less rigid bracing system than that of Phase 1.

Stage	East Diaphragm wall	North Diaphragm wall
1	Excavate to -2.2m and installed temporary strut	Excavate to -2.2m at d-wall, and to -6.6m with sloping berm with sloping berm
2	Excavate to -4m	Installed raking strut
3	Excavate to -6.6m with berm	Removal of berm
4	Removal of berm	Removal of raker after completion of buttress
5	Removal of temporary strut after completion of buttress

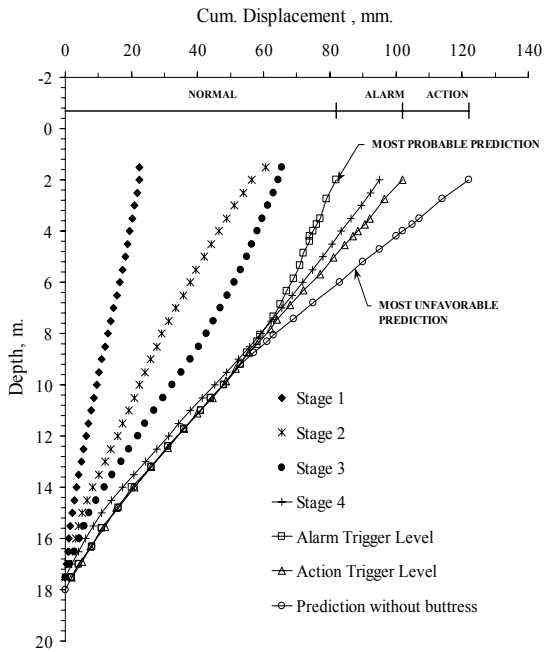
Fig. 12. Phase 2 North Wall - Monitored diaphragm wall deflection at different stages with trigger levels

With assurance of diaphragm wall performance from monitoring results of Phase 1, original plan of using horizontal struts for North diaphragm wall was modified by using raking struts instead. As can be seen in Fig. 12, deflection of North diaphragm wall (with raking strut support) is significantly higher than that of East diaphragm wall (with horizontal strut support). The main reason of larger movement of north diaphragm wall is due to the fact that it was supported only by the berm for the long period (about 52 days) before completion of raking struts so that soil-berm became soften during the long elapsed un-strutted period. Time-dependent deflection pattern due to softening and deformation of soft clay can be observed in North diaphragm wall as illustrated in Fig. 13. North diaphragm wall moved progressively toward excavation before completion of raking struts (at 52 days) as can be seen in Fig. 14.

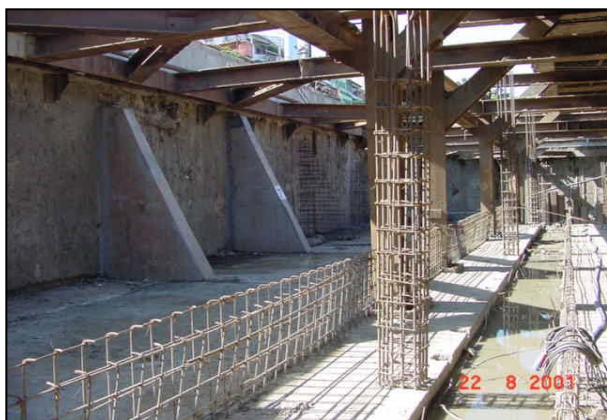
Fig. 13. View of buttress-support diaphragm wall prior to temporary bracing removal

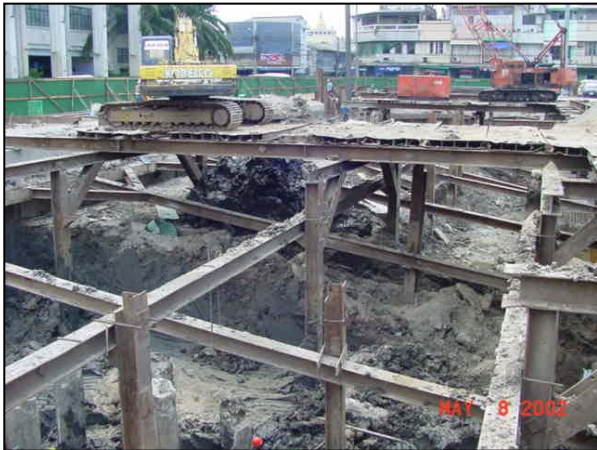
Fig. 16. View of raker and soil-berm support – soil-berm was removed locally in bay

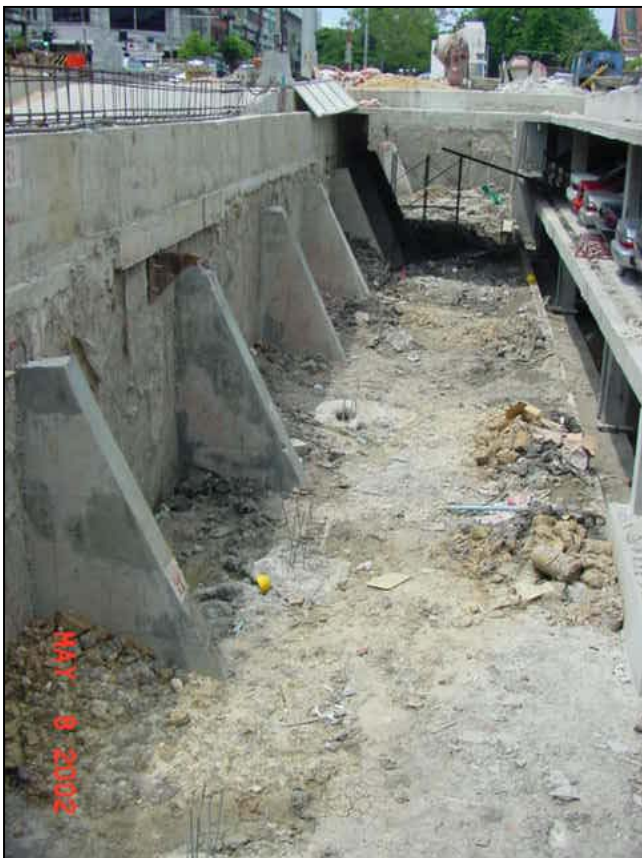
Fig. 17. View of buttress-support diaphragm wall after removal of temporary bracing
