International Conference on Case Histories in Geotechnical Engineering (2004) - Fifth International Conference on Case Histories in Geotechnical Engineering

## Geoenvironmental Site Characterization to Treatment: Lead Contaminated Firing Range Case Study

## GEOENVIRONMENTAL SITE CHARACTERIZATION TO TREATMENT: LEAD CONTAMINATED FIRING RANGE CASE STUDY

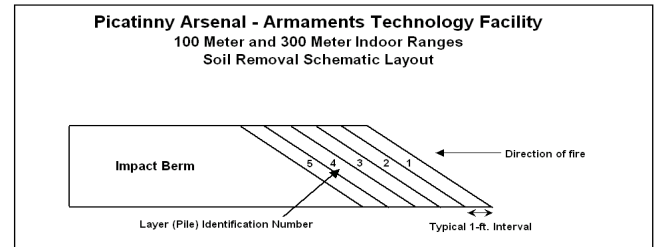
Fig. 1 – Material Removal Schematic for ATF Soil Impact Berms

A second sampling effort was performed during soil removal activities at each berm. In order to determine the variation in the soil conditions as a function of the depth into the berms, it was decided that the soil would be removed in successive 1-ft. thick layers parallel to the face of the berm. A schematic of the removal process is shown in Fig. 1.

During berm excavation, individual stockpiles of the soil in each layer were created. The material was then screened to remove oversized soil particles, projectiles and any undetonated rounds that may have existed within the soil. The screening process was initiated using two screens. A 1/8-in. upper screen was used to remove the larger materials and reduce the loading imposed on the lower, finer #10 (2.36-mm) screen.

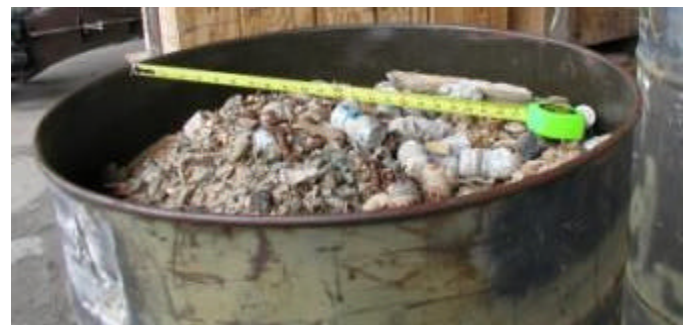
Fig. 2 – Oversized Projectile Fragments Removed From ATF Soil Impact Berms

At the outset of work on at the 300-m range, excessive clogging of both screens occurred and was caused by the presence of moisture within the soil. The moisture existed as a result of range maintenance activities that involved the use of a water spray applied to the surface of the berm to provide dust control during test firing operations. Attempts to mitigate the problem using a 1/4-in. upper screen and a 1/8-in. lower screen were likewise unsuccessful. Following a review of the historical usage of the range, it was decided that munitions fired at this location that posed a potential safety issue could be removed by using a 3/8-in. by 4-in. slotted screen. This screen was then used to process the remainder of material from this range. However, approximately 3-tons of soil that had been successfully screened over the #10 sieve prior to changing the screening method were stored separately from the remainder of the processed material. The over-sized soil and projectile particles collected on the 3/8-in. by 4-in. slotted screen were stored in 90-gal metal drums. A photograph showing the typical contents of the drums is presented in Fig. 2.

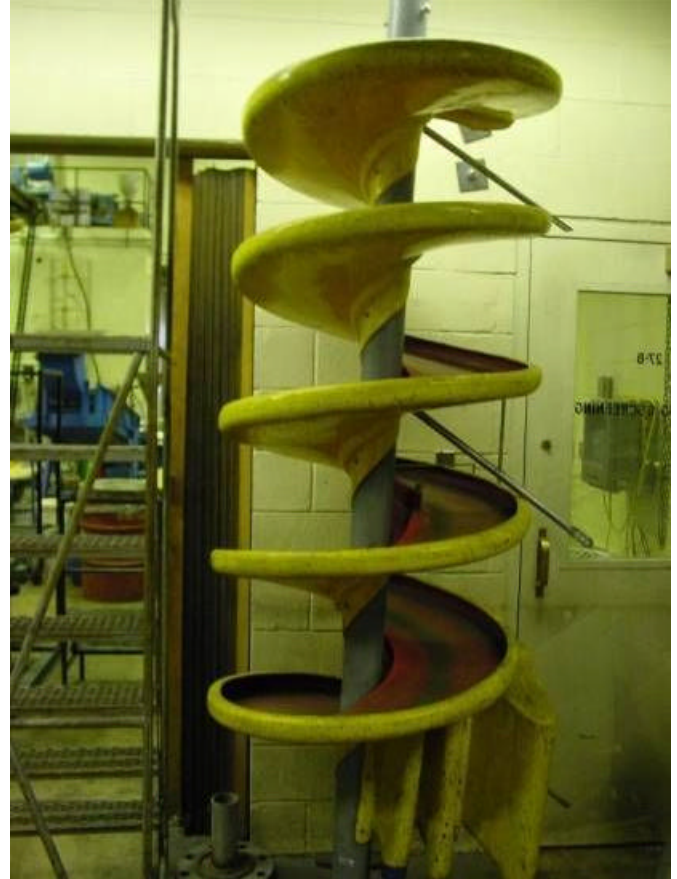
Fig. 3 – Five-Turn Spiral Concentrator

Spiral concentrators are common to the mining industry and are used routinely to fractionate materials containing particles of different densities. Basically, the spiral concentrator is a continuous helically-shaped channel located around a central axis. The configuration and number of flights or “turns” incorporated into the system is dependent upon the specific application for which the concentrator will be used. A typical five-turn unit is shown in Fig. 3. During operation, the material is discharged in slurry form at the top of the spiral and in the course of the downward travel through the spiral the denser, larger particles tend to collect along the interior of the channel while, due to centrifugal forces, the lighter particles report to the outer edges of the channel. A series of finger levers is located at the bottom of the device and the segregation of the discharged materials is done manually using these levers. The selection of the lever settings or “cut points” is made by the operator and is based upon both the visual inspection of the discharge and experience gained following analysis of post-treated material. While appearing crude in its level of sophistication, this equipment has been proven to provide an effective, low-cost means of material separation.

While the device is simple in appearance, its performance is based upon numerous parameters such as the “pitch” or angular orientation of the flights, the number of flights, the size distribution and shape of the particles being separated, the magnitude of the density differences between components, and the solids concentration and flow rate during operation. Other, less obvious but much more complex phenomena cited in the literature (Atasoy and Spottiswood, 1995; Davies et. al., 1991; Holtham, 1992; ) such as hindered settling, Bagnold forces, and existence of various flow regimes within the slurry as it travels down the spiral all but eliminate a theoretical prediction of the effectiveness of the separation process. As such, pilot-scale tests are usually necessary to reliably evaluate the performance of a specific spiral concentrator for the soil under consideration.

Linatex five-turn spiral concentrator with a medium pitch orientation. A composite sample created by combining equal masses of material from the Layers 1&2 container of the 100-m range and the Layer 1 soil from the 300-m range was used in the evaluation. The soil was prepared for testing by first removing the material coarser than the #10 sieve and finer than the #200 sieve since this was reported by the manufacturer to be the particle size range over which this unit was to be most effective.

In the first test series, performed using a 5-turn medium pitch spiral and a material feed consisting of the entire -#10 + #200 fraction of the composite sample, the total lead concentration of the treated soil (middlings) was reduced from an initial value of about 18,600 mg/kg to as low as 1670 mg/kg. The data also indicated that the effectiveness of the lead removal decreases with increasing solids concentration. While a mass balance was not performed during this initial assessment, visual observations of the "heavies" or concentrated metals stream indicated the quantity of sand reporting to this stream did not appear to be substantial.

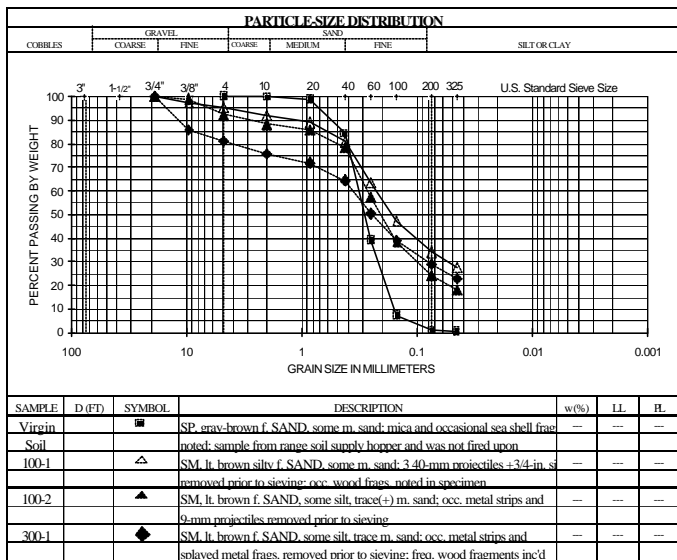
Fig. 4. Particle Size Distribution of ATF Impact Berm Soil From Face of 100-m and 300-m Berms

Particle-Size Analysis. The results of the particle-size analyses performed for this study are presented in Figs. 4 through 7. Figure 4 presents the grain size distribution of soil samples collected at the face of the impact berm at each range in their pre-removal condition. Also shown in this figure is the grain size distribution of soil used to construct the berms prior to its being fired upon. Examination of this data reveals the following:

- The soil prior to use in the berm (virgin soil) is a medium to fine sand containing mica and occasional sea-shell fragments. No metal fragments or other deleterious materials were observed.
- A significant quantity of material larger than the #10 sieve is present in the soil samples collected at the face of both berms. This is attributed to the projectile fragments that collect on the berm surface after firing. Visual examination revealed that essentially all of this material is heavy metal fragments.

The soil collected at the face of the berms has undergone a significant degree of particle breakdown resulting from numerous projectile impacts. This effect is shown clearly in Fig. 5, which presents the particle-size distribution of the same samples as shown in Fig. 4, but without the + #10 size metal and projectile fragments. As can be seen from this comparison, there is a substantial increase in the percentage of material passing each sieve size. For example, the quantity of soil finer than the #200 sieve (0.074-mm) increased from 0.8% in the original soil to as much as 35.8% for the 100-m-1 sample and 35.6% for the 300-m sample.

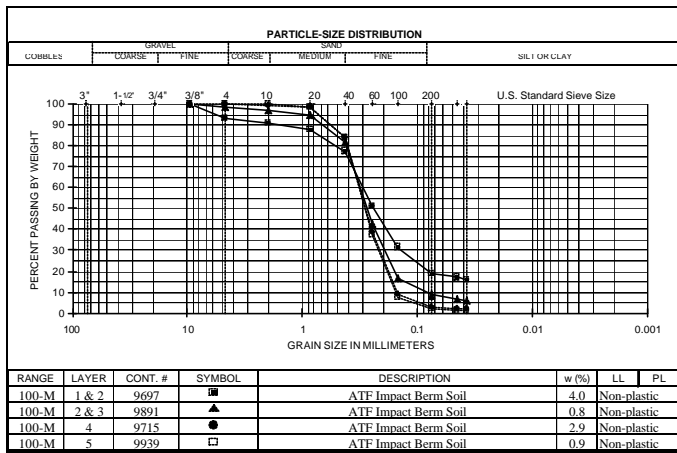
Fig. 6. Post-Removal Particle-size Distribution of Impact Berm Soil from 100-m ATF Range

The results of the sieve analyses performed using the post-removal screened material stored in the 20-CY waste containers are shown in Figs. 6 and 7 for the 100-m and 300-m ranges, respectively. A review of these data reveals the following:

The soil nearest the impact surface of each berm has sustained the greatest amount of particle breakdown as is shown by the gradual decrease in the fineness of the soil gradation as a function of distance into the berm (increasing layer number). Since some storage containers have a mixture of various layers, the magnitude of the breakdown versus depth from the impact face cannot be reliably assessed, however the trend is valid.

- The quantity of projectile fragments coarser than the #10 sieve decreases with distance into the impact surface for both berms indicating a reduction in the number of projectiles that were present at these depths. It must be noted that some variation in the projectile concentrations is also likely since different screens having different opening sizes were used during the removal and screening process for each range. However, since the same type of screen was used during removal within a given range, comparisons of data for samples collected within a range are believed to more reliable than comparisons made between ranges.

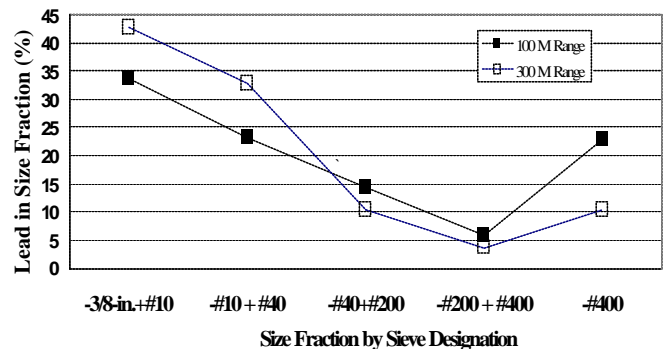
Fig. 8 – Percentage of Total Lead in Size Fraction for ATF Impact Berm Soil From 100-m and 300-m Ranges

Total lead concentration data are also presented for selected particle size ranges and vary from 132,000 mg/kg to 6,510 mg/kg. While the magnitude of the values varies between the two range berms, the concentration trends are similar with highly elevated lead concentrations in the fine gravel to medium sand particle sizes (-3/8-in. to #40) where the material found is primarily metallic projectile fragments. Lower lead concentrations are found in the fine sand particle size but increase substantially with decreasing particle size. However, given that the quantity of soil comprising each particle size range varies, it is necessary to determine not only the concentration of lead in each size fraction, but the percentage of the total quantity of lead contained in each fractionated range. These values are presented in Fig. 8 and reveal a similar trend for both soils. However, a slightly greater quantity of lead is found in the coarser size fractions at the 300-m range and the finer lead fraction is substantially higher in the 100-m range. One explanation for this behavior may be that the projectiles undergo a greater degree of fragmentation in the 100-m range due to a higher impact velocity given the shorter distance traveled and lesser energy lost prior to impact.

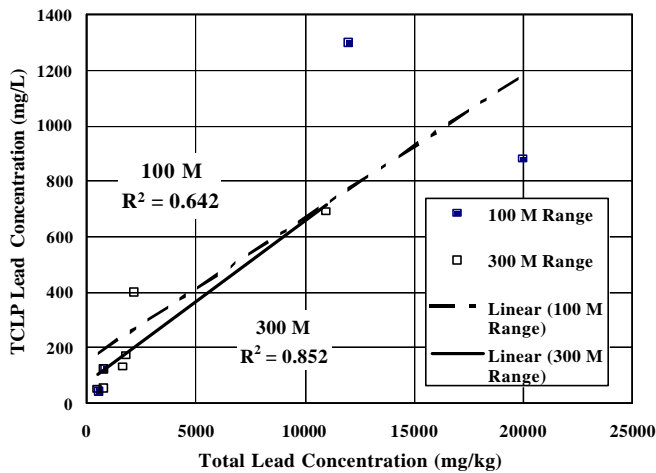
Fig. 9 – Total Lead Concentration versus TCLP Lead Extraction for ATF Impact Berm Soil at 100-m and 300-m Ranges

The TCLP data from the berm soils range from 1,300 mg/L to 40 mg/L. Linear correlations of these data with corresponding total lead concentrations are shown in Fig. 9 which shows correlation coefficients ( $R^2$ ) of 0.642 and 0.852 for the 100-m and 300-m range data, respectively. Given the limited number of tests performed and the potential for sample variation caused by the presence of larger sized metal fragments, the reliability of these correlations is deemed reasonable. In all cases, these results exceed the EPA TCLP regulatory limit for lead of 5-mg/L and the soil therefore would be classified as a hazardous waste.

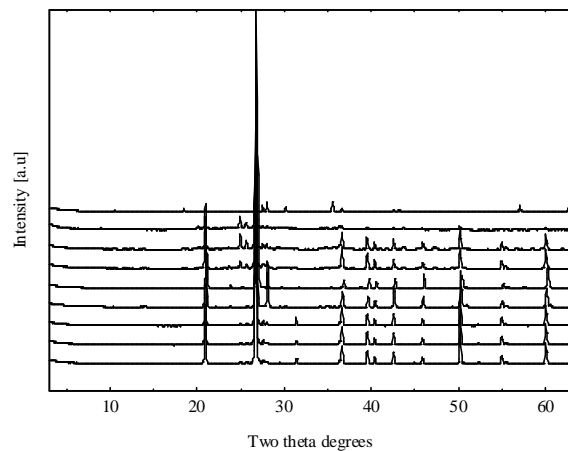
Fig. 10. XRD powder diffraction pattern for various size fractions of ATF soil; from bottom to top +4, -4+10, -10+40, -40+100, -100+200, -200+325, -325down, -325up, and Magnetic phases.

**XRD Results.** X-ray diffraction data of the various particle size fractions of the material contained in the first two feet of the 100-m range are illustrated in Fig. 10.

The mineral assemblage consisted primarily of granite origin quartz, feldspar, muscovite and typical granite accessory minerals (minerals in granites that undergo weathering at different rates and form weathering products consistent with their chemical composition). The soil also contains a small amount of magnetic material (1.5 wt %), which was later found to be a magnetite-hematite mixture. Quartz, one of the most stable minerals, is known for its high resistance to weathering. Mica minerals may also remain relatively unweathered in many granite residues. Feldspar, on the other hand, weathers quite rapidly forming clay minerals like kaolinite. Ferromagnesian minerals (most of the black minerals rich in iron and magnesium) also weather rapidly to form clays and iron oxides. However, because of the soil origin (dredged sand) most of the clay minerals that may have formed had been subsequently washed away. No significant organic fraction was identified.

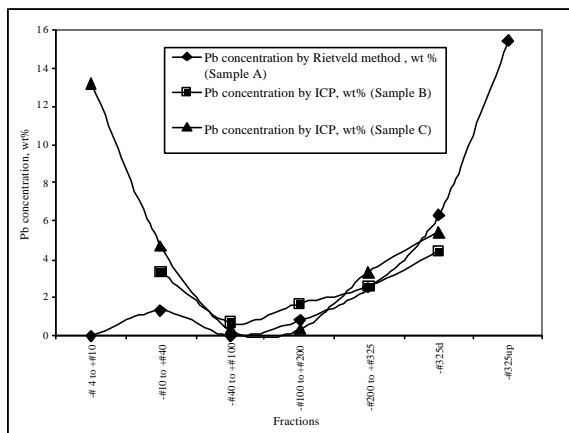
Fig. 11. Plot of total Pb concentration versus size-fractions. Pb concentrations are either calculated based on the cerussite content as determined by the Rietveld method (Sample A) or measured by ICP-OES (Samples B and C)

Table 3 presents the results of the Rietveld-based mineralogical quantification of the various particle size fractions. The first row in this table shows the percent of total sample (wt %) represented by each fraction. The subsequent rows show the percent content (wt %) of each individual mineral identified within the individual fractions. Moreover, as shown in Fig. 11, comparison of the total lead quantities measured using the analytical (ICP-OES) method with the lead quantities computed based on the cerussite contents (determined by the Rietveld quantification method) correlated well for all of the finer fractions (-40 to -325 up). This is an indication that in the finer fractions most of the lead exists in the form of cerussite. Lead concentrations obtained by ICP-OES using independently prepared samples (shown as a “Sample C” in the figure) were also in good agreement. The curve of lead concentrations based on cerussite contents does not agree well with the analytical lead curves (Samples B and C) for the coarser fractions (-4 to +40). This is attributed to the fact that in the ATF soil coarser fractions Pb primarily exists in metallic fragment forms with only a limited amount of cerussite present.

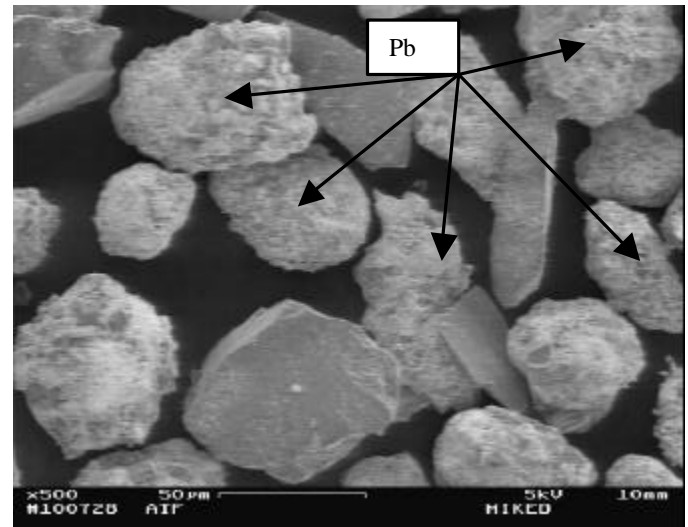
Fig. 12. ATF soil SEM picture of Pb fragments. White surface layer covering the Pb fragments is cerussite.

**Scanning Electron Microscopy.** In this phase of the study, several lead fragments were collected during analysis of the soil using the optical microscope and then examined using the SEM. Overall, SEM analyses revealed that the metallic lead fragments were mostly covered by a white surface layer of cerussite. Figures 12 and 13 show SEM pictures of

selected Pb fragments and associated cerussite formations. The identification of the presence of cerussite had a profound impact on the results of the lead removal studies as will be subsequently discussed.

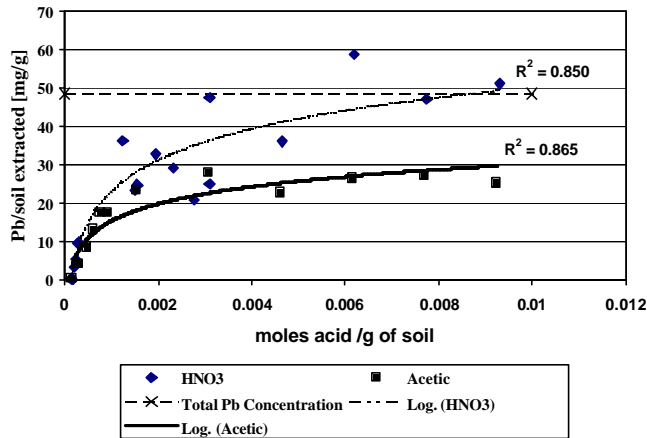
Fig. 14. Total Lead Extraction Results Using Nitric and Acetic Acids

**Chemical Extraction Test Results.** The findings obtained in the bench-scale chemical extraction study are presented graphically in Fig. 14. This figure contains a summary of the quantity of lead removed per quantity of soil treated as a function of the molarities of both the nitric and acetic acids. The results indicate that at similar molarities, the nitric acid has a significantly greater capacity for solubilizing the particles of lead and/or lead species. Furthermore, the quantity of lead removed using the nitric acid approaches the total lead concentration level of approximately 50,000 mg/kg contained in the soil prepared for this experiment. It should be noted that this concentration is greater than the values obtained in both the initial characterization phase and mineralogical analyses presented above. It is believed that this difference as well as the scatter in the data shown are due in large part to experimental variation resulting from the inclusion of the -3/8-in. + #4 portion of the material in the limited-sized (10-g to 12-g) test specimens used in this study. Validation of these results will be addressed in subsequent analyses yet to be conducted. However, it is clear that acetic acid must be tested at higher molarities such that sufficient hydrogen ions are made available to

overcome the buffering capacity of the soil and bring about additional dissolution of the lead.

An initial investigation using both acetic and nitric acids was performed to assess the lead solubilization capacity for each. While it would be expected that the nitric acid, at the same molarity, would provide a more thorough dissolution and reach thermodynamic equilibrium in a shorter time than acetic acid, the latter was included in the study based upon a number of other considerations including:

The experiment involved first the preparation of individual sample aliquots 10-g to 12-g in weight which were obtained using a riffle splitter. The soil used in the testing was taken from the 100-m range (Layers 1 & 2 sample) and was representative of the entire distribution of particle sizes present in the sample. The acid solutions were prepared at molecular concentrations and resulting pH values required to cover the range of interest for the study. For the acetic acid the pH of the solutions ranged from approximately 5.0 to 2.6, while for the nitric acid the pH range was from about 4.5 to values too low for reliable pH measurements to be obtained (<0.9).

The soil aliquots were then placed in 125-ml capacity polyethylene bottles and the test solution was added using a 10:1 liquid to solid ratio in all cases. Each bottle was mixed over a 24-hr. period using the same rotating tumbler used in TCLP testing. Mixing by means of the tumbler was selected in lieu of a glass beaker-magnetic stirrer alternative so as to minimize the potential for breakdown of the particles. Such a reduction in particle size could lead to erroneous results (e.g., a higher solubility potential of the finer particles that could result from stirrer-induced grinding during the mixing process). At the conclusion of the mixing period, the samples were vacuum-filtered over a 0.45 µm glass fiber filter. Aliquots of the aqueous extract were taken for both measurements of the post-treatment pH and the lead concentration in solution. The lead concentration measurements were obtained using an ICP-OES.
