Design of Bridges Against Seismic Faulting : Methodology and Applications

Recent Advances in Geotechnical Earthquake Engineering and Soil Dynamics and Symposium in Honor of Professor I.M. Idriss

May 24-29, 2010 • San Diego, California

DESIGN OF BRIDGES AGAINST SEISMIC FAULTING : METHODOLOGY AND APPLICATIONS

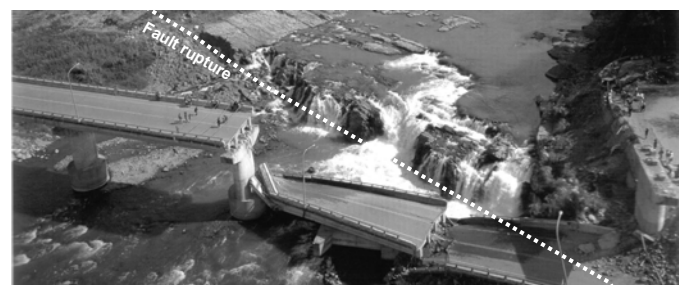
Fig. 1. Collapse of two spans of the Bei-Fung bridge due to tectonic dislocation in the 1999 Chi-Chi (Taiwan) earthquake.

Nevertheless, several bridges were damaged due to surface faulting in the 1999 Chi-Chi earthquake [Kawashima, 2001; Pamuk et al., 2005]. One such example is illustrated in Fig. 1, referring to a prestressed concrete bridge, the Bei-Fung

viaduct in Fung-Yan City [photos adapted from Hwang, 2000]. The Chelungpu thrust fault crossed its south abutment with an upthrust of about 7 m. The result: collapse of two spans of the bridge due to differential displacement between the piers.
