Experimental Investigation of Plastic Demands on Piles During Lateral Spread-Induced Loads

Recent Advances in Geotechnical Earthquake Engineering and Soil Dynamics and Symposium in Honor of Professor I.M. Idriss

EXPERIMENTAL INVESTIGATION OF PLASTIC DEMANDS ON PILES DURING LATERAL SPREAD-INDUCED LOADS

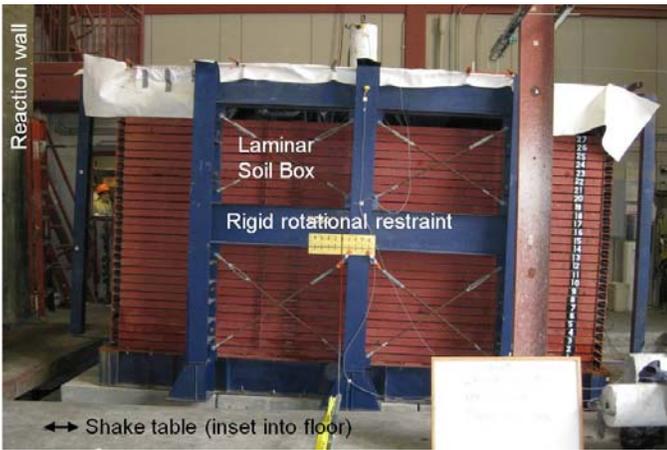
Fig. 1. Laminar soil box on the shake table at UCSD Powell Laboratories.

The laminar soil box is mounted on the uniaxial shake table in the Charles Lee Powell Laboratory at UCSD. The test setup is shown in Fig. 1. The shake table in the south Powell Laboratory has a maximum gravity capacity of 80 kips and a servo controlled dynamic rated actuator with a load capacity of 110 kips. It has a footprint of 10ft x 16ft and a total stroke of 12 inches. The maximum velocity of the shake table is 35 inches per second. The laminar soil box is comprised of 28 stacked frames with rollers sandwiched between the frames. Inside dimensions of the laminar soil box are 69.7" (W) x 154" (L) x 74.0" (H). A single reinforced-concrete pile was placed vertically in the laminar soil box and surrounded by loose saturated #30 silica sand with a target relative density of $D_r = 50\%$. The pile was fixed at the base. The laminar soil box was mounted on concrete blocks to create a gentle slope of approximately 3.5%. The test was conducted at 1-g.

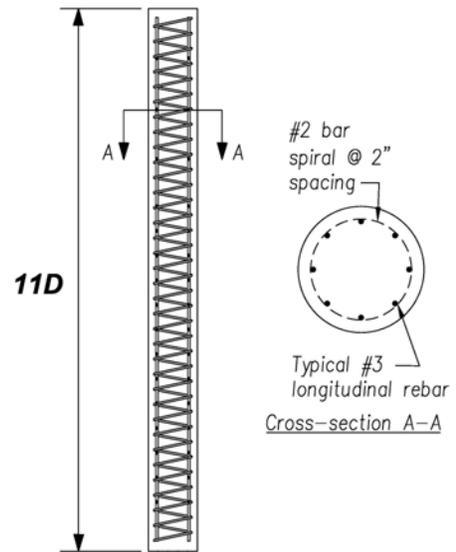
Fig. 2. Construction drawing for reinforced-concrete pile.

The reinforced-concrete pile was constructed from normal strength concrete, Grade 60 #3 longitudinal reinforcement, and #2 wire spiral for confinement. During casting of the specimen, a concrete slump of 8.5” was measured. From compression tests of 6” diameter cylinders, the day of test concrete strength f'_c was 4.52 ksi. Yield strain and strength of the #2 wire spiral and the #3 longitudinal reinforcement are summarized in Table 1 below. The reinforced-concrete pile was 110” long with a diameter of 10”. Concrete cover was 1” thick, and the spiral reinforcement spacing was 2” (Fig. 2).

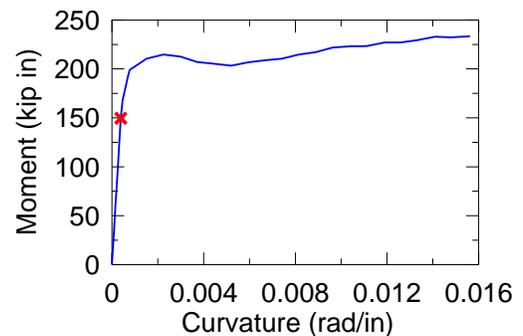
Fig. 3. Moment versus curvature plot for the reinforced-concrete pile circular section. Red “x” denotes values of the yield moment and yield curvature.

Concrete compression strength and steel reinforcement stress-strain values were used to calculate the moment versus curvature relation for the circular section (Fig. 3). Yield moment of the section was 148 kip in, and yield curvature of the section was 0.00038 rad/in per the analysis by the software program XTRACT.

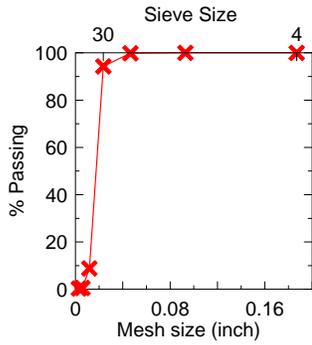
Fig. 4. Grain size distribution test results for #30 silica sand (GeoCon report)

Three layers of soil were placed around the reinforced-concrete pile in the laminar soil box. The bottom-most layer was a dense sand layer, the middle layer was a saturated sand layer, and the topmost layer was a stiff crust layer. Each layer was separated by a plastic sheet, which was intended to mimic an impermeable layer. The same grain size (#30 silica sand) was used for the bottom and middle layers of soil (Fig. 4). The maximum dry density of this sand was 101.0 pcf; the minimum dry density was 80.1 pcf. The minimum void ratio is 0.66; the maximum void ratio is 1.09. Specific gravity is 2.686. (GeoCon report)

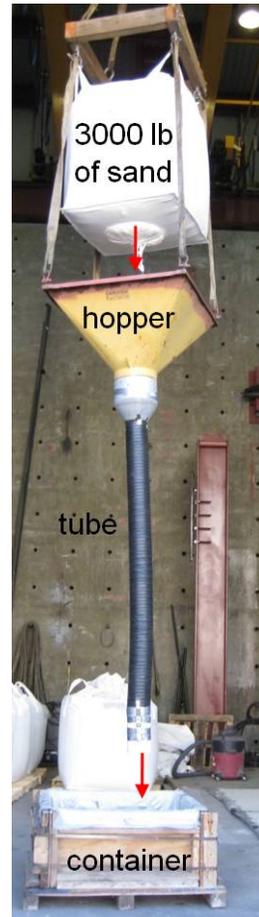
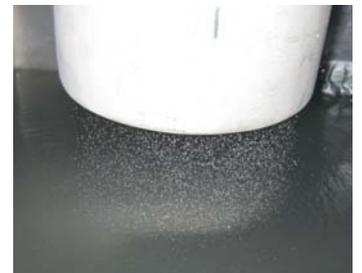
Fig. 5. Pluviation equipment for placing sand at left (hopper and tube with meshes). Trial pluviation container is shown at end of tube. At above right, typical sand falling into standing water.

To achieve a homogeneous saturated soil layer of target relative density $D_r = 50\%$ for the middle layer, the method of pluviation was used to place the soil into the laminar soil box. Initial pluviation trials were conducted to determine the best method of placement for the kiln dried #30 silica sand (Fig. 5). A bag of kiln dried sand was suspended over the hopper. This hopper had a series of specifically sized meshes at the beginning and at the end of the tube. Via this tube, the sand was dropped into the container, which contained a certain volume of still water. The sand grains fell from the end of the tube, which was positioned approximately two inches above the water, and fell into the water. The sand grains then subsided gently through the eight inches of water and settled onto the bottom of the container. Sand grains were dropped into the water until a five inch thick lift was achieved. This particular method of placing soil was able to achieve a relatively loose density of soil. The volume of sand that was dropped into the container was measured, and the weight of the bag of sand was measured before and after pluviation. Sand was weighed by a heavy-duty scale with a maximum capacity of 10000 lbs; each tick mark equaled 50 lbs. By using this data, the relative density of the saturated soil layer was estimated. After obtaining a reliable relative density from the pluviation trials, the kiln dried sand was placed into the laminar soil box by using the same method. The saturated sand layer with a thickness of 25" (2.5D) had a density of 117 pcf and a friction angle of 36°. Estimated relative density of the saturated layer was fairly close to the target of 50%.

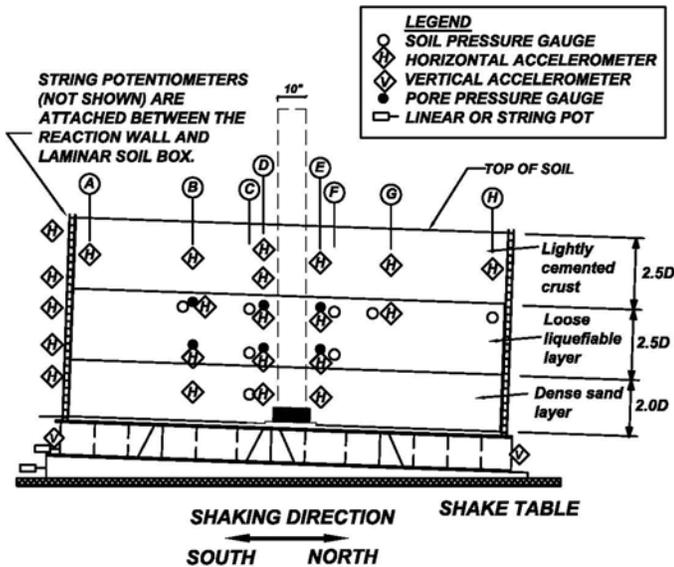
Fig. 6. Schematic (elevation view) of instruments used on laminar soil box.

In Fig. 6 and Fig. 7, a schematic of the instruments on the laminar soil box and embedded in the soil layers is shown. Accelerometers were placed on the south outside of the laminar soil box. String potentiometers (not shown) were installed to measure the displacement of the south laminar frames. Horizontal accelerometers, pore pressure transducers, and soil pressure transducers were embedded in the soil layers where appropriate along the centerline of the pile within the soil. Instruments at line "A" and "H" are placed 0.5D away from the laminar face of the box liner; instruments at line "B" and "G" are placed 3D away from the respective pile face; instruments at line "C" and "F" are placed 1D from the respective pile face; and instruments at line "D" and line "E" are placed 0.5D from the respective pile face.

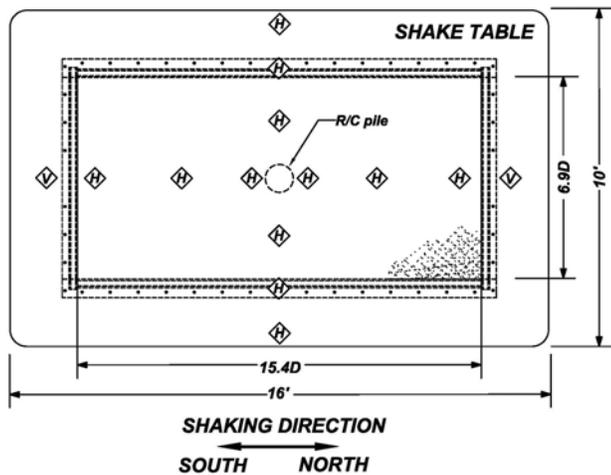
Fig. 7. Schematic (plan view) of instruments used on laminar soil box.

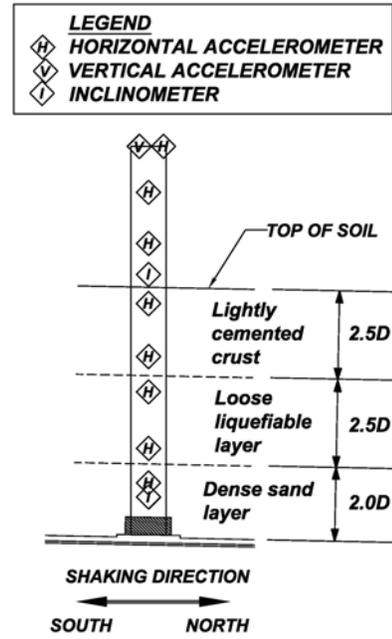
Fig. 8. Schematic of instruments attached to pile.

Accelerometers and inclinometers were attached to the surface of the reinforced-concrete pile (Fig. 8). The reinforced-concrete pile was also instrumented with embedded high-elongation strain gages which were placed length-wise (in pairs) on the longitudinal reinforcement (#3 bar) at the extreme south and north locations (Fig. 9).

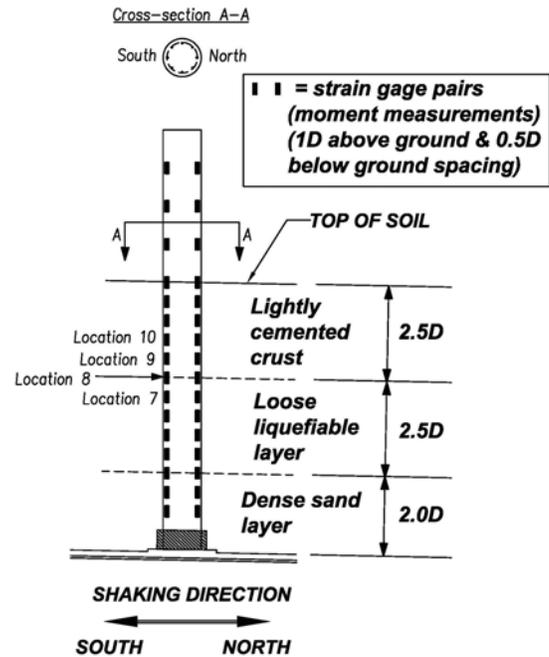
Fig. 9. Schematic of strain gages embedded in reinforced concrete pile.

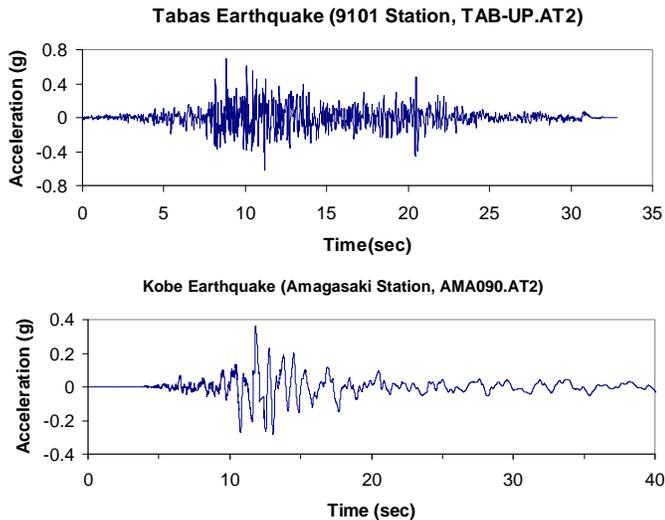
Fig. 10. Time history of ground motions.

Dynamic base shaking was applied to the specimen. Two scaled earthquake ground motions (Fig. 10) were applied in the course of testing: one from the 1978 Tabas, Iran earthquake (PGA 0.688g), and the other from the 1995 Kobe, Japan earthquake (PGA 0.356g).

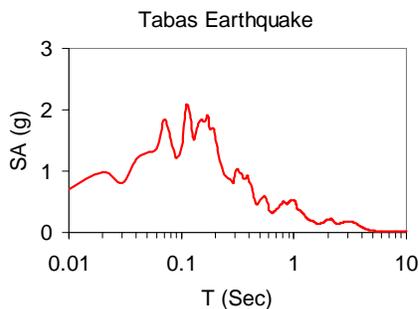
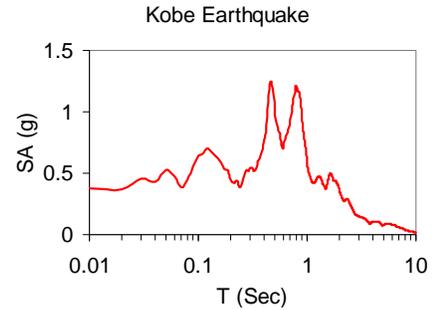
Fig. 11. Response spectra of ground motions.

From a hammer test to the specimen before applying the ground motions, the first mode frequency of the specimen was measured to be 9.9 Hz with a damping of approximately 1%. This gives the specimen a natural period of approximately 0.63 seconds. Response spectra of the Tabas and the Kobe ground motions show differing maximum response at periods of 0.07 second to 0.2 second and 0.4 second to 1.0 second, respectively.

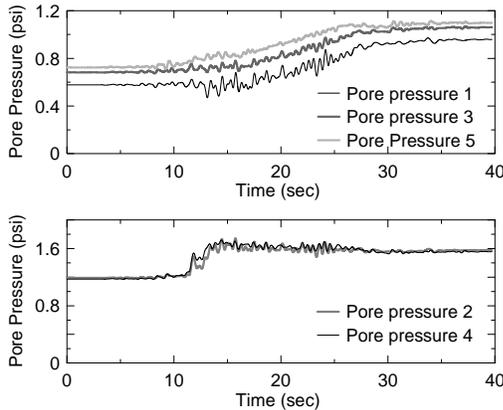
Fig. 12. Pore pressure measurements from Tabas 25% ground motion input.

Time history data from the pore pressure instruments are shown in Fig. 12 and Fig. 13 for the ground motion inputs of Tabas scaled to 25% and Tabas scaled at 100%. Pore pressure instruments 1, 3, and 5 are closer to the surface of the saturated soil layer, and pore pressure instruments 2 and 4 are near the bottom of the saturated layer. During the Tabas 25% ground motion, liquefaction of the saturated layer is observed from the increasing trend in the pore pressure data. The pore pressure increases and then levels off.

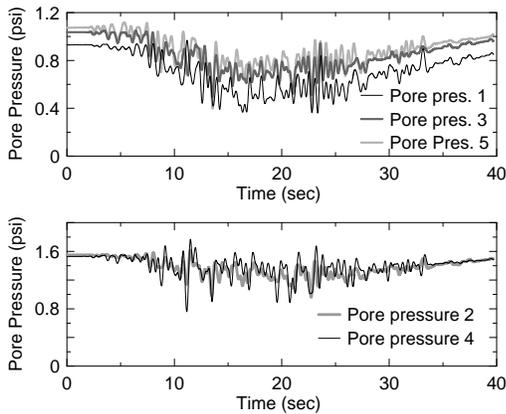
Fig. 13. Pore pressure measurements from Tabas 100% ground motion input.

At the later ground motion input of Tabas 100%, a curious trend in the pore pressure data is observed. As the magnitude of the acceleration of the shake table increases, the general trend of the pore pressure data dips in value. When the magnitude of the acceleration decreases, the pore pressure rises. This may be attributed to the phase transformation behavior of the saturated sand layer during strong shaking. The sand is transitioning from contractive to dilatant behavior (and back); these transitions are illustrated by both the sharp decreases in pore pressure and the “dipping” trend of the data.

The pore pressure measurements gradually increase again after time = 22.5 seconds. This coincides with a decrease in the magnitude of the acceleration of the shake table from a negative peak acceleration of 0.45g that tapers gradually to zero. Peak table accelerations from Tabas 100% range from 0.52g to -0.53g. Peak accelerations from Tabas 25% range from 0.16g to -0.14g. Due to the lower magnitude of shaking for Tabas 25%, widespread deliquescence of the saturated soil layer was not observed.

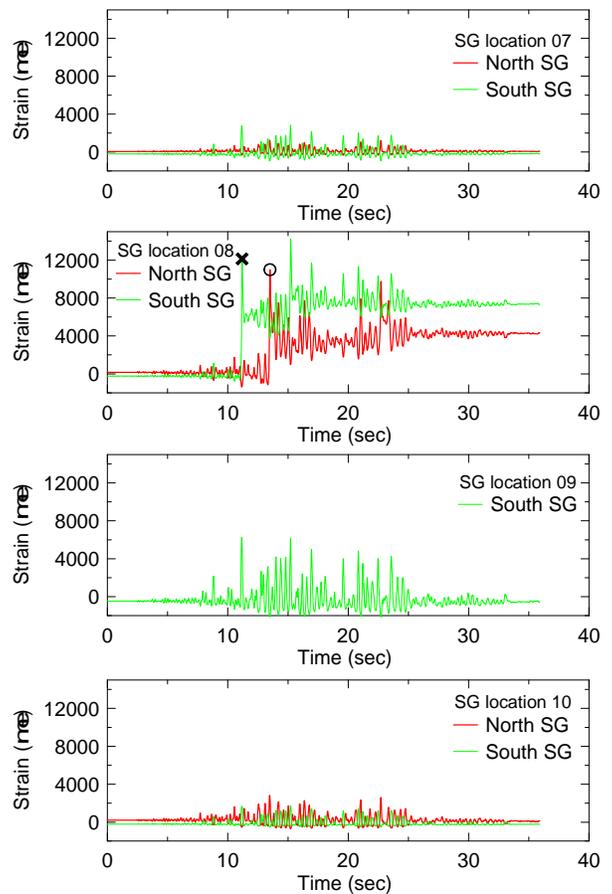
Fig. 14. Embedded pile strain gages time history.

During testing of the specimen, strain in the longitudinal reinforcement did not reach yield strain until the Tabas ground motion at 100% was applied. At this point in the testing sequence, non-linear strains were observed in the strain gages at location 8 (see previous Fig. 9). Location 8 was just at the interface between the crust and the saturated soil layer. This region with extreme variation in soil stiffness was where the largest strains were expected to be observed (Fig. 14). In the saturated soil layer (location 7), the strains were comparatively much smaller than at the crust to saturated soil interface (location 8). Within the crust region, the accompanying strains were also comparatively lower at strain gage location 9 and 10. The north strain gage at location 9 was no good during the Tabas 100% ground motion, and thus is not shown.

Strains at location 8 showed large changes in the strain that occurred due to the effect of the acceleration of the crust. A small “x” marks this occurrence of large strain for the south side strain gage at time = 11.189 seconds, and a small “o” marks the occurrence for the north side strain gage at time = 13.504 seconds (Fig. 14). These peaks in strain correspond to abrupt accelerations in the crust (Fig. 15). Although there were corresponding peaks in the acceleration records for the shake table and the saturated layer, it was the massive heavy crust layer that had the largest magnitude of acceleration at those particular times, and thus appears to be the main cause of these strains in the pile.

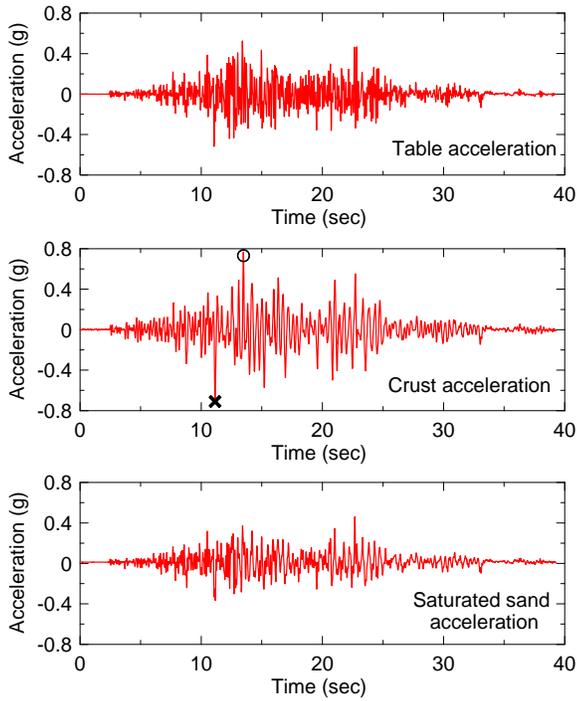
Fig. 15. Recorded accelerations of the shake table, the crust, and the saturated sand layer.

Peak accelerations in the crust are noted with a small “x” for peak negative acceleration and a small “o” for peak positive acceleration. There was a time lag between peak acceleration of the crust and jump in strain for the steel reinforcement. Peak negative acceleration for the crust occurred at time = 11.139 seconds. After 0.05 seconds, the jump in strain for the south strain gage at location 8 occurred. Peak positive acceleration for the crust occurred at time = 13.479 seconds. After 0.025 seconds, the jump in strain for the north strain gage at location 8 occurred.

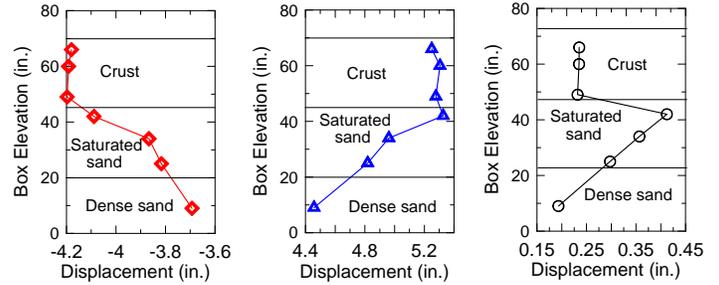
Fig. 16. Horizontal displacement of laminar frames versus vertical height of same frames at time = 11.189 seconds (red, left), time = 13.504 seconds (blue, middle), and at the end (black, right).

String potentiometers attached to the south side of the laminar soil box show the profile of the laminar frames as the peak negative and positive accelerations of the crust occurred (Fig. 16). Not surprisingly, at peak negative acceleration, the crust was flung southward to a maximum negative displacement of 4.2 inches. The strain gage at location 8 was approximately at the line delineating the boundary between the crust and the saturated sand layer as shown in the profile plots. At peak positive acceleration, the crust displaced towards the north direction a maximum displacement of 5.3 inches. At the end of the ground motion, the shake table returned to its initial displacement, but a profile of the displacement of the laminar frames showed residual displacements which differed for each soil layer.

The saturated sand layer had liquefied and moved down slope northward by 0.41 inches at this time in testing (Tabas 100%), and the crust had similarly displaced northward by 0.23 inches. This amount of movement in the crust was consistent with the movement at the pile top, which was measured to have moved a residual 0.25 inches of displacement. These residual displacements at the top of the pile, for the crust layer, and for the middle and bottom soil layers suggest that the reinforced-concrete pile has deformed from its initial shape during testing.

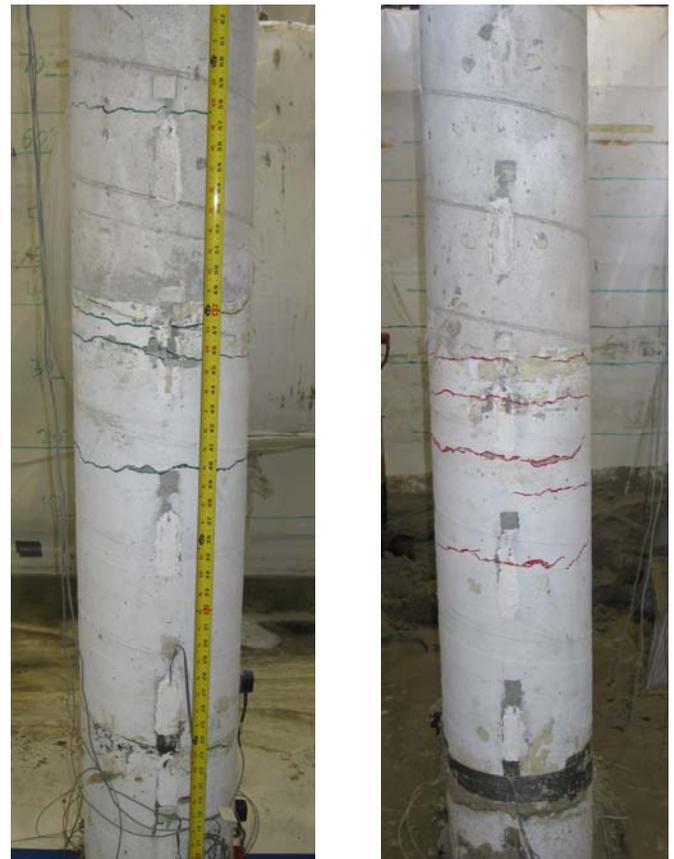
Fig. 17. Overall view of south (left) and north (right) faces of the exterior of the pile during demolition (post test).

Physical observations during demolition of the specimen support the recorded strain data. Cracks in the reinforced-concrete pile occurred mainly in the corresponding region of large strains close to the interface between the crust and the saturated soil layer (Fig. 17). On the left photo, the south face of the pile has cracks marked in green ink. Four large cracks

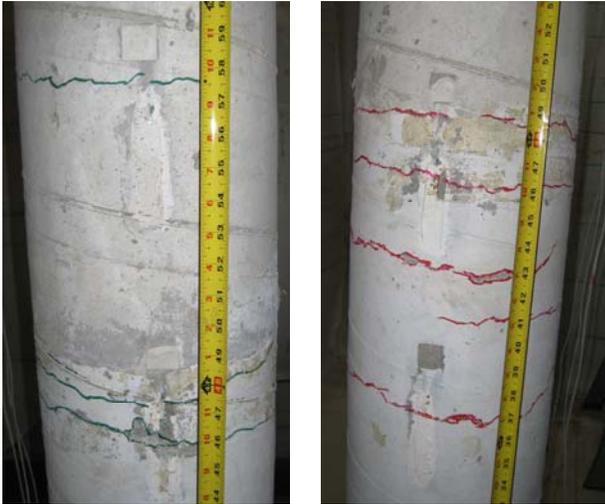
Fig. 18. Close up of cracked region of pile. South face on left; north face on right.

were observed for the south face at these elevations on the pile at 59", 49", 47" and 40". These elevations correspond to the general locations 7 to 10. On the right photo, the north face of the pile has cracks marked in red ink. Five cracks are visible on this face at pile elevations of 49", 47", 45", 42" and 37". These elevations again correspond to the region near locations 7 to 10. Some spalling of the cover concrete occurred near location 8. Close ups of the cracked regions show this in more detail (Fig. 18). At location 8, visible cracks extend around the pile (Fig. 19).

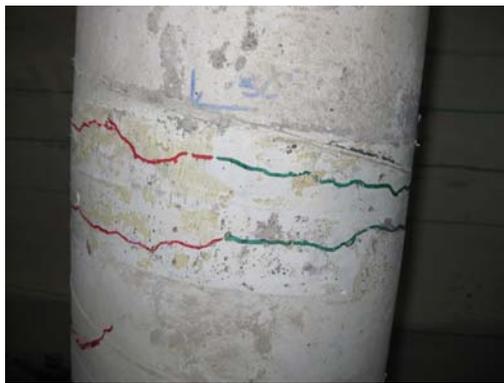
Fig. 19. Cracked pile at location 8 (at the interface between crust and saturated sand layer).

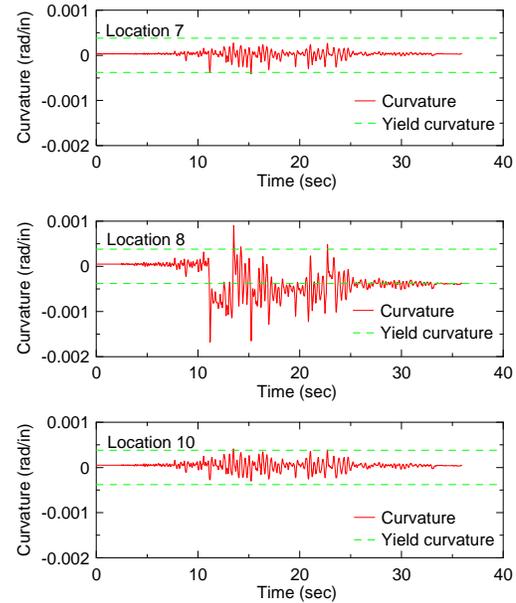
Fig. 20. Curvature time history for selection locations (Tabas 100%).

Non-linear behavior of the reinforced-concrete pile was observed in the moment and curvature behavior of the section. From Fig. 20, the calculated curvature time history of the same region for the pile shows maximum curvature at the boundary between the stiff crust layer and the saturated soil layer. Similar trends are observed for the moment (Fig. 21). These moments are derived from a simple “look up” function that is based on the sectional moment-curvature plot from the software program XTRACT.

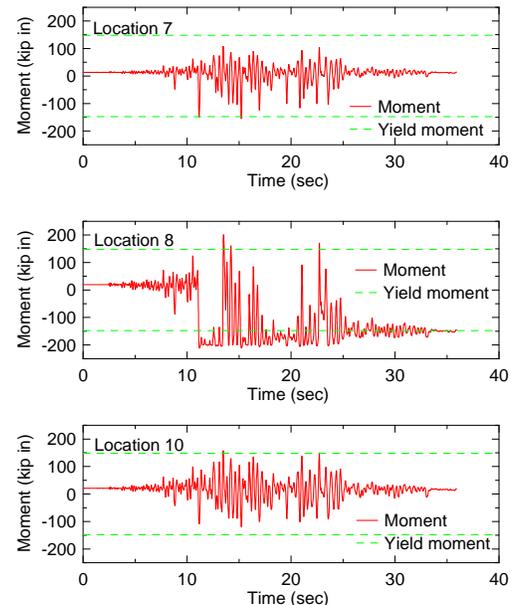
Fig. 21. Moment time history for selected locations (Tabas 100%).

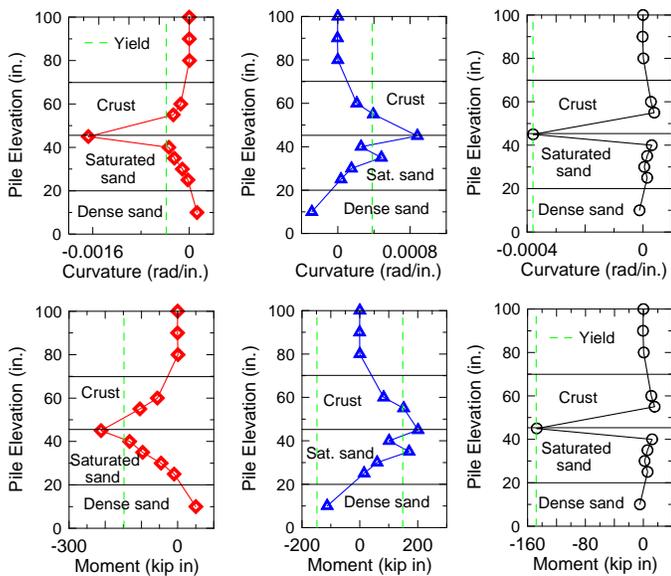
Fig. 22. Curvature and moment profiles versus the pile length at time = 11.189 seconds (red, left), time = 13.504 seconds (blue, middle), and at the end (black, right).

The value of the curvature and moment along the length of the pile at certain times during ground motion Tabas 100% is shown in Fig. 22. Again, these profile correspond to the moments in time of peak negative acceleration and peak positive acceleration of the crust. From the curvature profiles, a slight double curvature of the pile is observed. This double curvature does not appear to occur when the pile is at rest. A permanent kink appears to have been formed at crust to saturated soil boundary instead.

Additionally, opposite signs for the value of the moments were generated at the bottom of the pile and at the interface region. For the leftmost moment profile in Fig. 22, the moment at the bottom of the pile is positive and the moment at the interface region is negative. Similarly, the middle moment profile plot shows a large negative moment at the bottom of the pile and positive moment at the boundary interface.
