Investigation of the Coefficient of Earth Pressure for Improved Ground by Compaction Grouting in the Full-Scale Field Liquefaction Experiment

Recent Advances in Geotechnical Earthquake Engineering and Soil Dynamics and Symposium in Honor of Professor I.M. Idriss

INVESTIGATION OF THE COEFFICIENT OF EARTH PRESSURE FOR IMPROVED GROUND BY COMPACTION GROUTING IN THE FULL-SCALE FIELD LIQUEFACTION EXPERIMENT

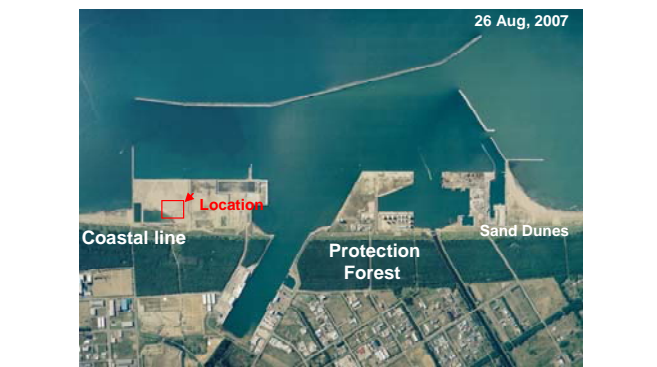
Photo 1 Aerial Photograph of Experimental Site

Photo 1 shows the location of the site in the coastal line of Ishikari Bay. The site consists of gentle slope of sea bed surface reclaimed with dredged sands and sand dunes. The typical soil profile is shown in Fig.3 and its characteristics are the following:

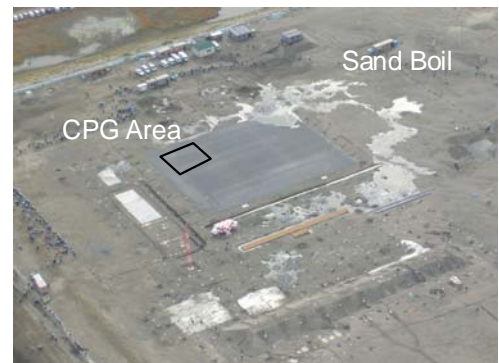
Photo.3 Bird's-Eye View of Experimental Site

Photo 3 shows the bird's-eye view of the experimental site after blasting. The sand boil and water due to liquefaction induced by the blast are observed. Most extreme sand boils were observed around untreated area.
