## Foundation Grouting for the Forks of Butte Powerhouse

**SYNOPSIS:** Construction of a powerhouse on unconsolidated landslide debris materials at the edge of a stream channel in a narrow, steep-sided canyon in northern California entailed application of an unusual combination of grouting techniques to protect the foundation during peak flows. These techniques included permeation grouting, displacement grouting, compaction grouting, and controlled hydrofracture grouting.

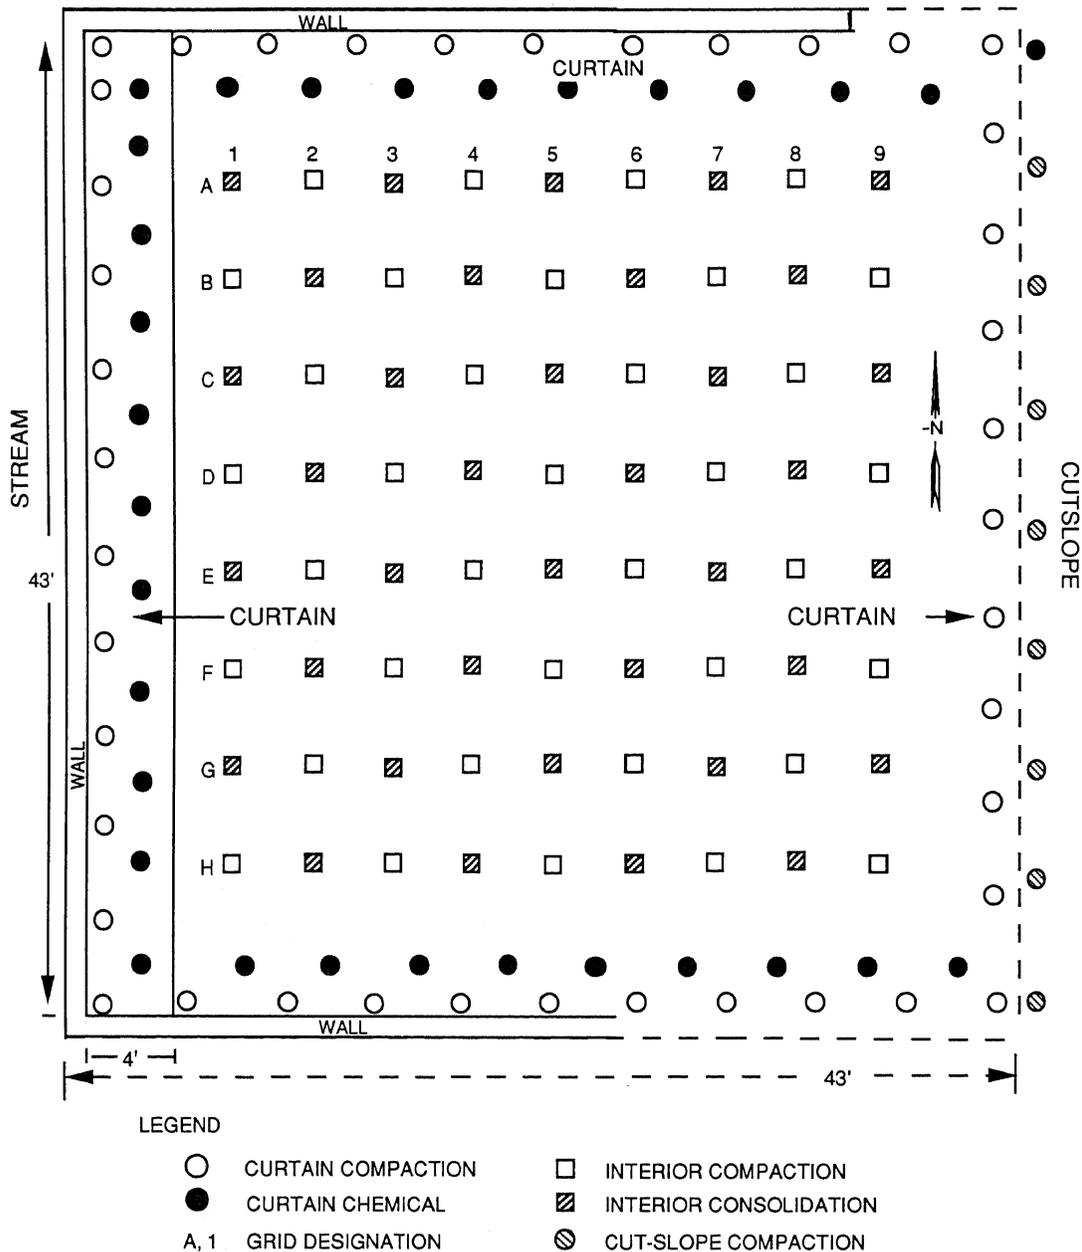
Figure 1. GROUT HOLE LAYOUT

The grouting program included the following elements: (1) construction of a two-line grout curtain to minimize stream underflow and to prevent contamination of the stream by grout; (2) filling of major voids and consolidation of finer-grained materials by displacement and compaction grouting; (3) cementation of sand and gravel deposits by controlled hydrofracture grouting; and (4) consolidation grouting of the landslide materials immediately upslope from the powerhouse. A total of 13,906 cubic feet (394 m<sup>3</sup>) of grout was injected into 151 borings drilled to an aggregate depth of 6,067 feet (1,849 m). The grouting program was done in two phases, so as to allow work on stabilization of the adjacent slope to proceed. The grout hole layout is shown on Figure 1.

A double-row grout curtain, with holes on 4-foot (1.2 m) centers, was constructed around the perimeter of the powerhouse site. This curtain had two purposes: the

A No. 10 (32 mm) deformed steel threadbar was socketed approximately 10 feet (3 m) into bedrock in each of the outer curtain holes along three sides of the perimeter, with the objective of securing the grouted alluvial and landslide mass in place. The outer curtain was constructed with a viscous soil-cement mortar mix, with Type II portland cement consisting of at least 12% of the total weight. In general, sufficient water was added to achieve a 0- to 2-inch (0 to 5 cm) slump. However, slumps up to 6 inches (15 cm) were used initially with the intent of permeating the interstices of boulder gravels suspected to be present at the bottom of the channel. The viscous grout was injected as the casing was removed in approximately 1/3-meter "pulls." The minimum injection pressure was approximately 10 psi per foot (226 kPa/m) of casing depth; this minimum was routinely exceeded in order to initiate movement of grout into the ground and to verify refusal. The grout acceptance in each hole typically was less than 100 ft<sup>3</sup> (2.8m<sup>3</sup>). However, inferentially as the result of intersecting voids between boulders, six intervals in five holes each accepted more than 100 ft<sup>3</sup> (2.8 m<sup>3</sup>) of grout, and one hole accepted more than 800 ft<sup>3</sup> (22.5 m<sup>3</sup>) of grout. The aggregate length of displacement-grouted curtain holes was 1,758 feet (535 m<sup>3</sup>), and the total volume of soil-cement grout injected in these holes was 5,638 ft<sup>3</sup> (159 m<sup>3</sup>).

Grout consisting of a sodium silicate/microfine cement mixture was injected into interior perimeter curtain holes on the north, south and west sides only. These holes were

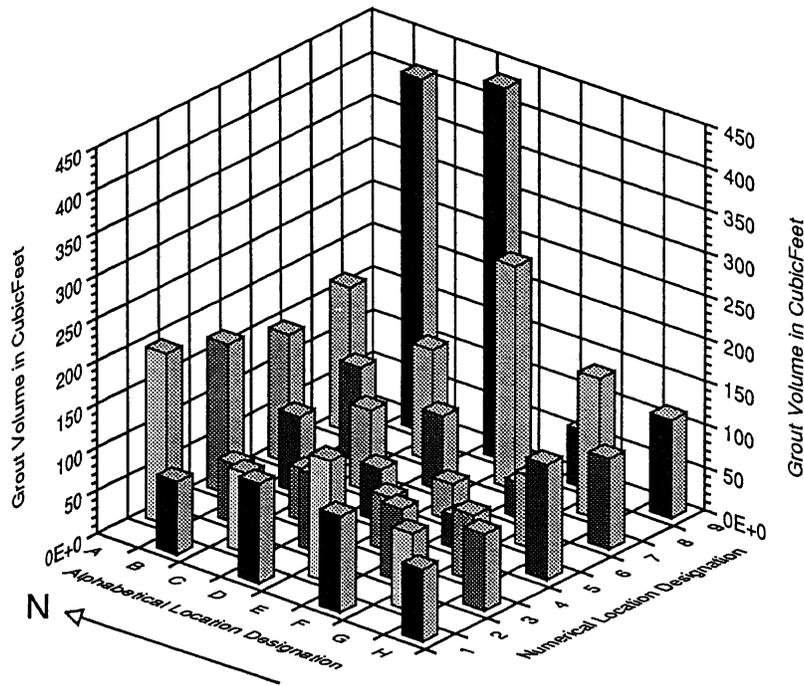
Figure 2. DISTRIBUTION OF COMPACTION GROUT TAKES

#### Compaction Grouting
